FINAL REPORT

MATERIALS COMPATIBILITY WITH THE VOLCANIC ENVIRONMENT

K. M. Htun  
Mechanical Engineering Department  
University of Hawaii  
Honolulu, Hawaii 96822

March 8, 1984

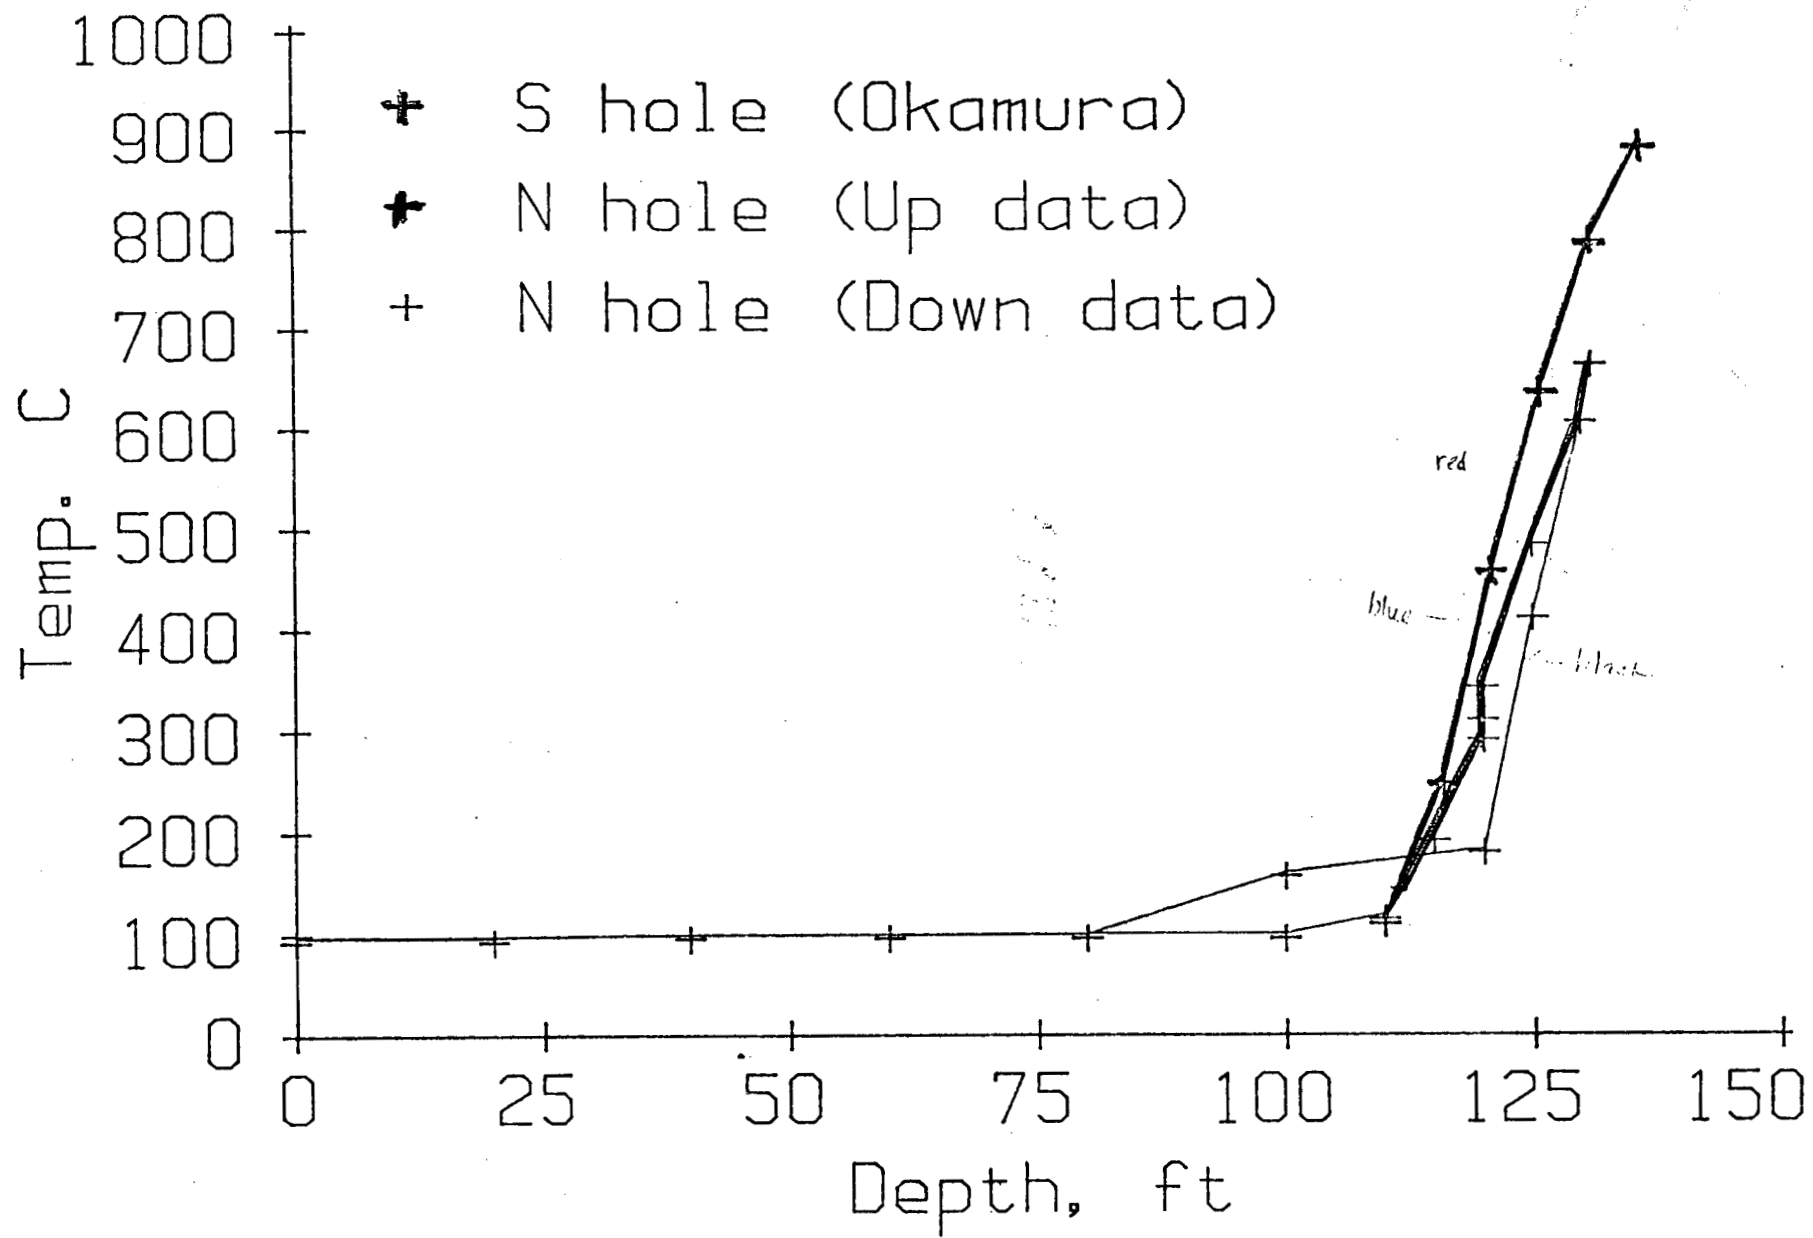
Fig. 1. The S hole temperatures, in the Kilauea Iki drill holes, were measured by R. Okamura of HVO on 10/14/76. The N hole temperatures were measured on 8/5/77. The down temperatures were determined as the T.C. was lowered, and the up data as the T.C. was raised after reaching bottom.

The temperatures in fissures at a more recent eruption site (1975) was about 240°C. Two 4-in. dia holes were drilled into the solidified lava lake in the Kiluea-Iki crater by Sandia in August and September, 1976. The temperature at the bottom of the S hole was 704°C. The temperatures measured by R. Okamura of HVO in the same hole, Fig. 1, was 887°C at the bottom. The first temperature was measured soon after drilling and was low possibly because of the chilling effect of the mud and water used in the drilling process. The drill hole temperatures were measured again on May 8, 1977, see Fig. 1. Note that the two temperatures shown are from two different holes, the 1976 data is from the S hole and the 1977 data is from the N hole. It was not possible to measure the temperatures in the S hole in 1977 because of an obstruction in the hole at about 4 m. depth.
