## **The Flathead Tunnel**

**A Geologic, Operations, and Ground Support Study,  
Burlington Northern Railroad, Salish Mountains,  
Montana**

Information Circular 8662

**By Eugene H. Skinner**

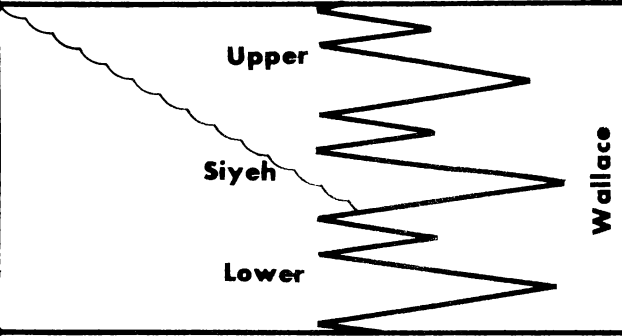
FIGURE 3. - Generalized stratigraphy of Salish Mountains.

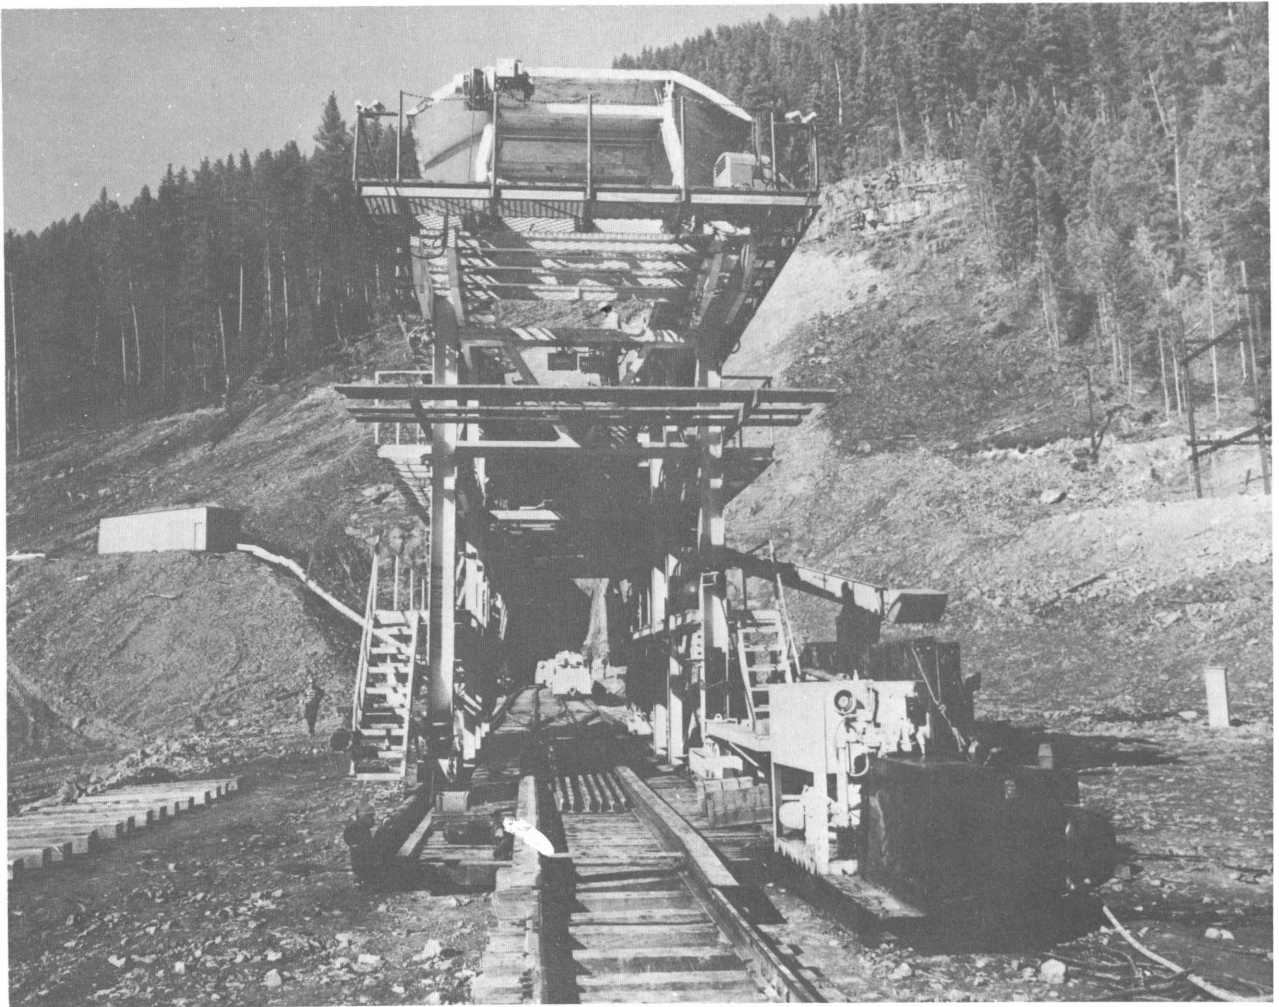
FIGURE 9. - Rear view of jumbo and sliding floor.

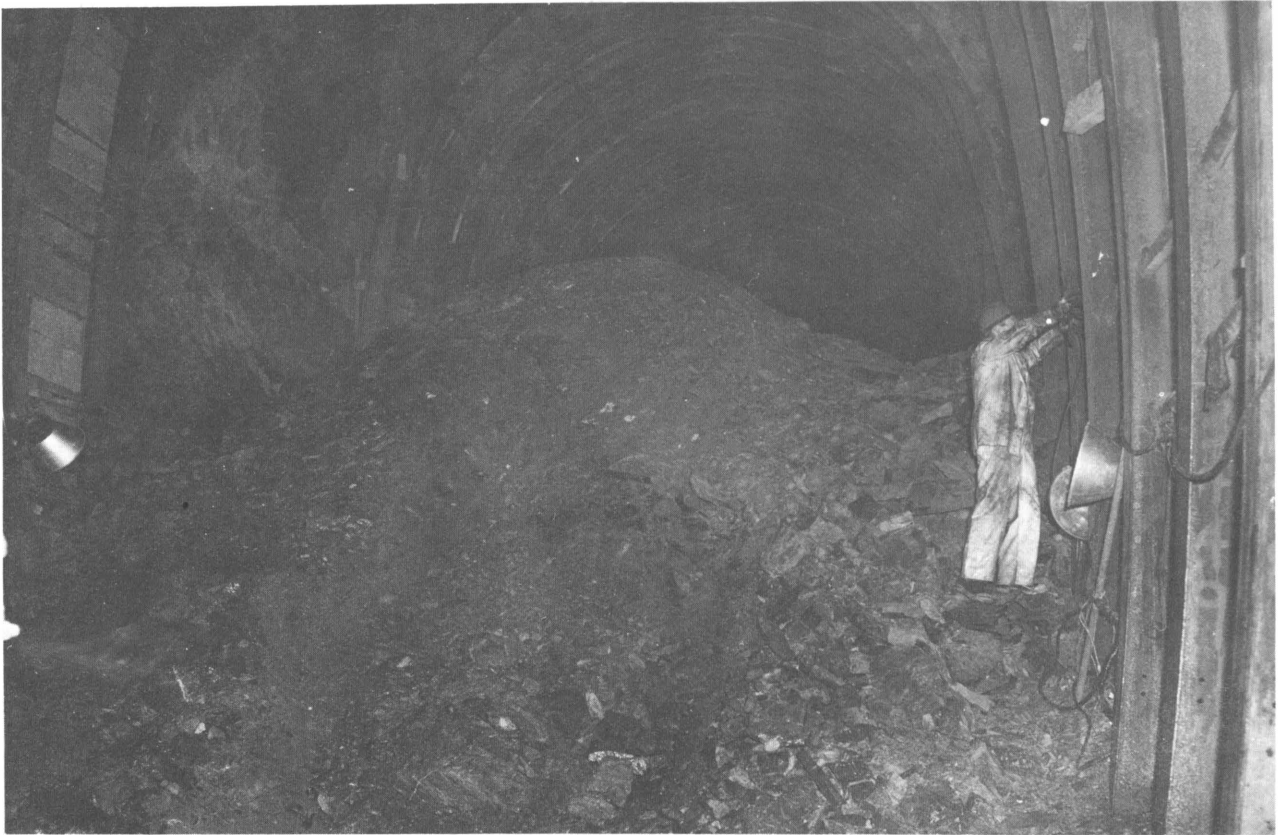
FIGURE 13. - Muck pile at final round, station 3157 + 01.

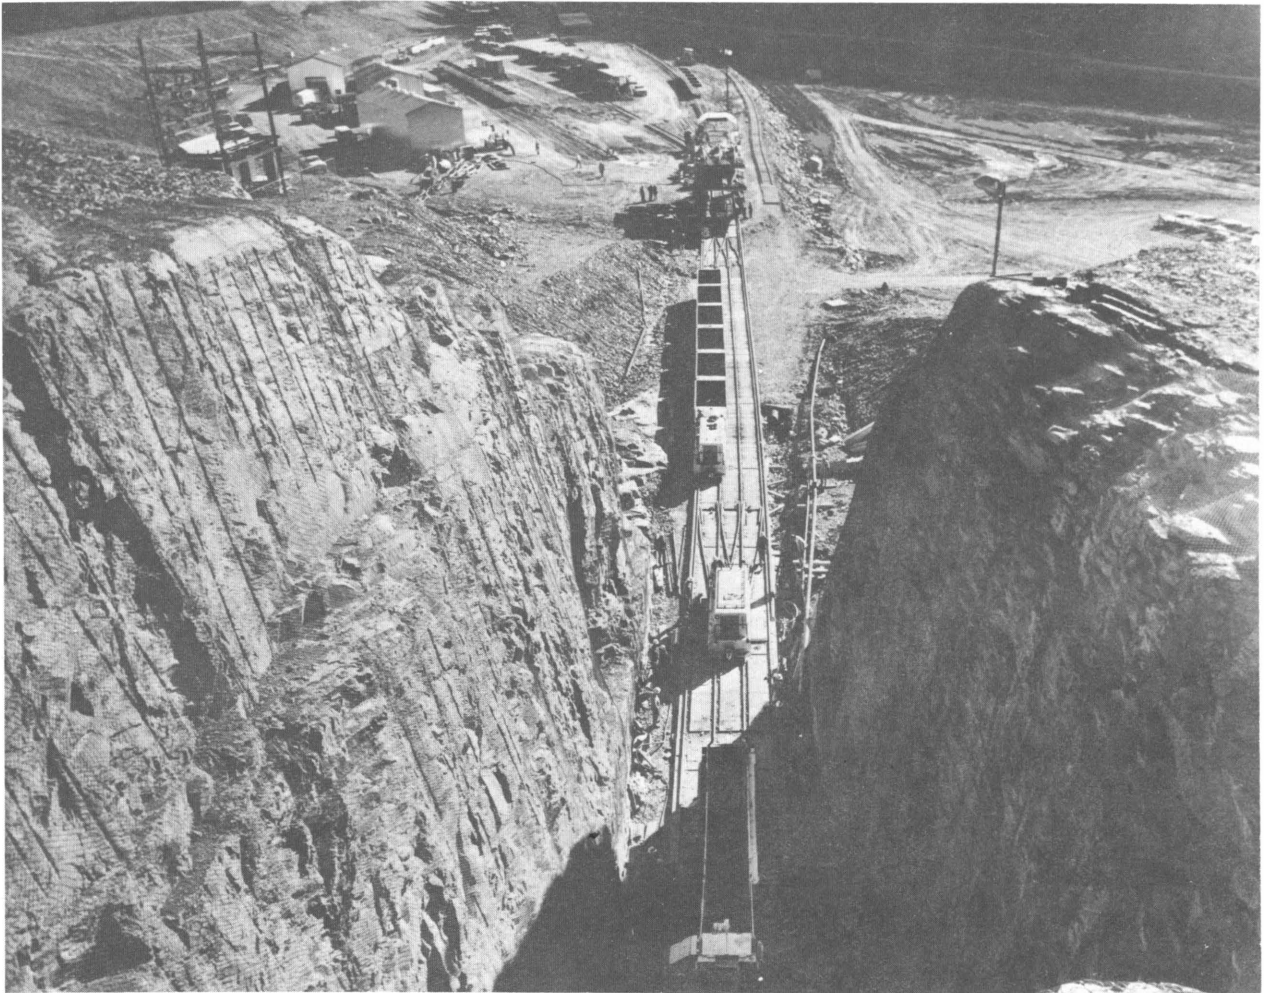
FIGURE 14. - Typical mucking equipment layout.

Two muck trains, made up of seven to eight cars each, handled loaded cars and positioned empty cars, respectively, for loading on the sliding floor. The train of empties was positioned alongside the train being loaded on the sliding floor. As a loaded train was moved away from the heading, empty cars were positioned to the mucking machine "on the fly." A third train was used for longer hauls to outside dumping sites. Additional muck cleanup along the invert was done at some distance behind the sliding floor with a Case model 310 backhoe. Muck from this cleanup was loaded into standby trains. This work was done during drilling and support cycles. It substantially reduced the amount of preparation required for succeeding concrete operations. Figure 14 shows the typical lineup of mucking equipment at the south portal. From foreground to background, note the Conway mucker, switching locomotives, muck train, and drill jumbo, respectively. All equipment shown rides on the sliding floor. Figure 14, at the south portal, and figure 35, at the north portal, also show the extensive rock bolting with chain link fencing at the rock cuts of both portals.

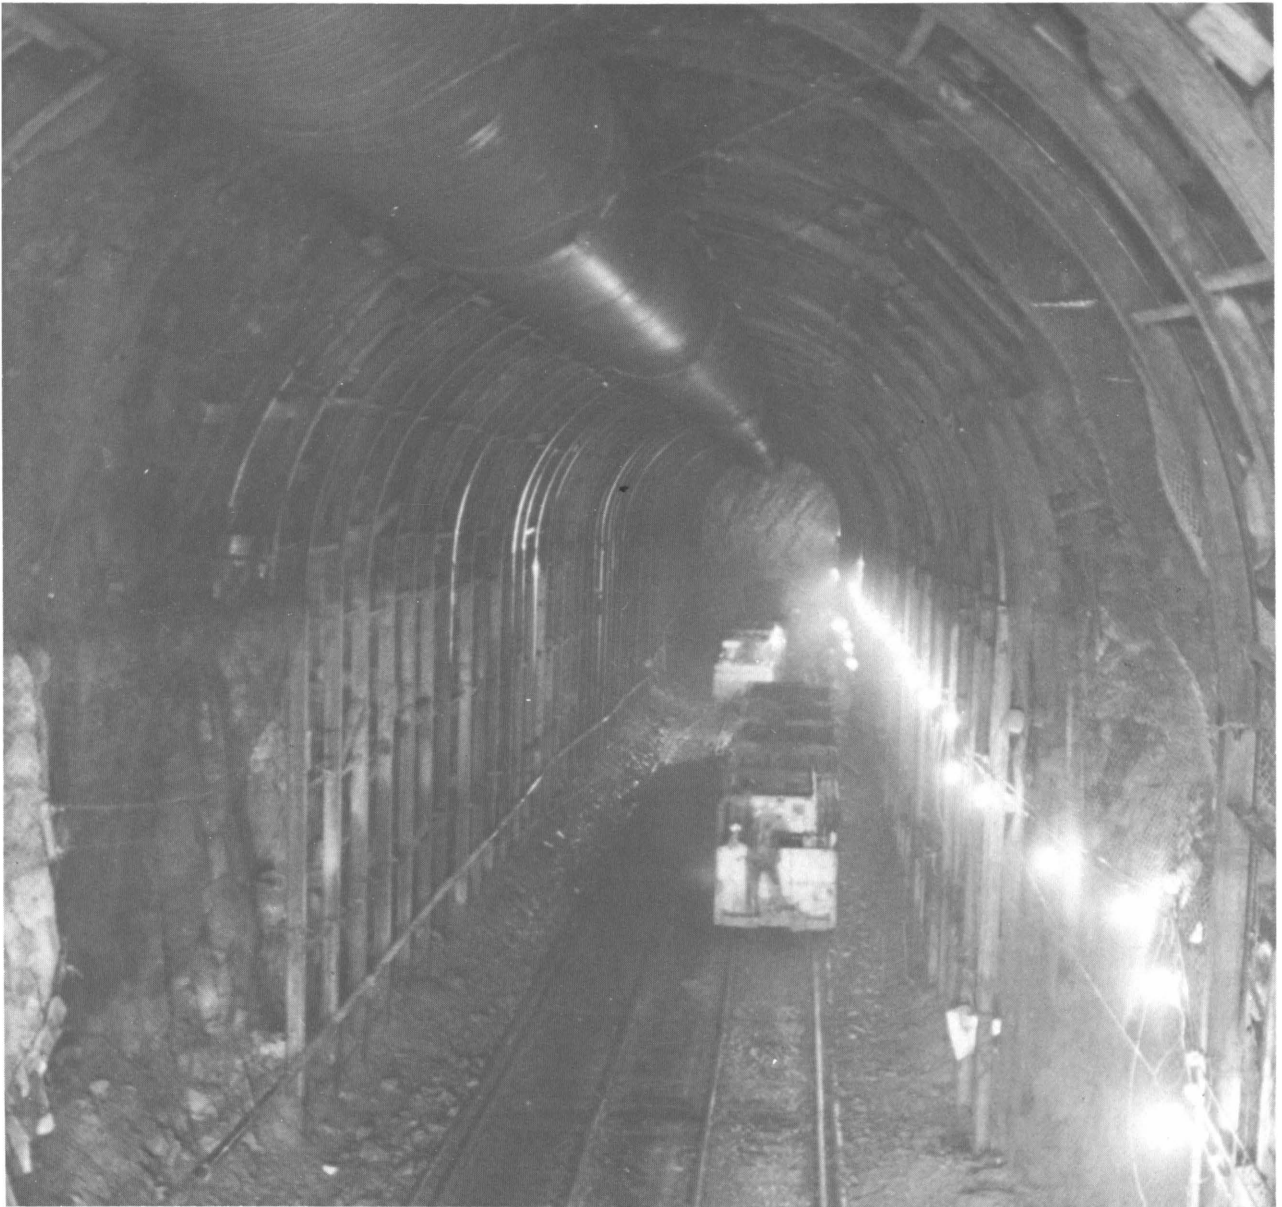
FIGURE 16. - Steel support in north heading.

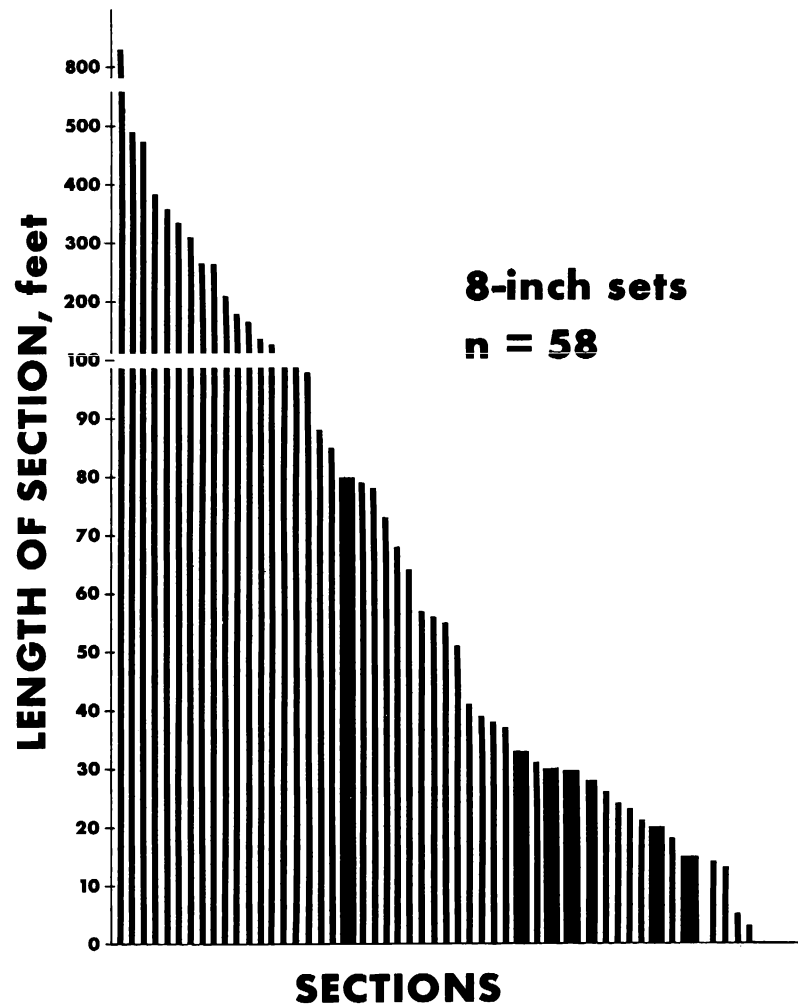
FIGURE 19. - Distribution of tunnel lengths supported with 8-inch sets.

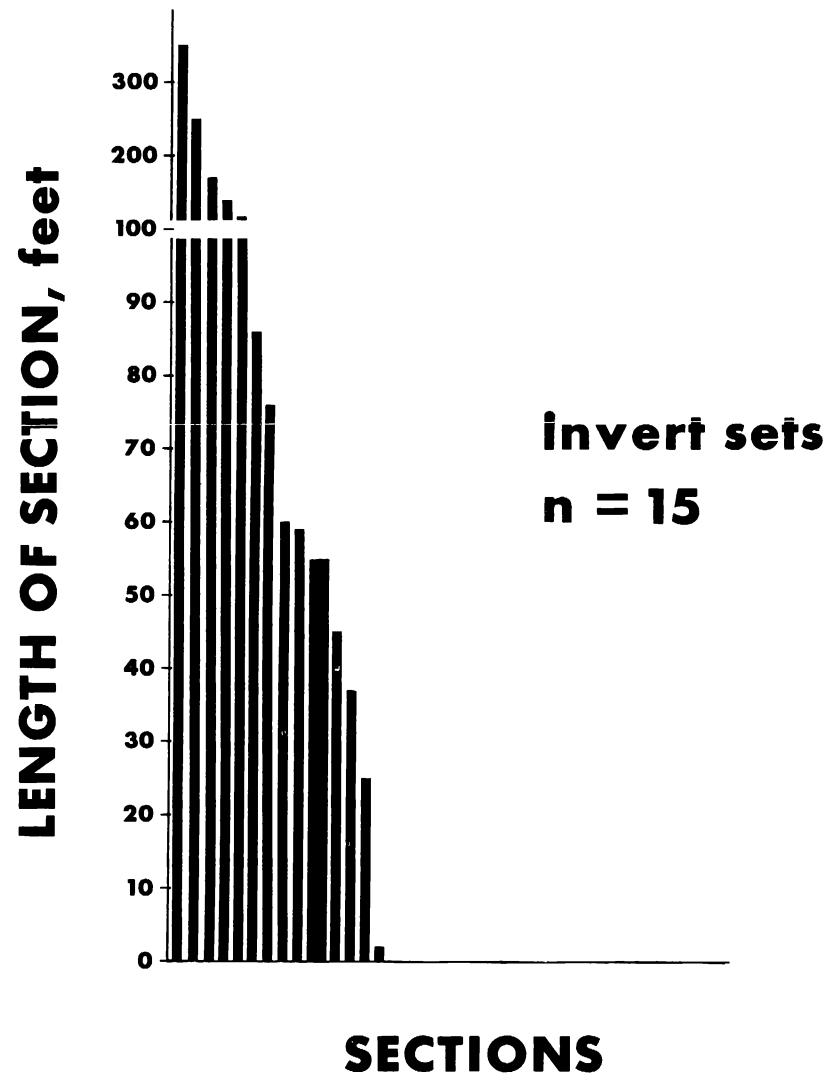
FIGURE 20. - Distribution of tunnel lengths supported with invert struts.

Approximately 1,530 feet of invert struts were placed, all within fault zones. The invert struts were 8-inch, 34.3-pound members used in conjunction with 8-inch steel sets designed for side loads. The Twin Meadows Fault required about 360 feet of continuous invert struts on 1.5-, 2-, and 3-foot centers, and the Gray Creek Fault about 125 feet on 3-foot centers. The east branch of the Elk Mountain Fault, however, used invert struts on 4-foot centers discontinuously over a length totaling about 1,700 feet. Ten sections of invert struts, ranging from about 20 to 250 feet and averaging 85 feet, were alternated with regular 8-inch sets in about equal lengths. Nearly the entire length was lagged solidly. Interestingly, all invert struts were placed only between stations 3110+64 to 3191+84, where the above-mentioned faults occurred. This 8,020-foot length represented about 23 percent of the total tunnel length. Coincidentally, combined 8-inch sets and invert strut support was 22.85 percent of the total, compared with the estimate of 20 percent requiring heavier support. Figure 20 shows individual lengths of tunnel supported with invert struts.

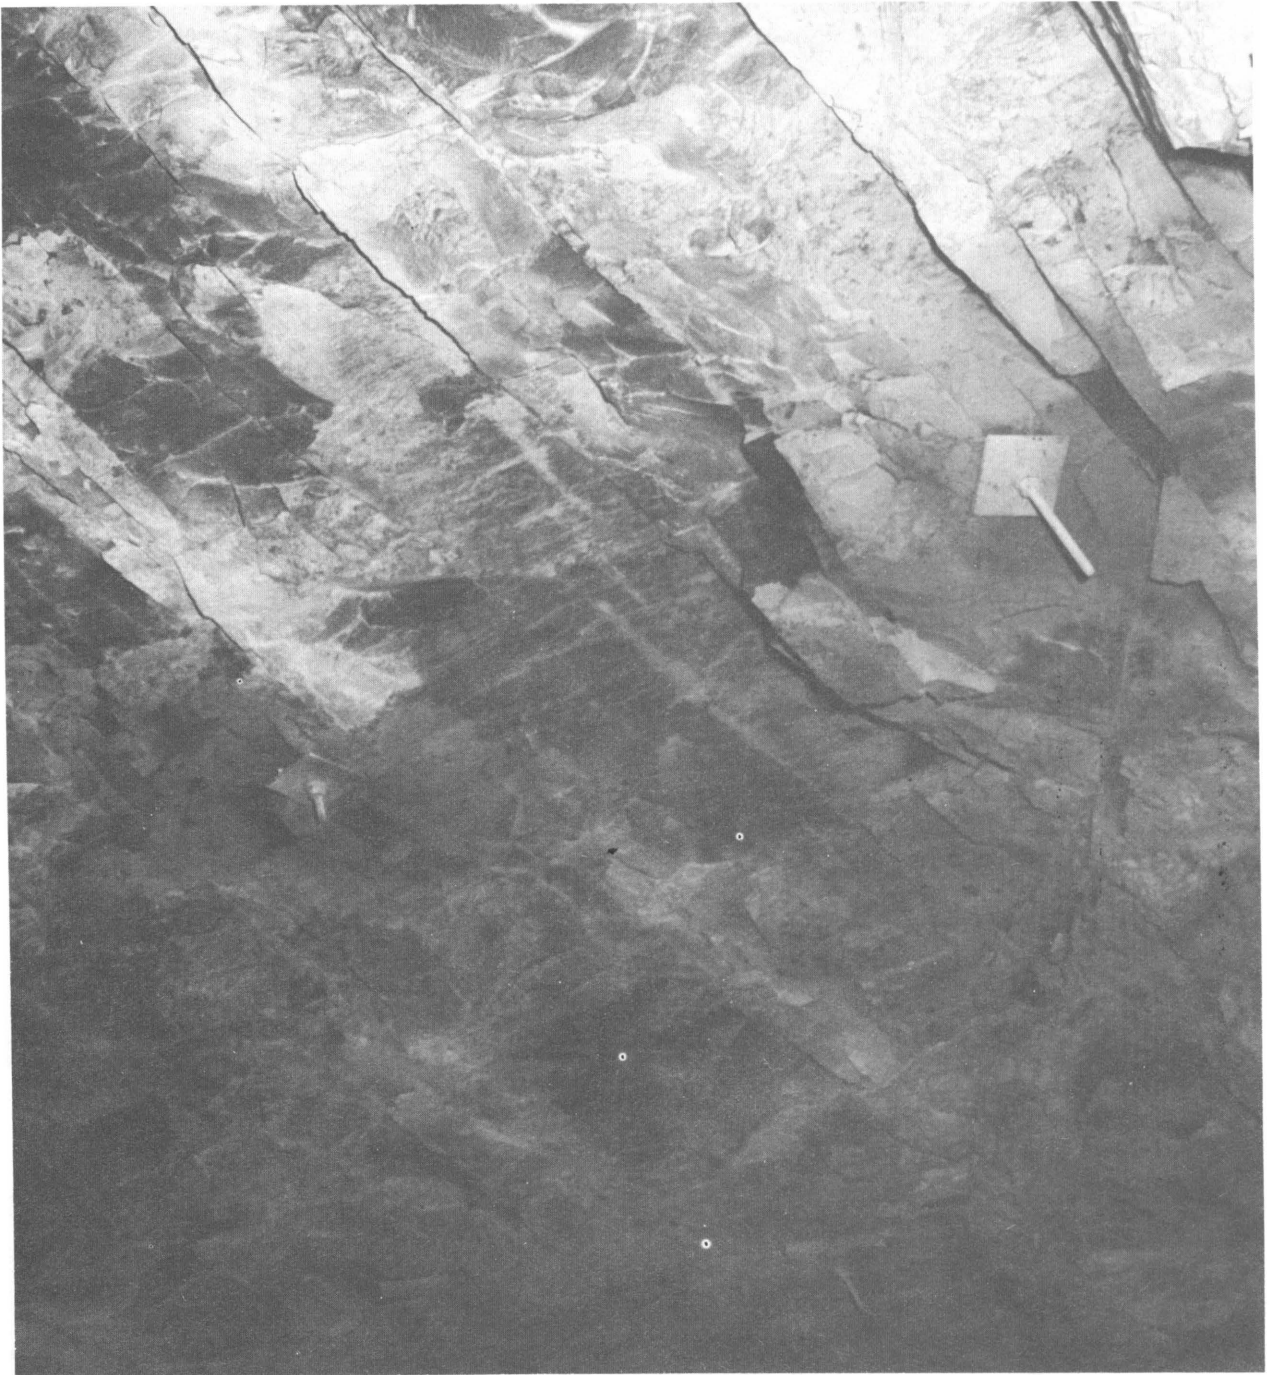
FIGURE 21. - Typical arch rock before rock bolting.

Rock-bolt support during tunnel driving was dependent upon round-by-round judgements and working conditions. Nearly 27.3 percent of the total tunnel length was rock-bolted. Rock-bolt support was authorized by mutual agreement in the field between the contractor and Corps of Engineers on a round-by-round basis. Both the contractor's supervisors and Corps of Engineers' inspectors had authorization to install supports as needed. Rock-bolt support followed section 4 of the tunnel excavation specifications (43). Specifications did not call for designated tunnel sections to require either rock bolts or steel sets. No bare rock sections were specified. Figure 21 shows typical rock structure before rock bolting. C.F. & I. 3/4-inch-diameter rock bolts were

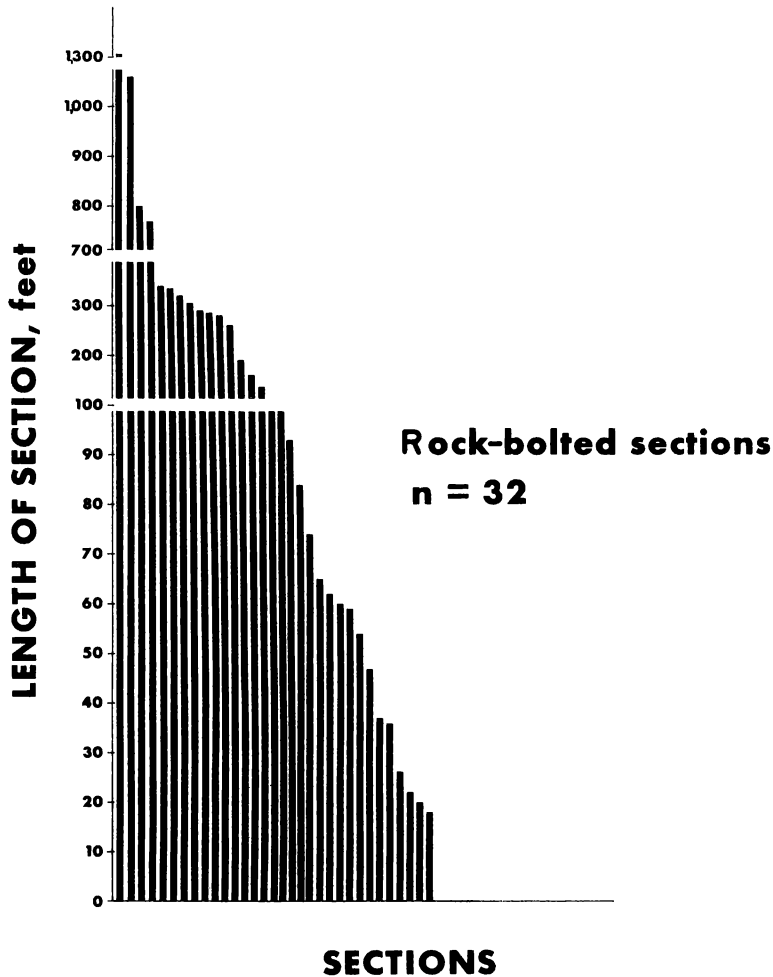
FIGURE 23. - Distribution of rock-bolt support.

No rock-bolted sections of any length were placed in the Elk Mountain Fault zone. Figure 23 shows the individual lengths of tunnel supported with rock bolts. The 27.3 percent of tunnel actually carried by rock bolts is somewhat less than the 40 percent predicted.

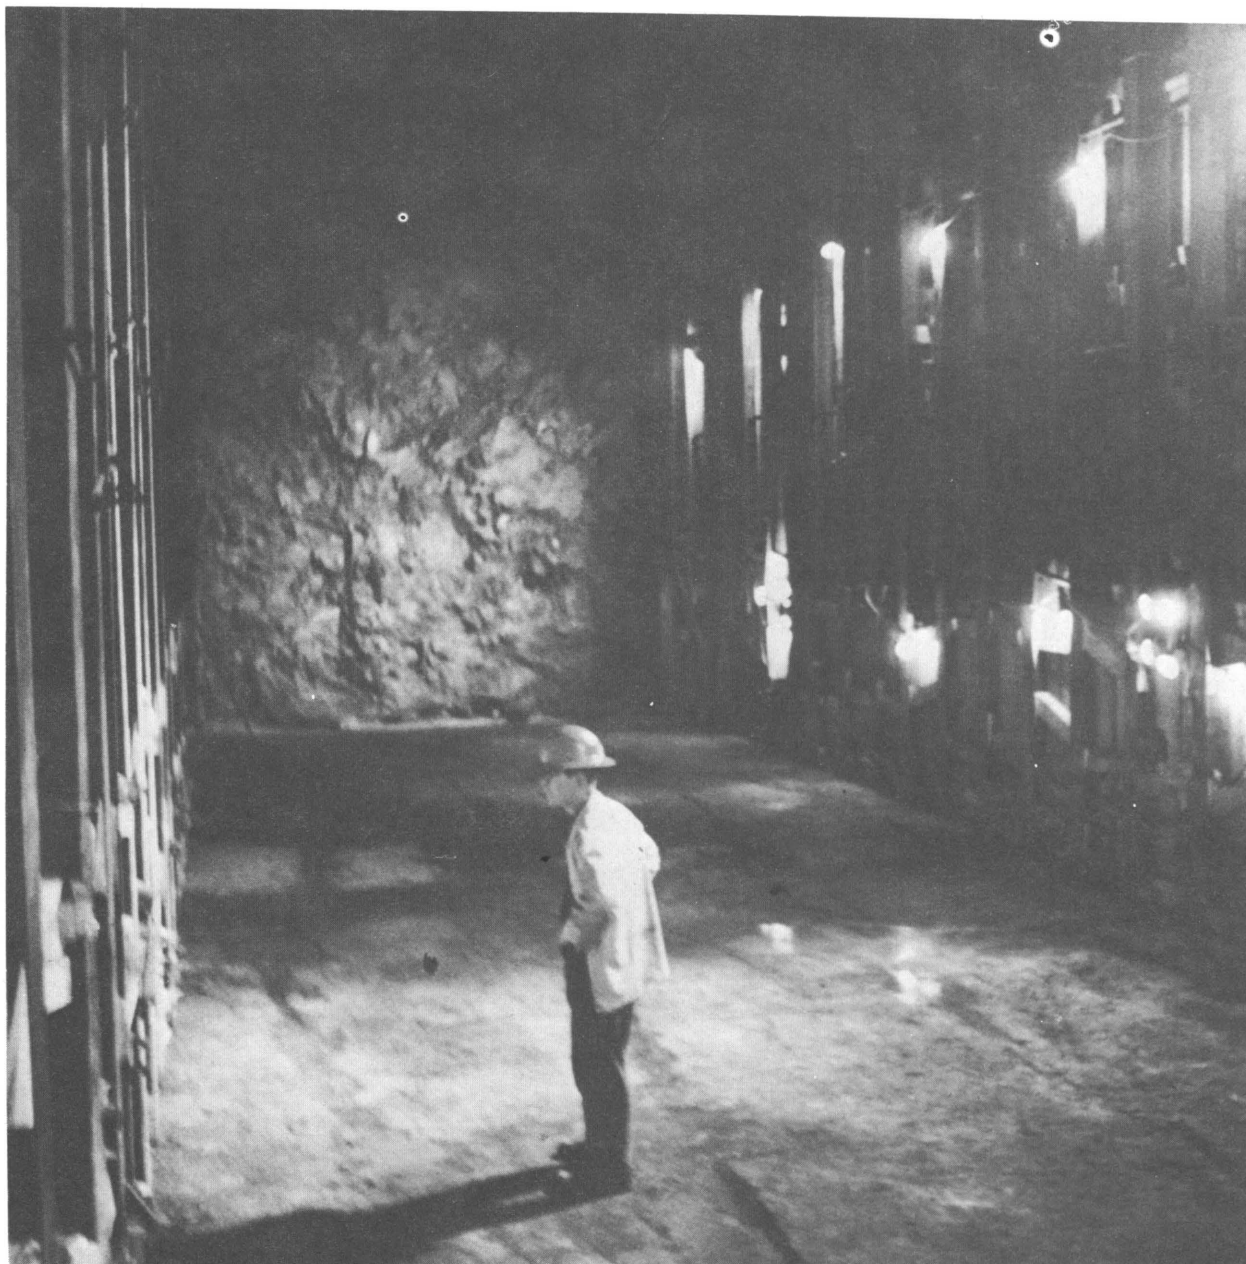
FIGURE 25. - Completed repair of rockfall section.

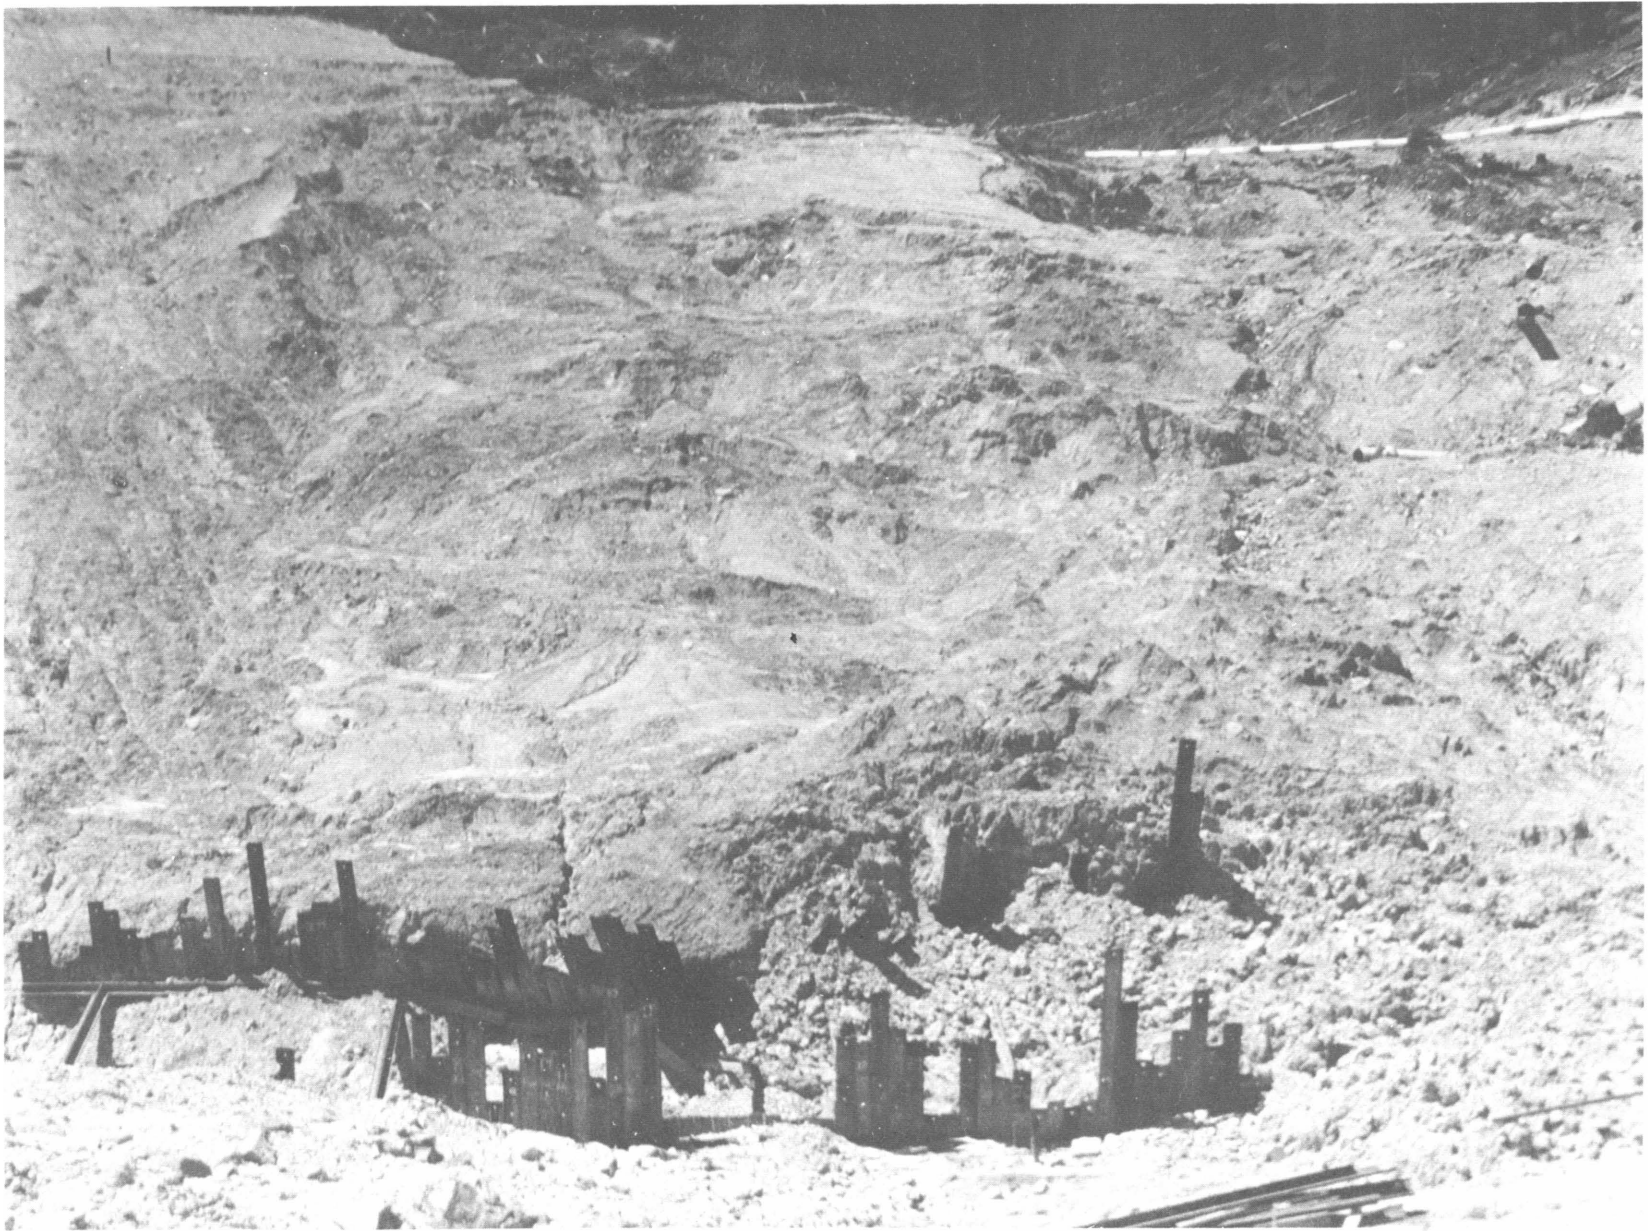
FIGURE 27. - Burrows Creek slide.

An extensive system of 22 horizontal drainage wells with slotted plastic liners was driven to the bedrock surface across the core of the slide during the summer of 1967. These drains produced temporary high initial water flows but substantially less than expected; half the holes quickly became dry. This drainage was in addition to previous drilling and a determined program of surface drainage. Sixteen exploratory holes had been drilled in the slide area during October and November 1966. Fourteen additional churn-drill holes were drilled during February 1967. They were all placed near the head of the slide. Selected holes were test pumped in March and April 1967: four of the

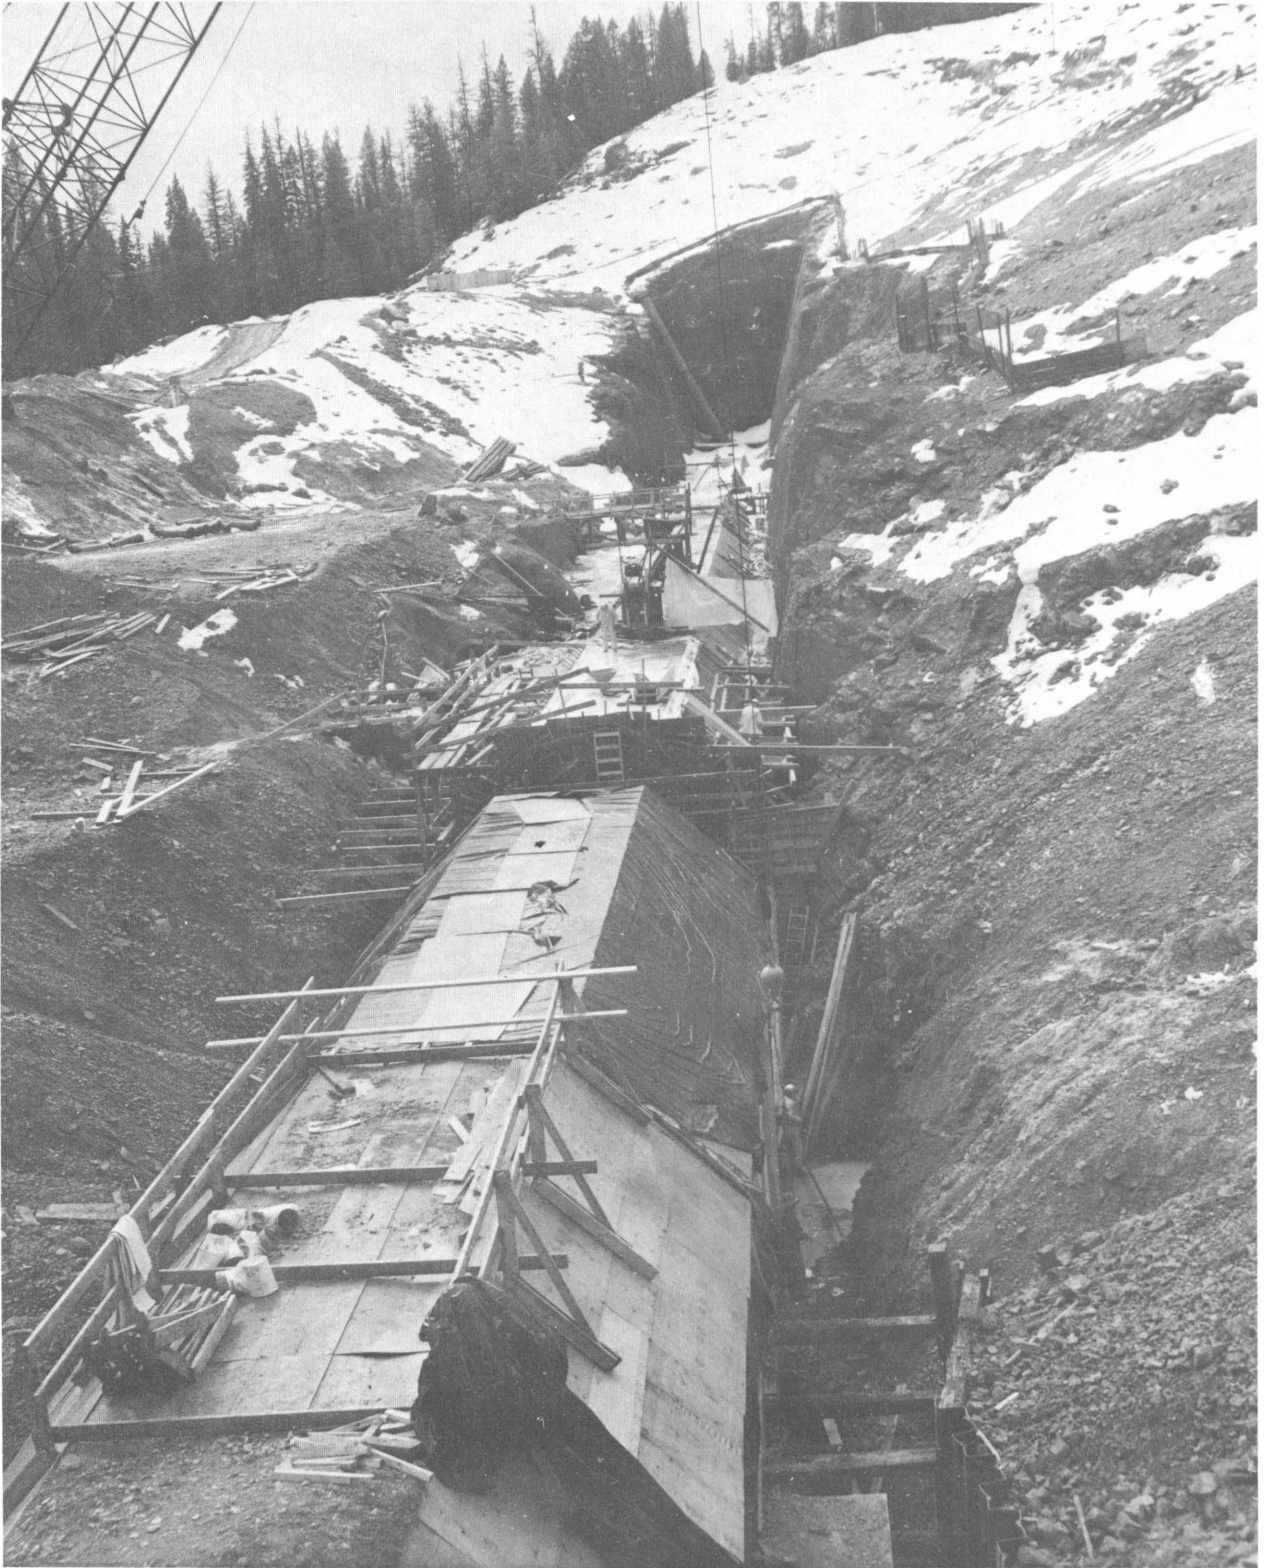
FIGURE 29. - Cut-and-cover construction, north portal.

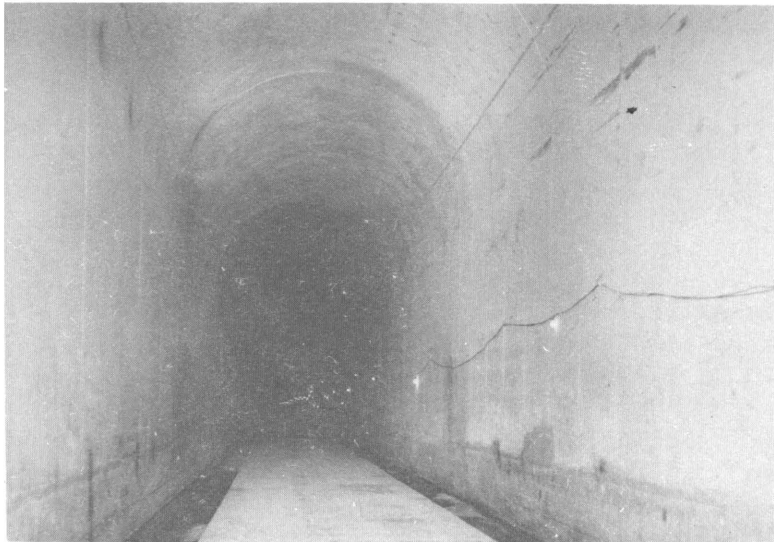
FIGURE 31. - Completed concrete-lined tunnel section.
