SNAP 7 PROGRAM
QUARTERLY PROGRESS REPORT NO. 6
Task 8--Strontium-90 Fueled
Thermoelectric Generator Development

February 1 through April 30, 1962

MARTIN COMPANY
NUCLEAR DIVISION

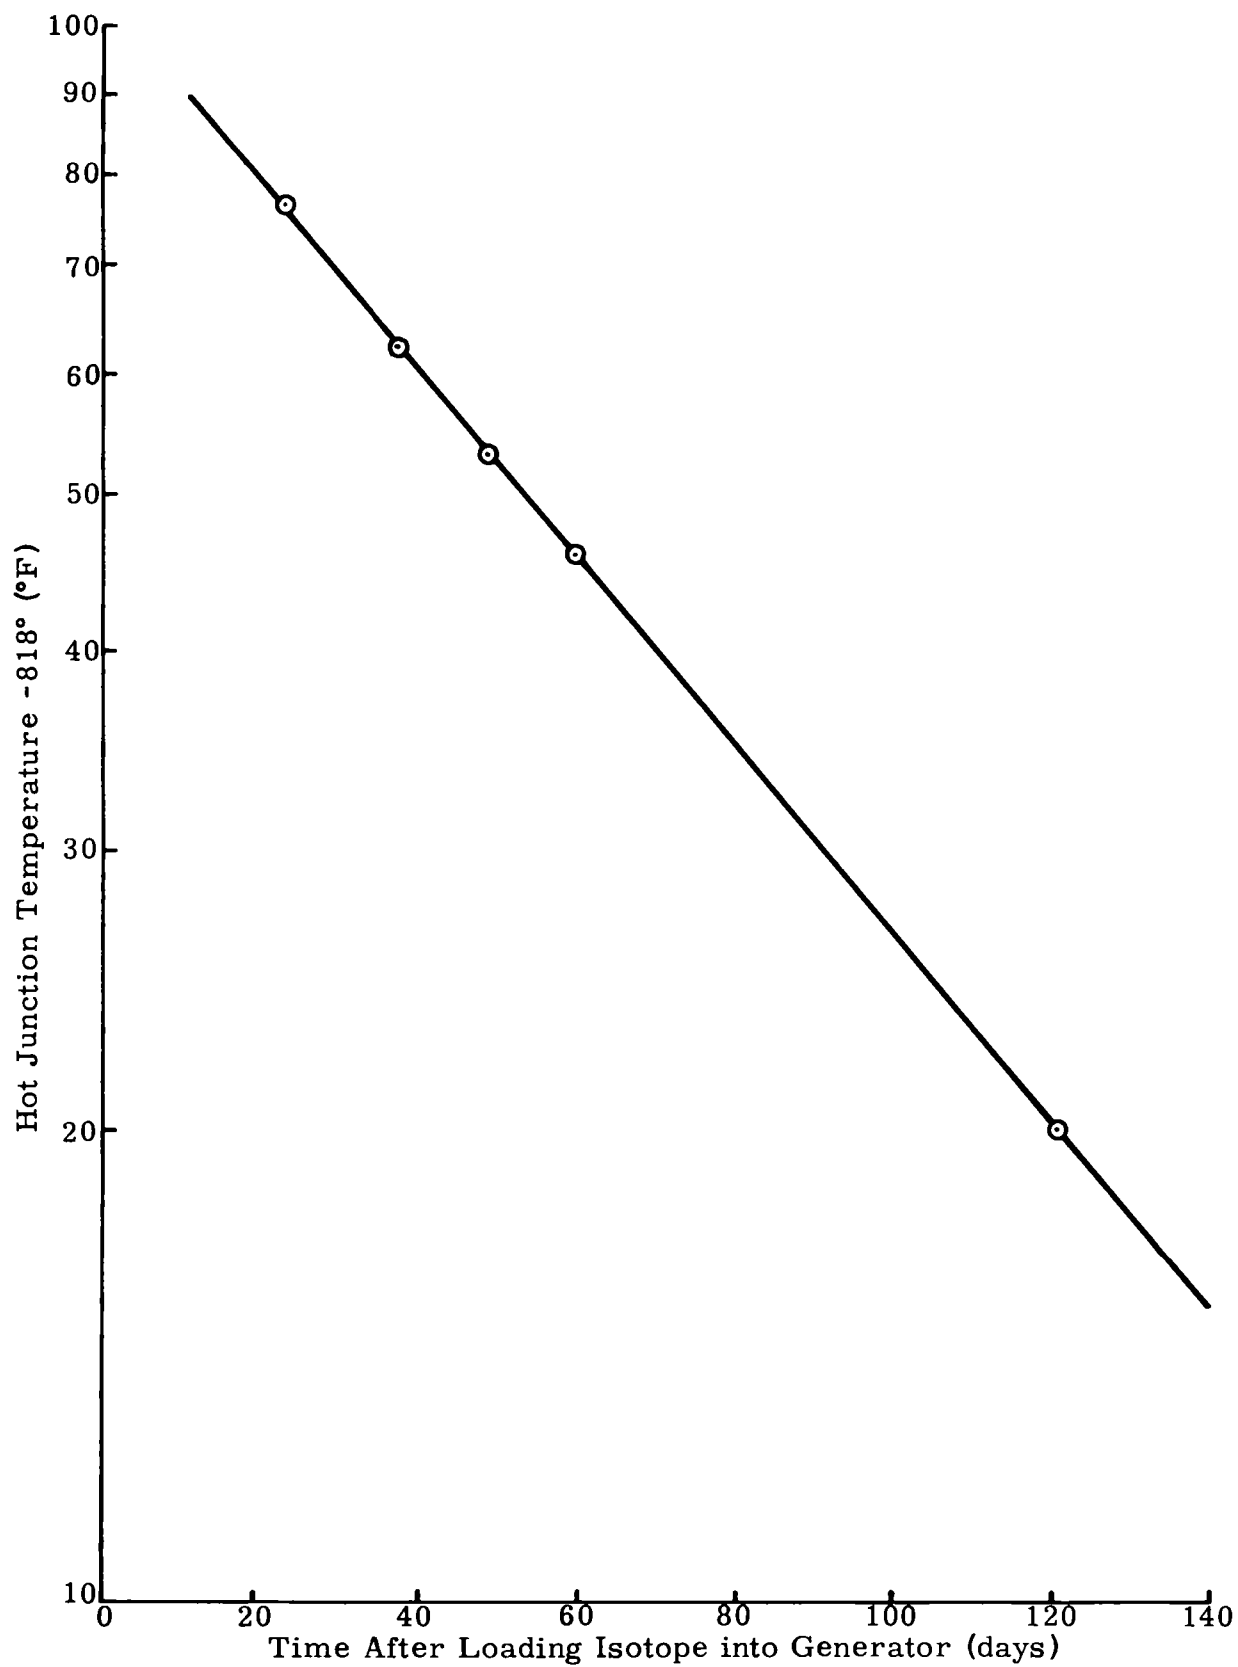
Fig. 1. Determination of Strontium-90 Hot Junction Temperature (ambient water temperature constant)

A third possible cause of the power-temperature decrease was then considered: excess Strontium-89 in the fuel. The slope of semilogarithmic plot of hot junction temperature versus time (assuming constant 40° F water temperature) was found to correspond exactly to that of a Strontium-89 decay curve (see Fig. 1). Accordingly, the curves of hot junction temperature and power output were extrapolated further in time, and measurements taken after the initial extrapolation have been found to lie on the curves (Fig. 2). As the extrapolation is extended for periods of more than a few months, the measured hot junction temperature gradually falls below the curve. This is due to the decay of Strontium-90, which was ignored in the extrapolation. The measured power output has tended to rise above the extrapolated curve, partly because of changes in the actual hot junction and cold junction temperatures resulting from the increase in ambient temperature. The power curve extrapolation is less accurate than the hot junction extrapolation since it is based more on design parameters than on performance.

Estimates of the Strontium-89 content were made by extrapolating the decay curve to determine what the hot junction temperature would have been had the fuel contained only Strontium-90. This temperature was found to be approximately 818° F. By examining electrical test data, it was found that, to produce this hot junction temperature with a cold junction roughly corresponding to that of the submerged generator, a heat input of 232 watts would be required. At insertion of the fuel into the generator, the heat input was approximately 270 watts. The Strontium-89 content at the time of fuel insertion was therefore approximately 40 watts; and the content at the time of encapsulation, approximately 80 watts. The contract was understood to call for a Strontium-89 inventory of no more than 40 watts.

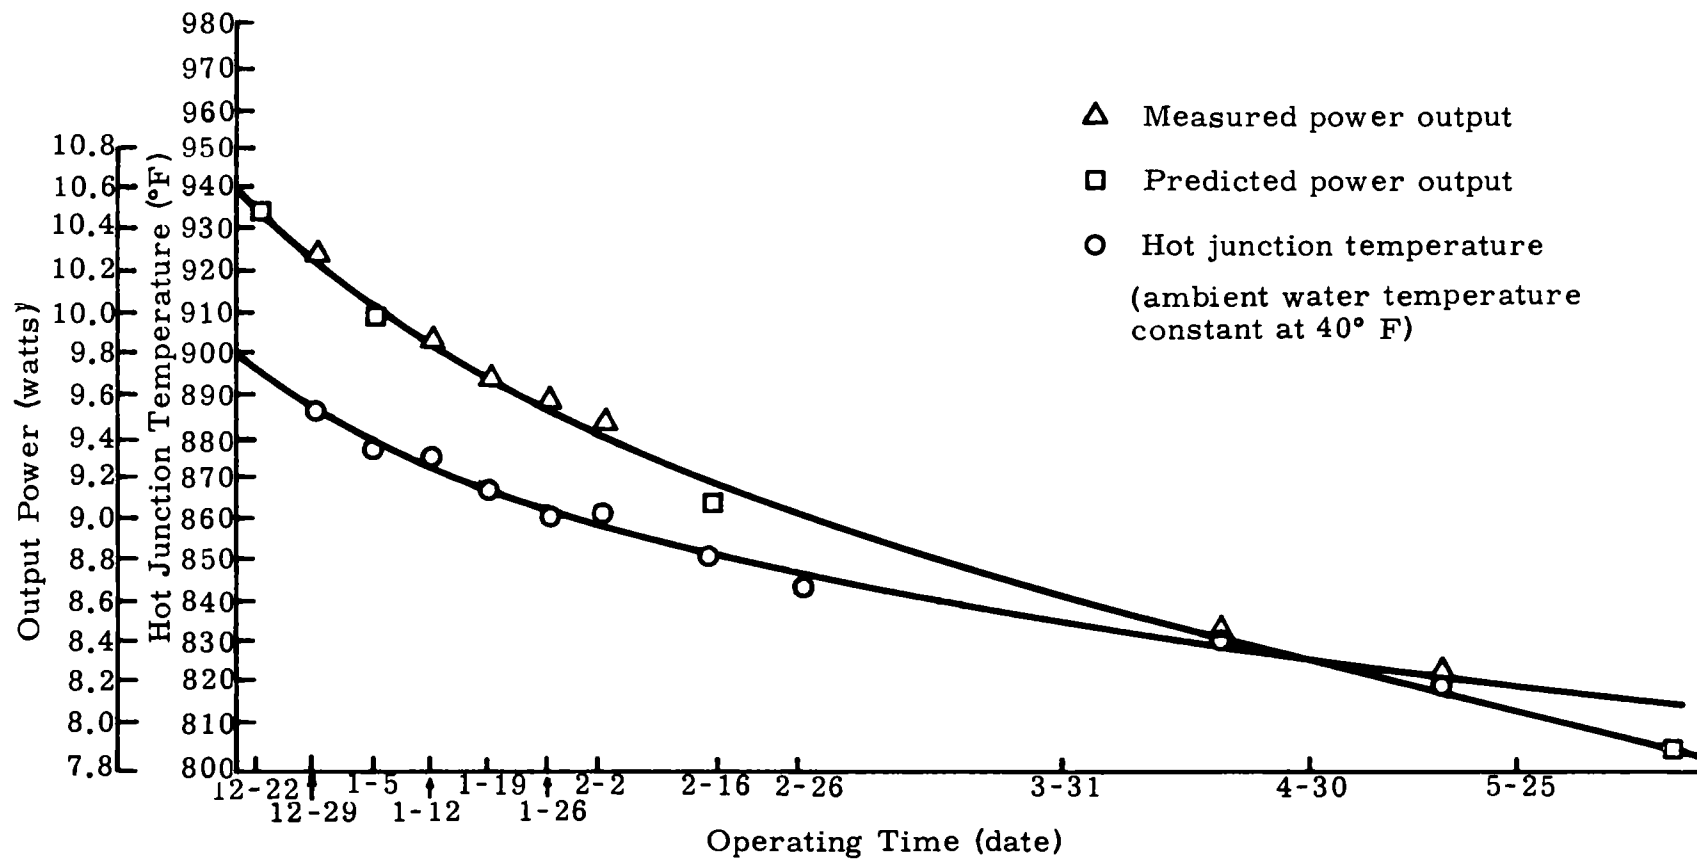
Fig. 2. Operational Data--SNAP 7A Thermoelectric Generator (ambient water temperature constant at 40° F)

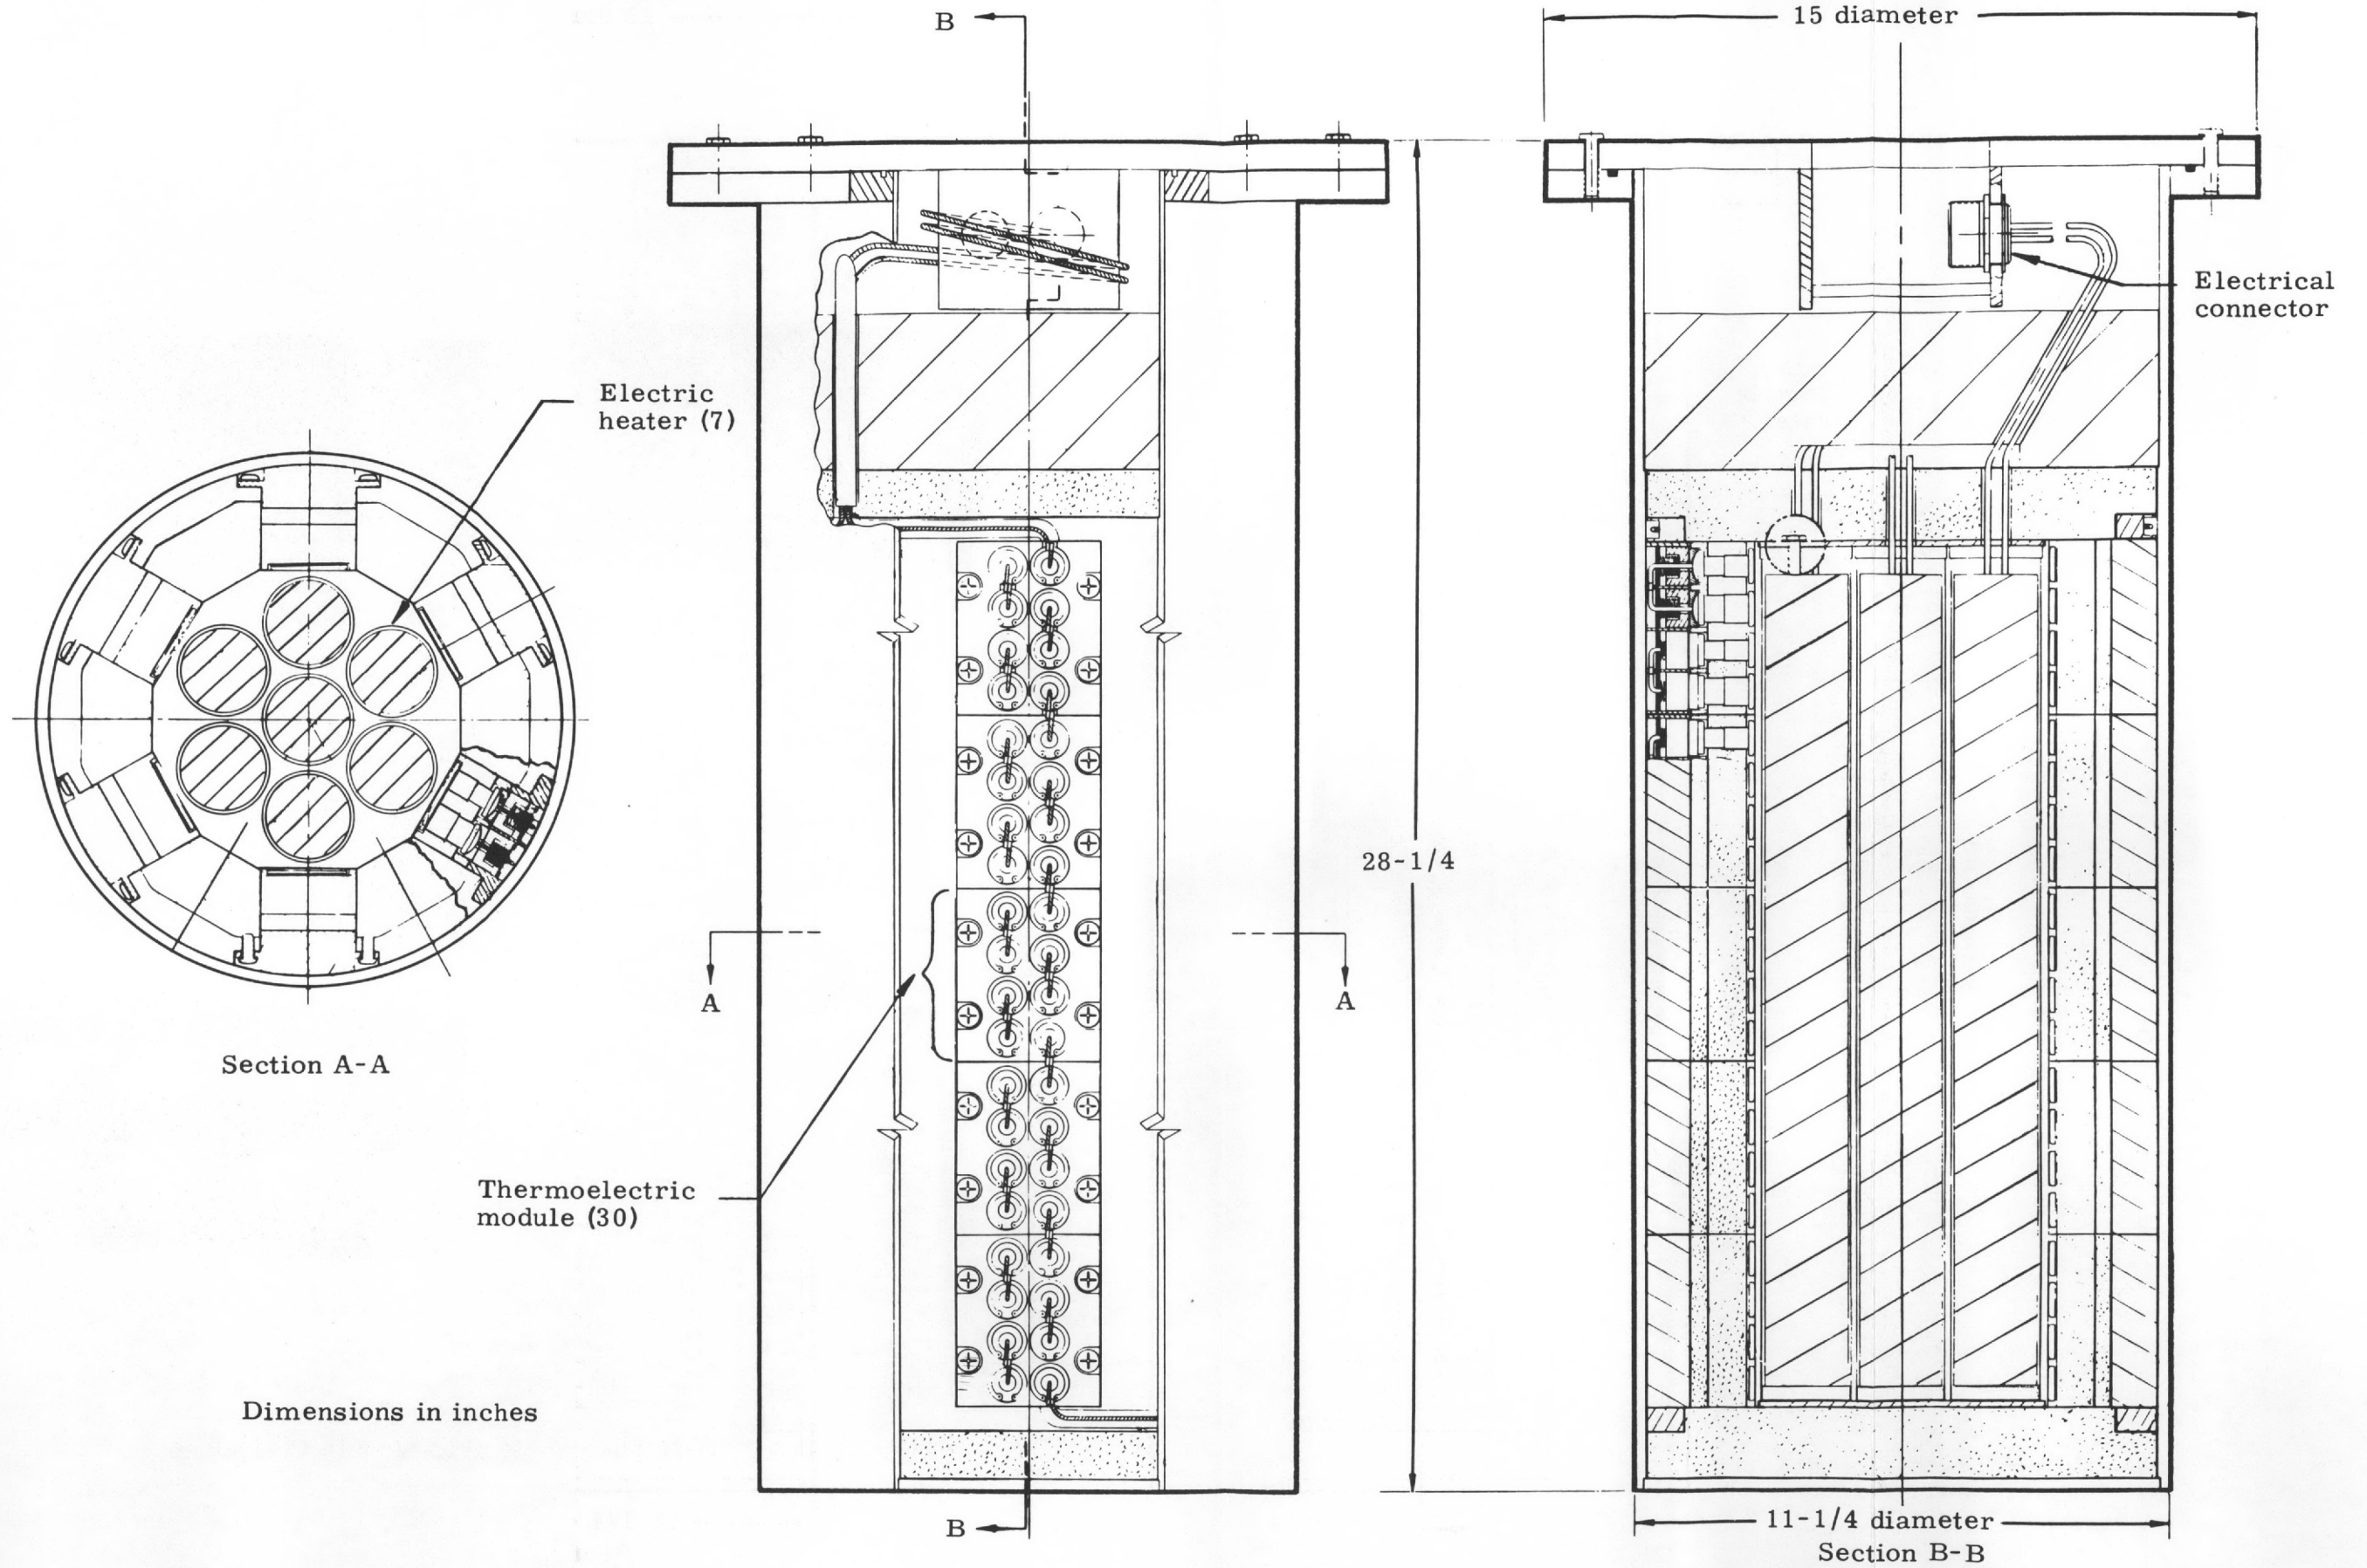
Fig. 3. SNAP 7 60-Watt Operating Model

The first 60-watt generator (Fig. 3) was assembled during the month of March. Thirty modules (Fig. 4) with all-Martin elements were installed. The springs that bear on the elements were inserted as the generator was built up. It was found that the generator cold sink frame (Fig. 5), which retains the module blocks, became barrel-shaped as a result of the force from the compression springs. The deflection was approximately 0.021 inch, and since the design clearance between the generator and container was 0.005 to 0.007 inch, the assembly could not be made. Three special clamping bands were then placed around the generator; the module retaining screws were loosened; and the generator diameter at the midpoint was pulled in. The module retaining screws were retightened, and the clamping bands were removed. The generator could then be readily placed in the container. The generator resistance was monitored during the clamping operation to indicate any damage to the thermoelements.

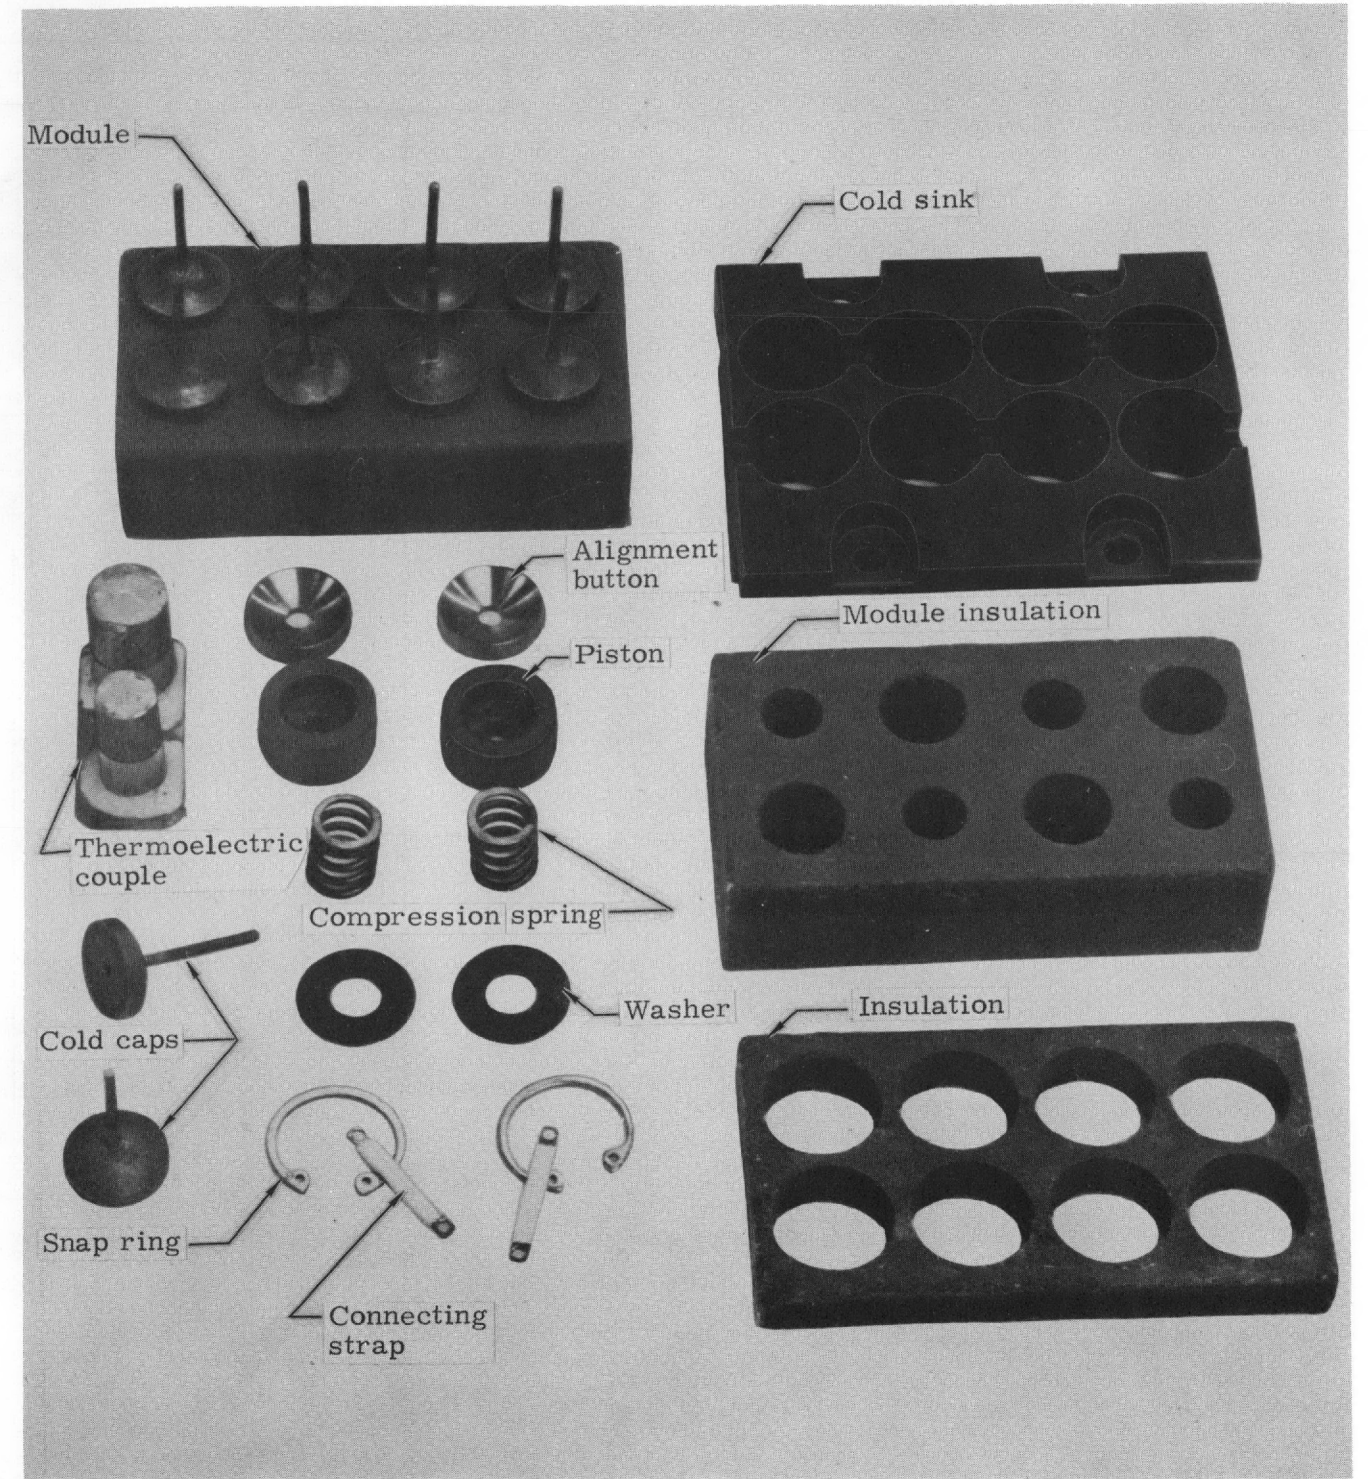
Fig. 4. SNAP 7B-D Thermoelectric Module Components

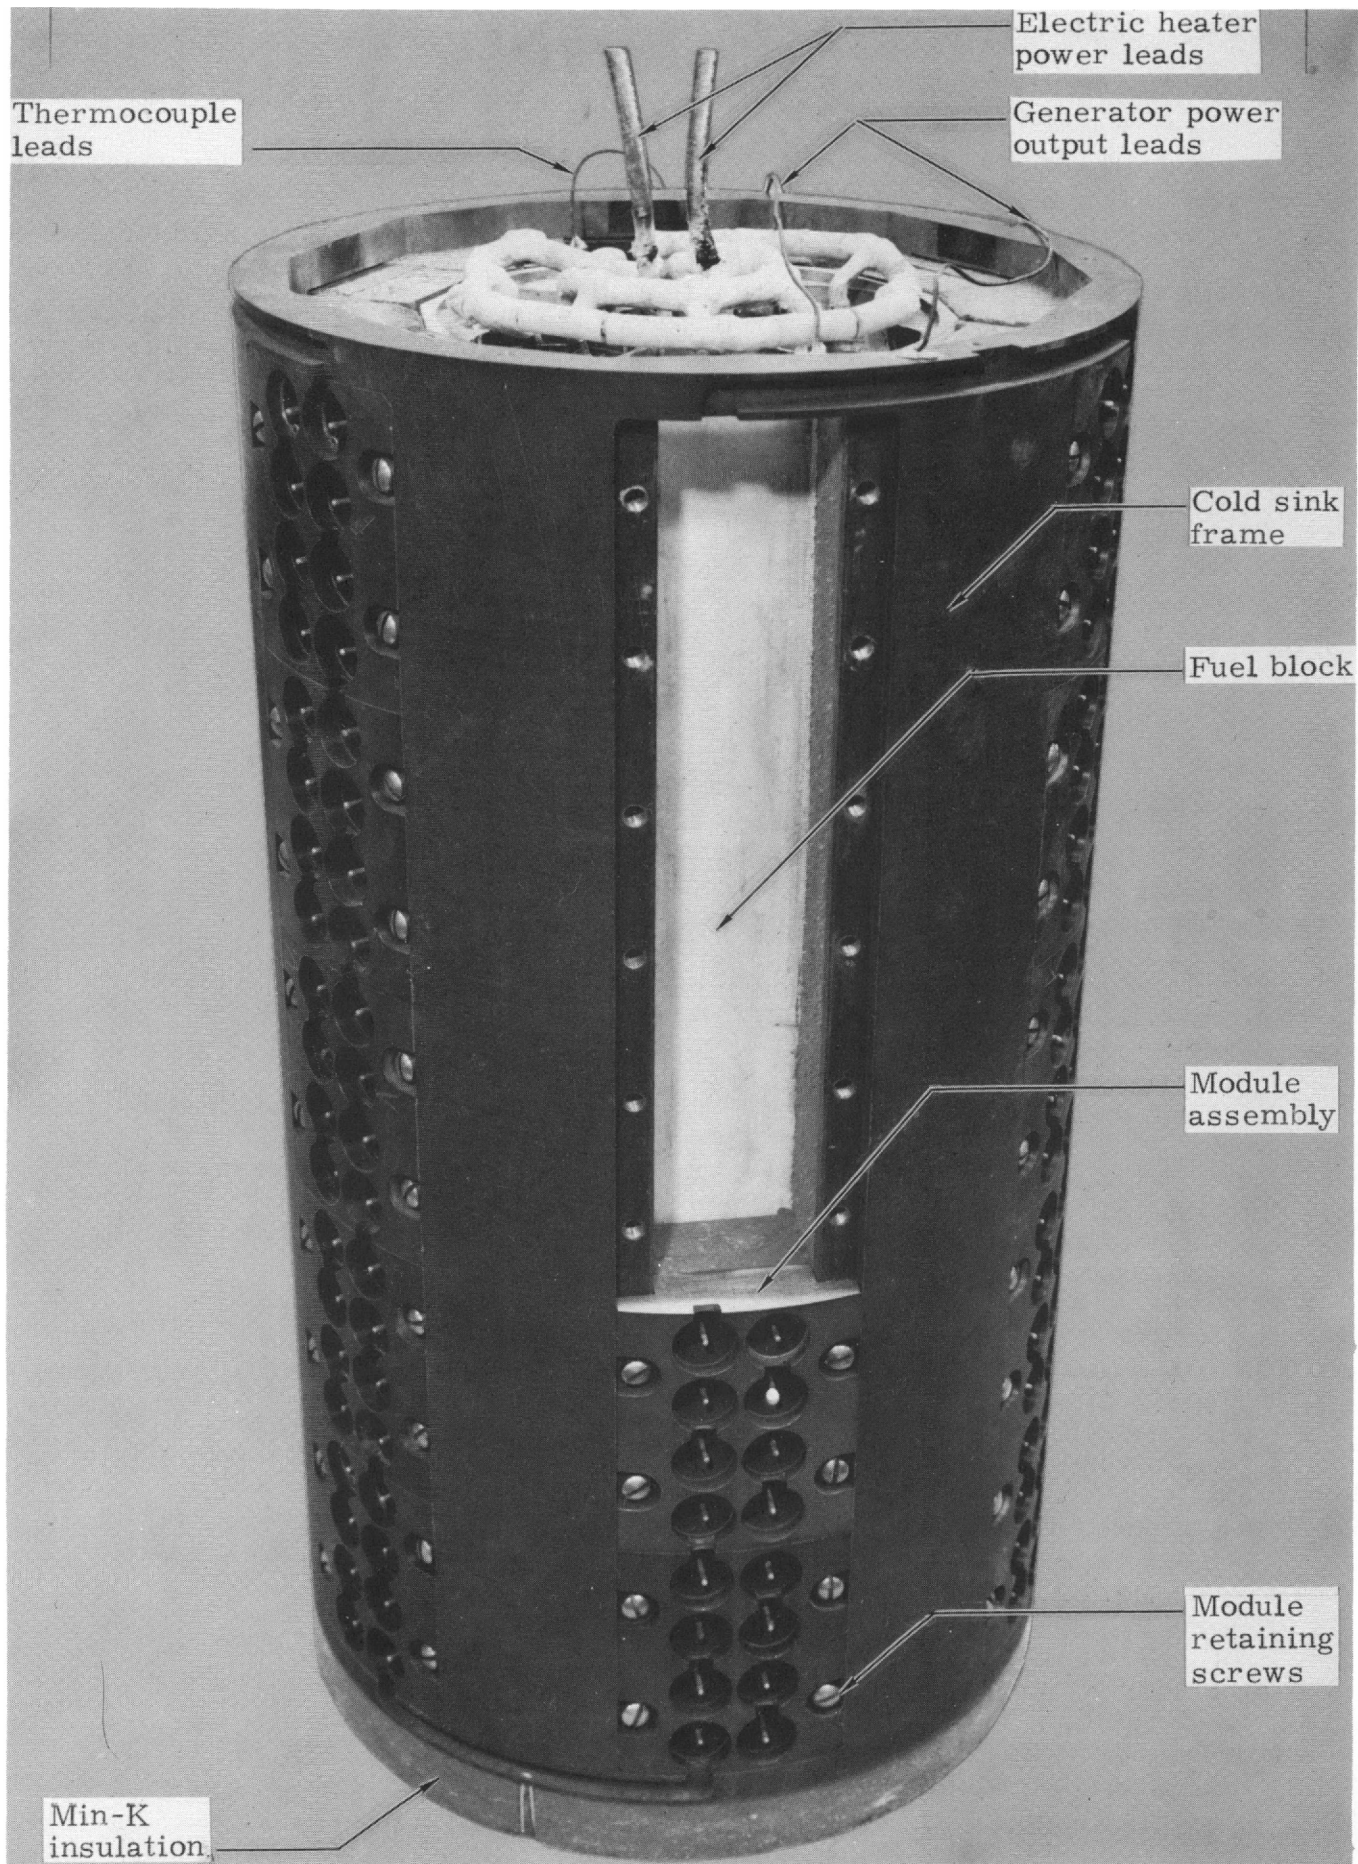
Fig. 5. SNAP 7B-D Thermoelectric Modules Assembled in Electrically Heated Generator (60-watt)

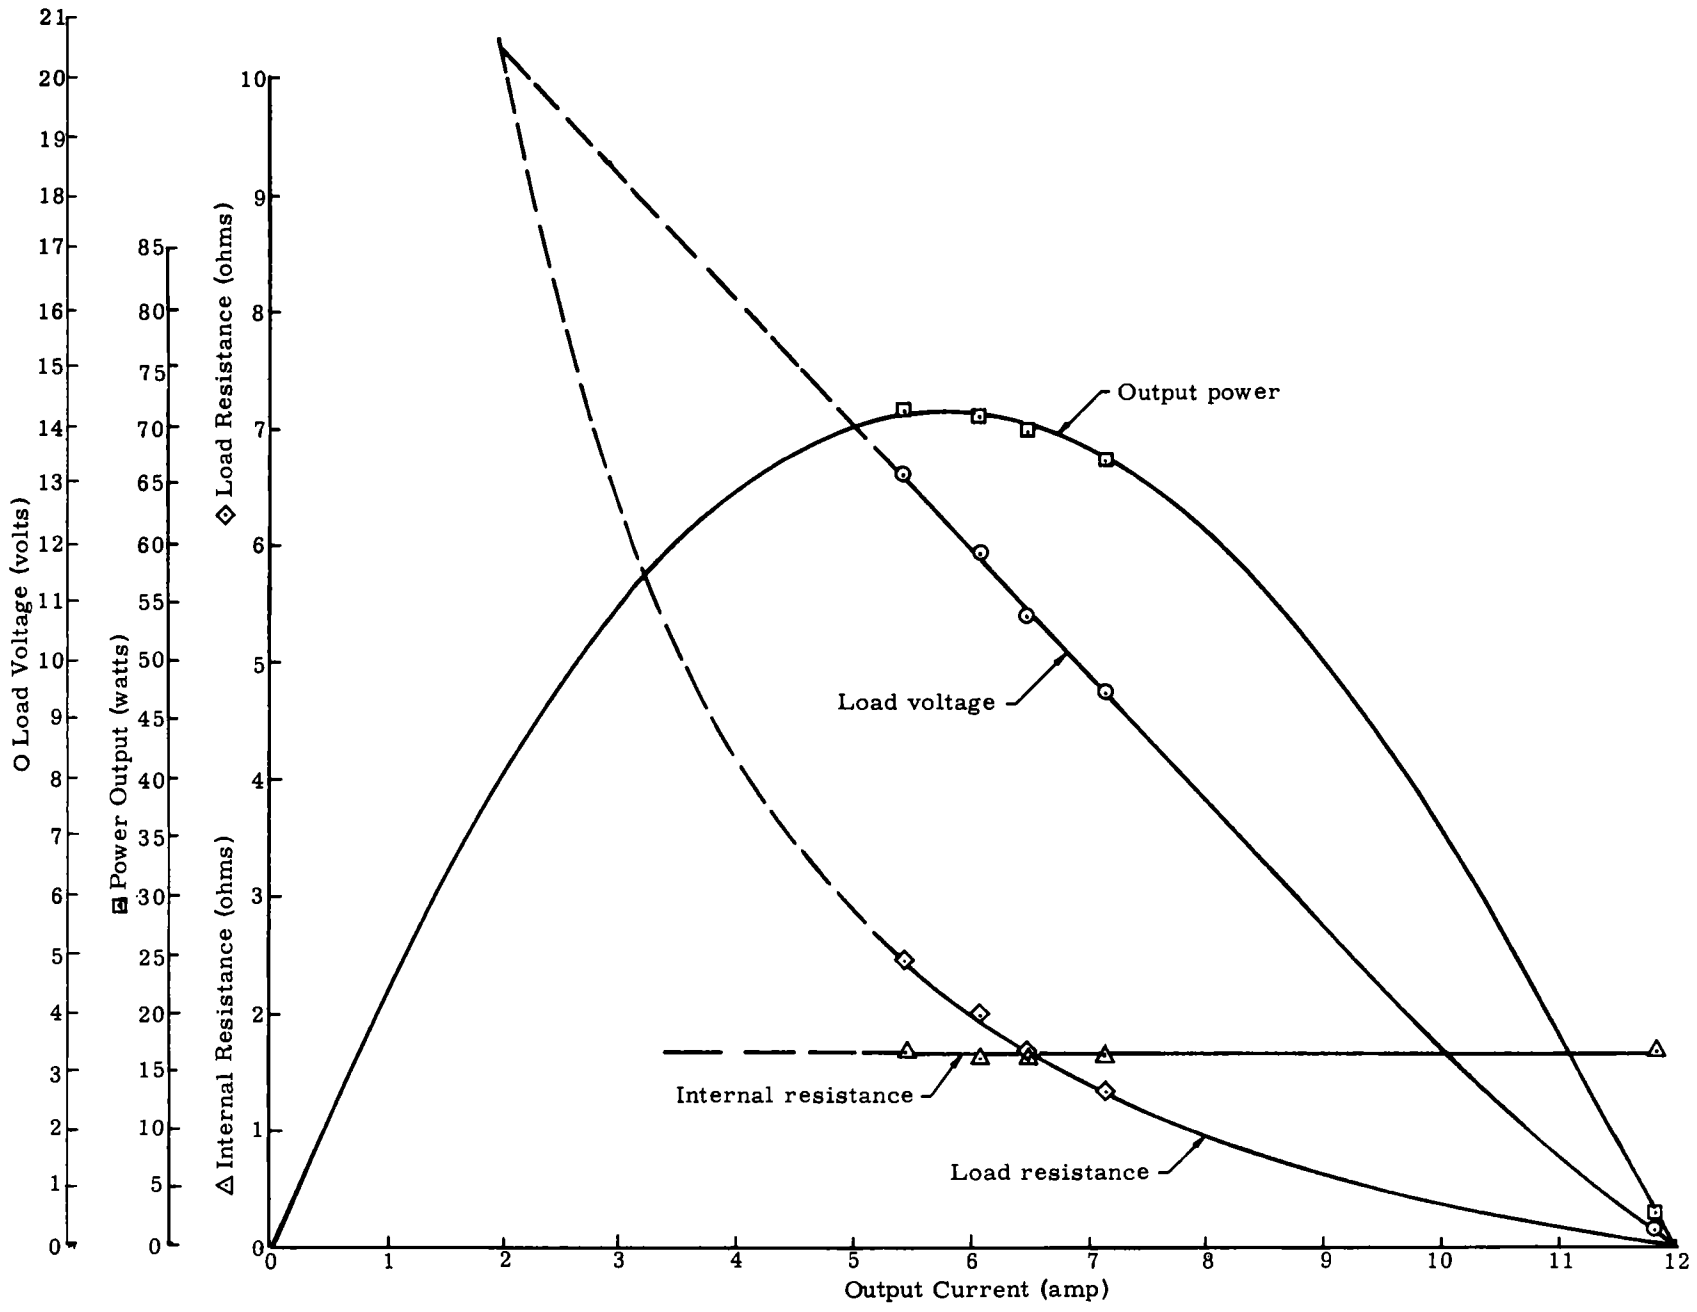
Fig. 6. SNAP 7D 60-Watt Generator--Parametric Data at Start of Life (electrical power input: 1480 watts; internal gas: pure helium)

Initially, the generator was tested at beginning-of-life conditions. The maximum temperature was established as 960° F at the hot junction, and, with a 100% helium atmosphere, the maximum power input was determined to be 1470 watts. With the power input constant at 1470 watts, the load resistance was varied. The resulting load voltage and output power curves are shown in Fig. 6; the corresponding hot junction and cold junction temperatures are shown in Fig. 7. The maximum measured temperatures are used in each case, rather than the average temperatures.

The currently planned SNAP 7D system does not include a converter or voltage regulator although a breadboard converter has been built and tested as a backup, in case the test program should indicate the need for the converter. As shown in Figs. 6 and 8, the output voltage can be kept in excess of the required charging voltage by controlling the load resistance. The battery procured for this system has sealed cells which will withstand 75 psi internal pressure, and 170-amp-hr capacity at a 2-hour rate. Three of these batteries constitute a battery pack. The battery can receive a charging current of 7 amperes continuously (factory tested at 10 amperes). The SNAP 7D wiring diagram is shown in Fig. 9.

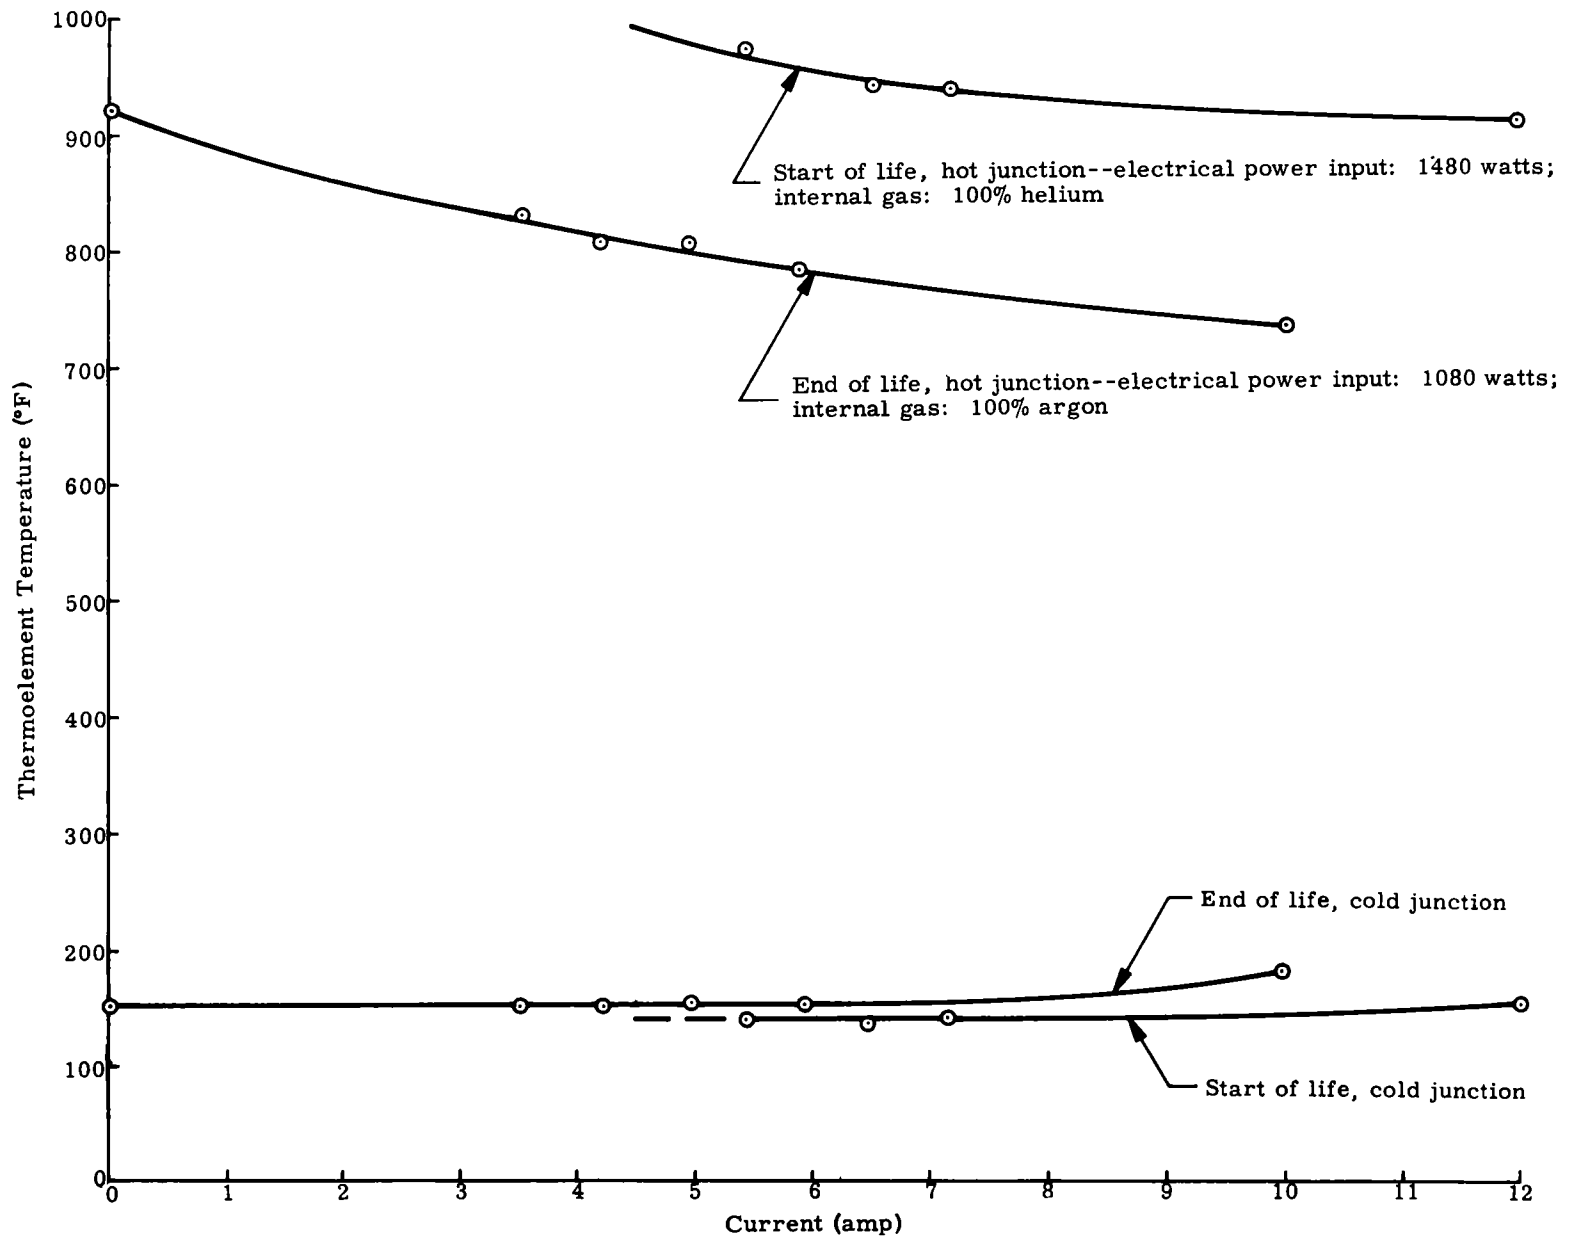
Fig. 7. SNAP 7D 60-Watt Generator--Thermolement Temperature Versus Current

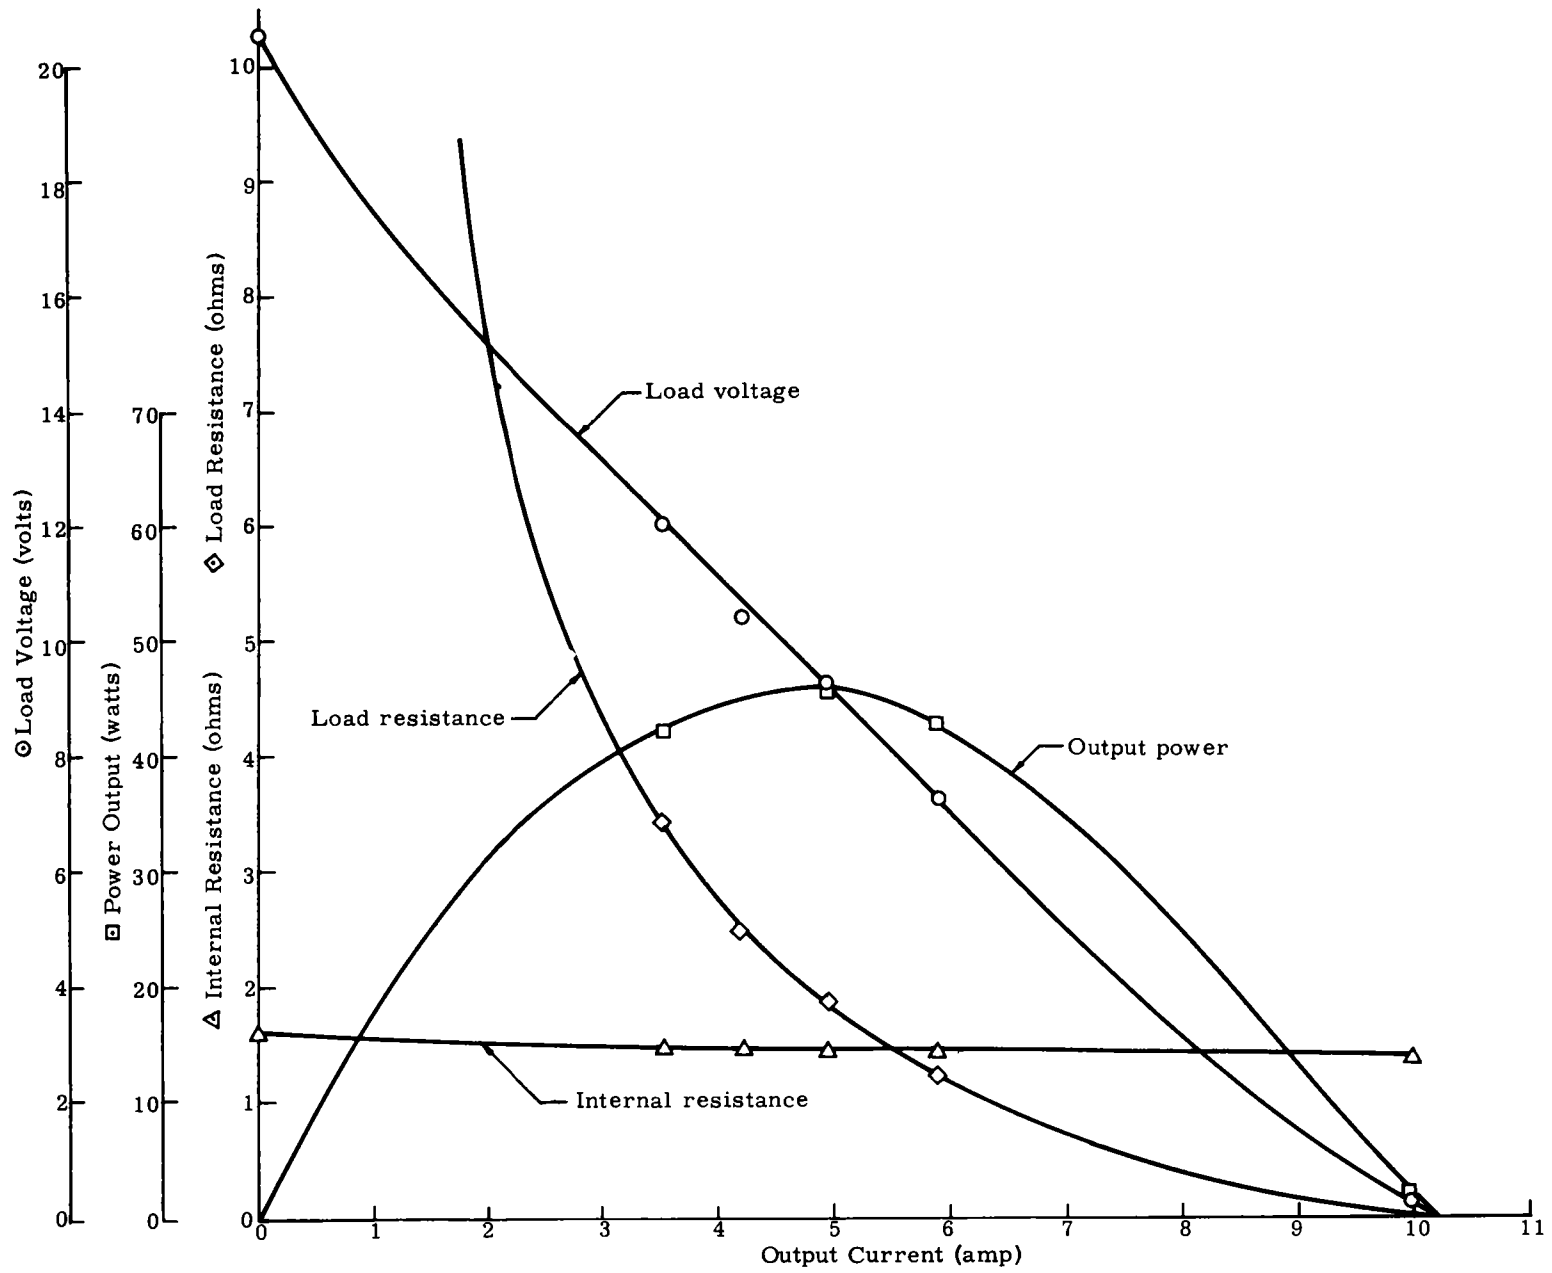
Fig. 8. SNAP 7D 60-Watt Generator--Parametric Data at End of Life (electrical power input: 1080 watts; internal gas: pure argon)

To allow for losses, the electrical input power was established at 1080 watts for the end-of-life condition. The gas fill in the generator was changed to 100% argon, and the parametric tests were repeated. The results are shown in Fig. 8, and the corresponding hot junction and cold junction temperatures are shown in Fig. 7. In order to achieve the 12 volts required for charging the batteries at the end of 10 years, the system will be operated at 3.5 amperes (42 watts). This is below maximum power but is sufficient to keep the batteries charged, even with only 72% charging efficiency. It is expected that the charging efficiency will be well above 72%.
