SNAP 7 PROGRAM
QUARTERLY PROGRESS REPORT NO. 6
Task 8--Strontium-90 Fueled
Thermoelectric Generator Development

February 1 through April 30, 1962

MARTIN COMPANY
NUCLEAR DIVISION

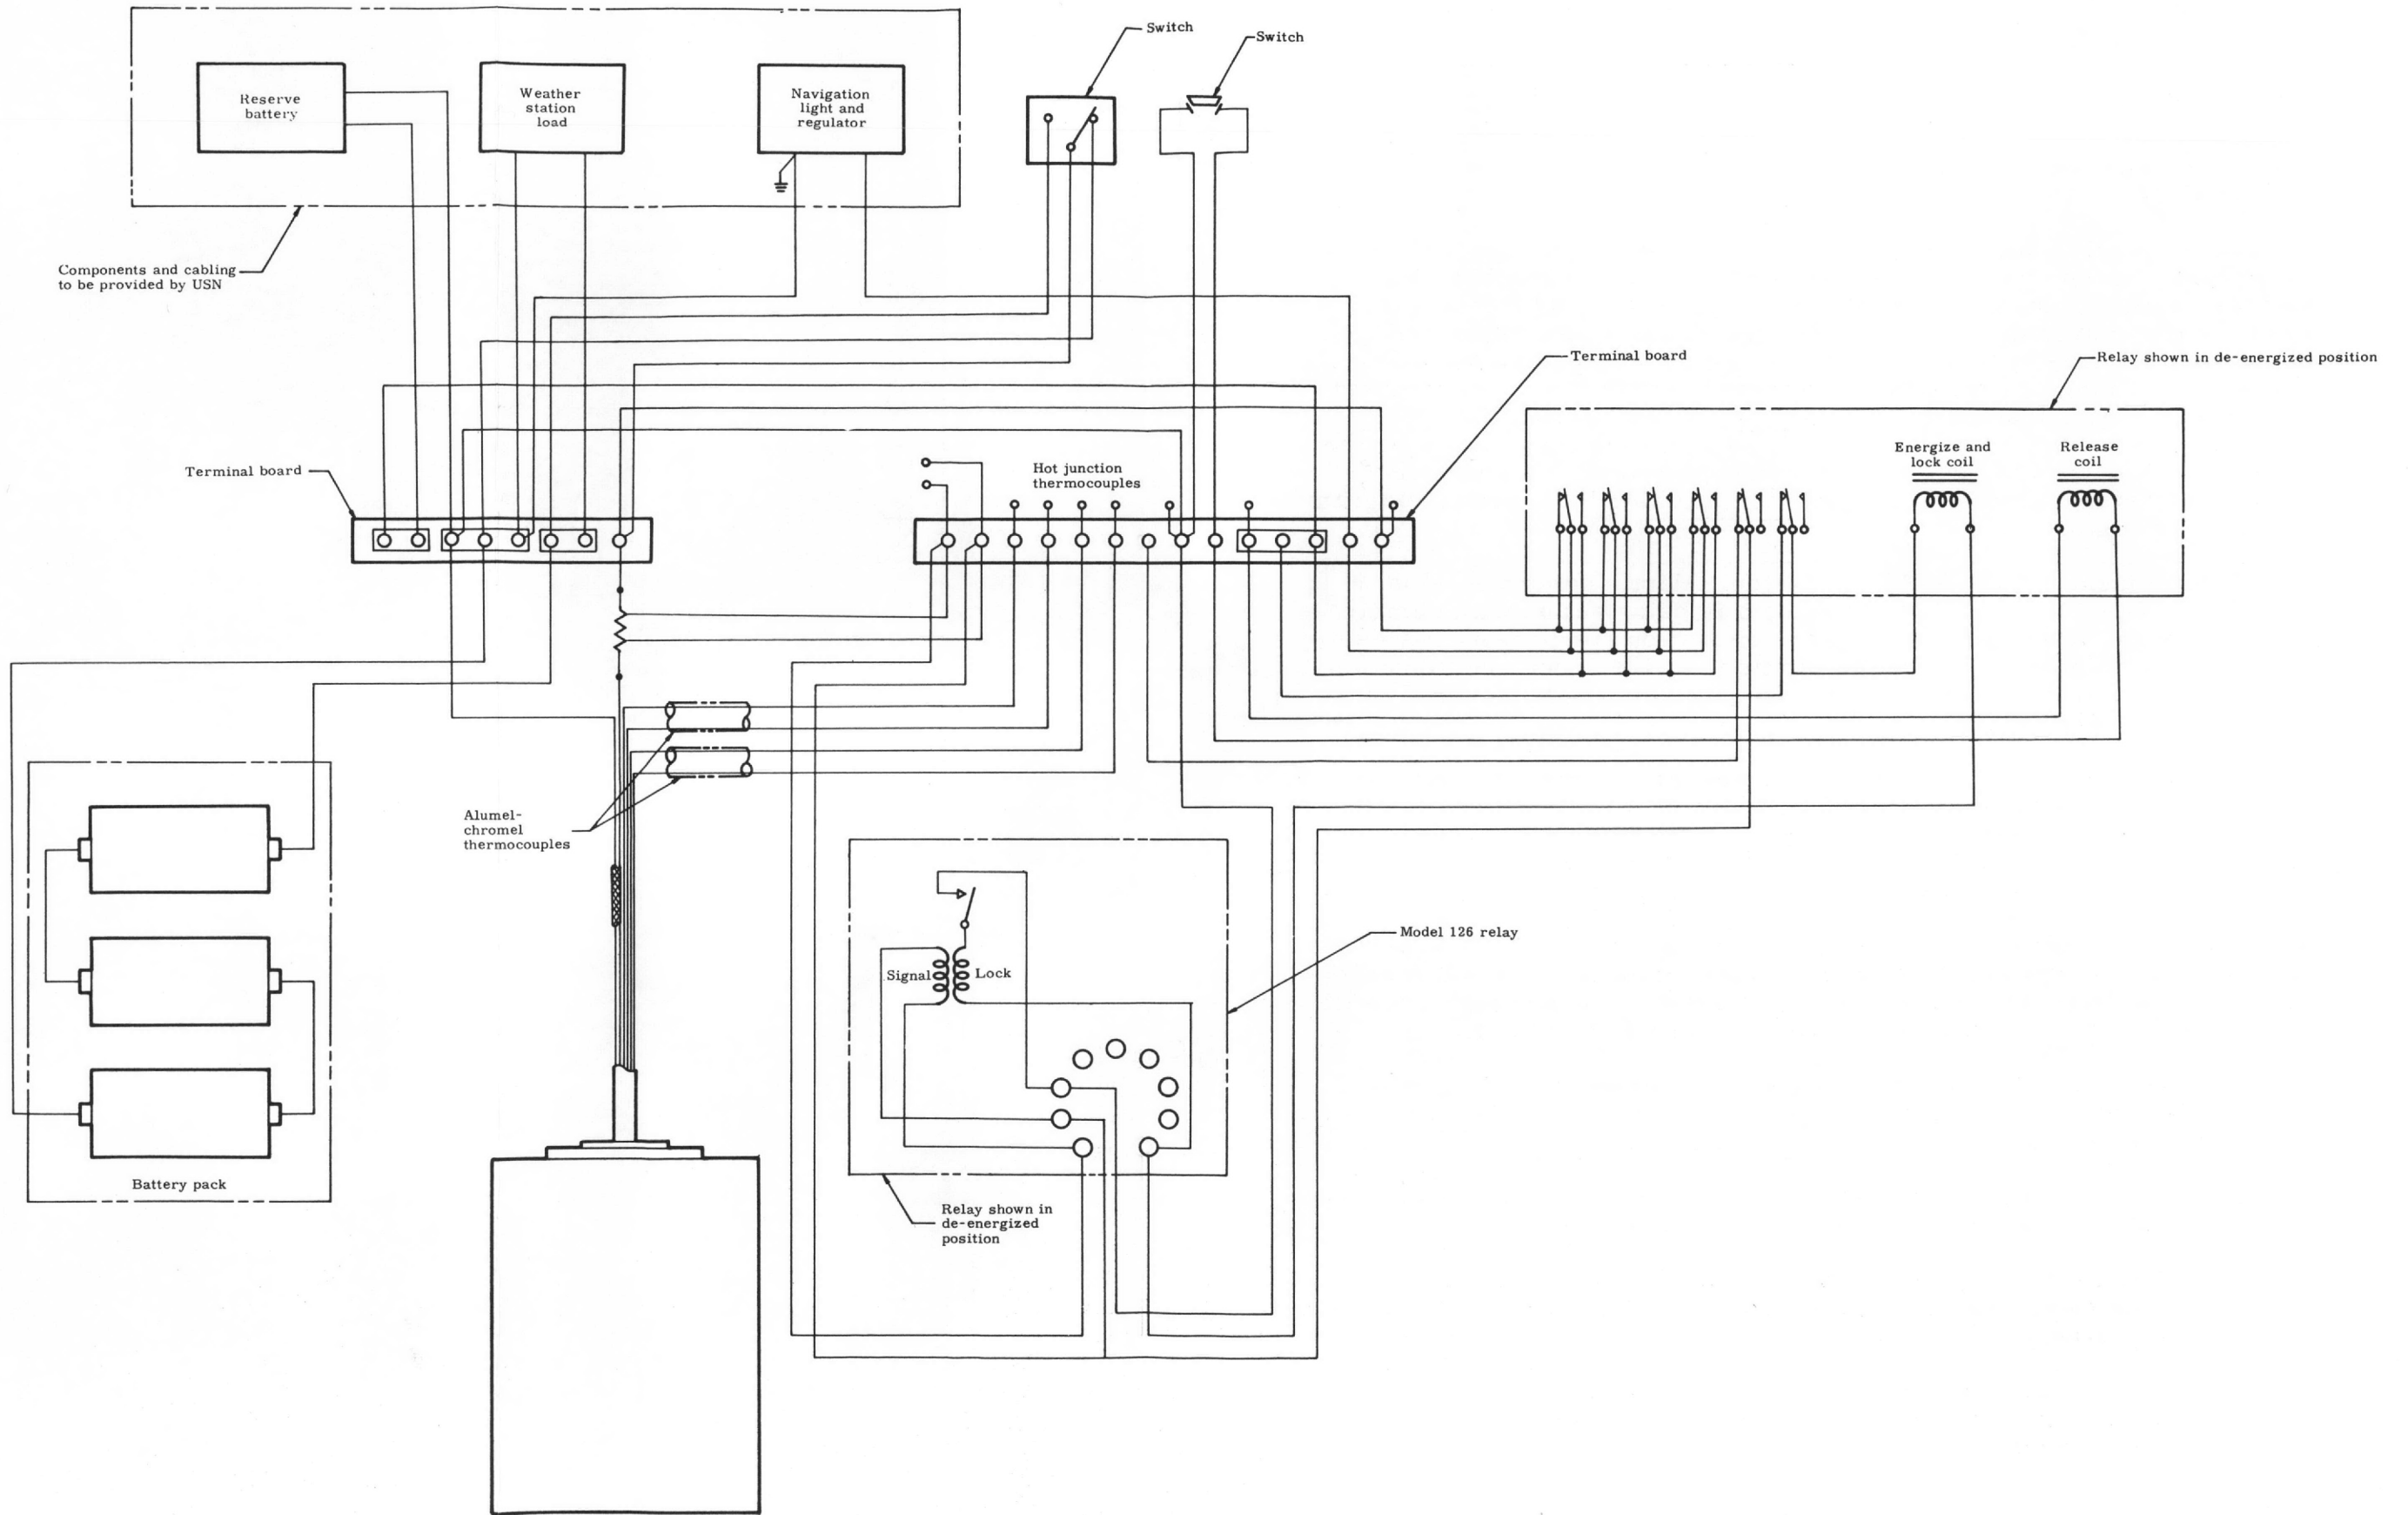
Fig. 9. SNAP 7D System--Schematic Diagram of Electrical System

The currently planned SNAP 7D system does not include a converter or voltage regulator although a breadboard converter has been built and tested as a backup, in case the test program should indicate the need for the converter. As shown in Figs. 6 and 8, the output voltage can be kept in excess of the required charging voltage by controlling the load resistance. The battery procured for this system has sealed cells which will withstand 75 psi internal pressure, and 170-amp-hr capacity at a 2-hour rate. Three of these batteries constitute a battery pack. The battery can receive a charging current of 7 amperes continuously (factory tested at 10 amperes). The SNAP 7D wiring diagram is shown in Fig. 9.
