August 1943 as
Advance Restricted Report 3H24

DEVELOPMENT OF THERMAL ICE-PREVENTION EQUIPMENT
FOR THE B-17F AIRPLANE

By Alun R. Jones and Lewis A. Rodert

Ames Aeronautical Laboratory
Moffett Field, California

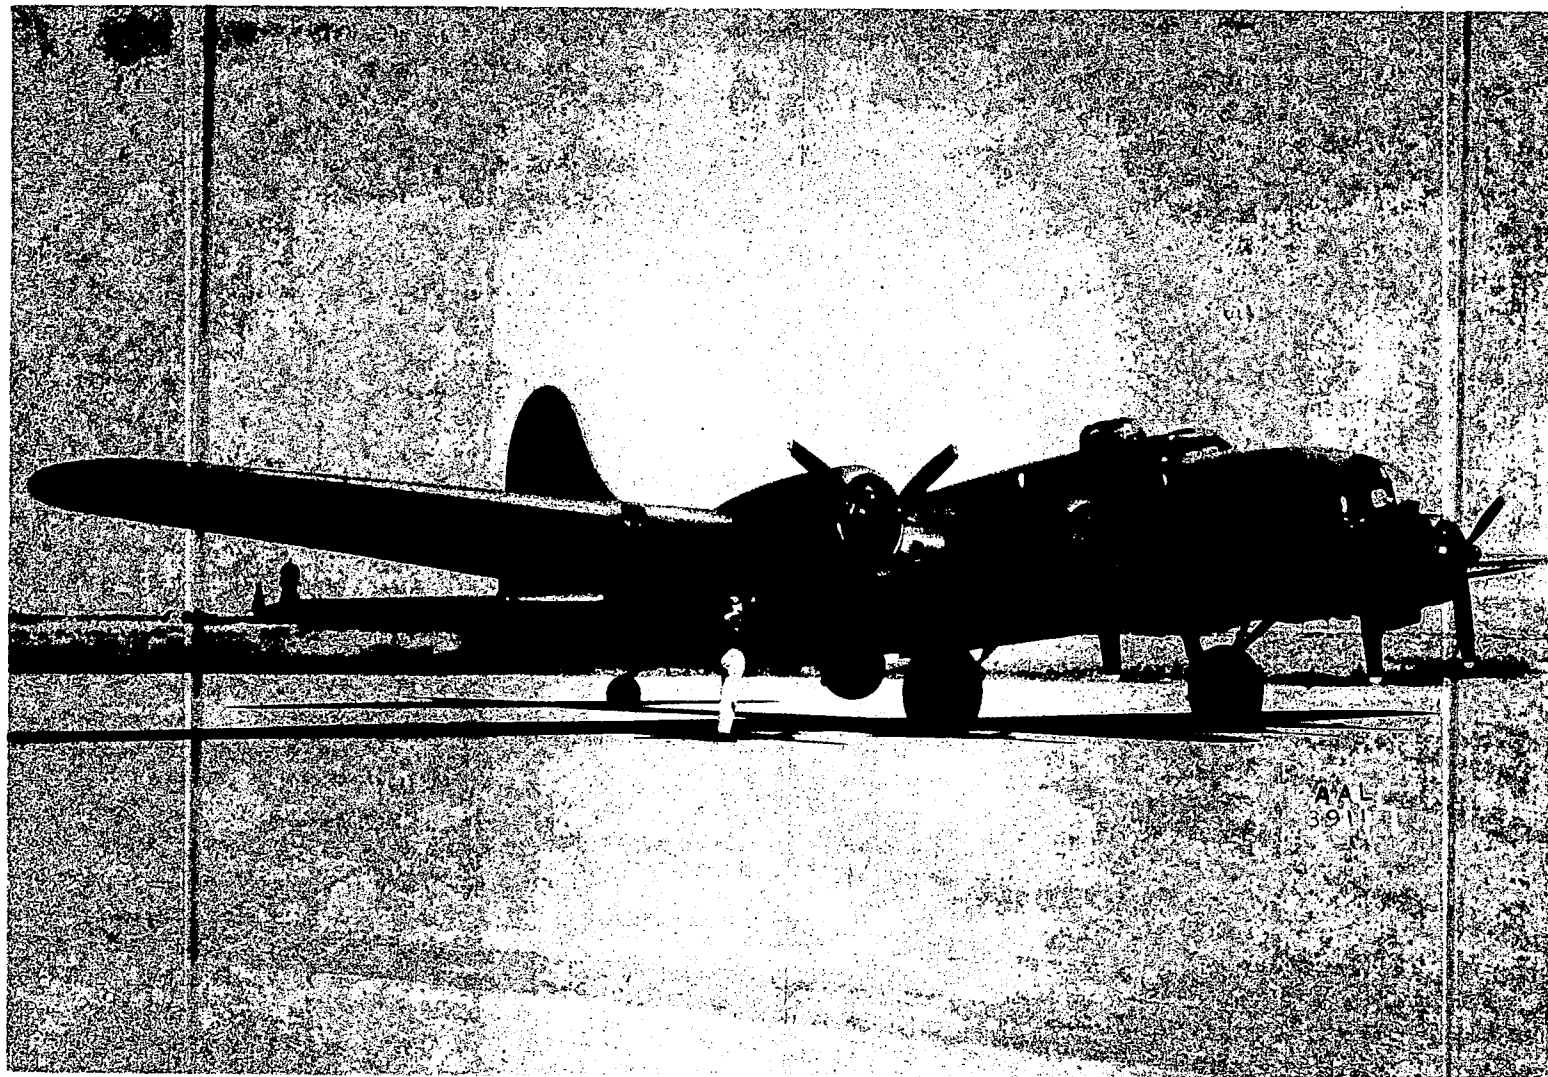
Figure 1.- The B-17F airplane in which thermal ice-prevention equipment was installed and tested.

The B-17F airplane is shown in figure 1. The airplane is a midwing monoplane of the heavy bombardment type, powered by four Wright model R-1820-97 engines, having a sea-level rating of 1000 horsepower. Each engine is equipped with an exhaust-driven type B-2 turbosupercharger.

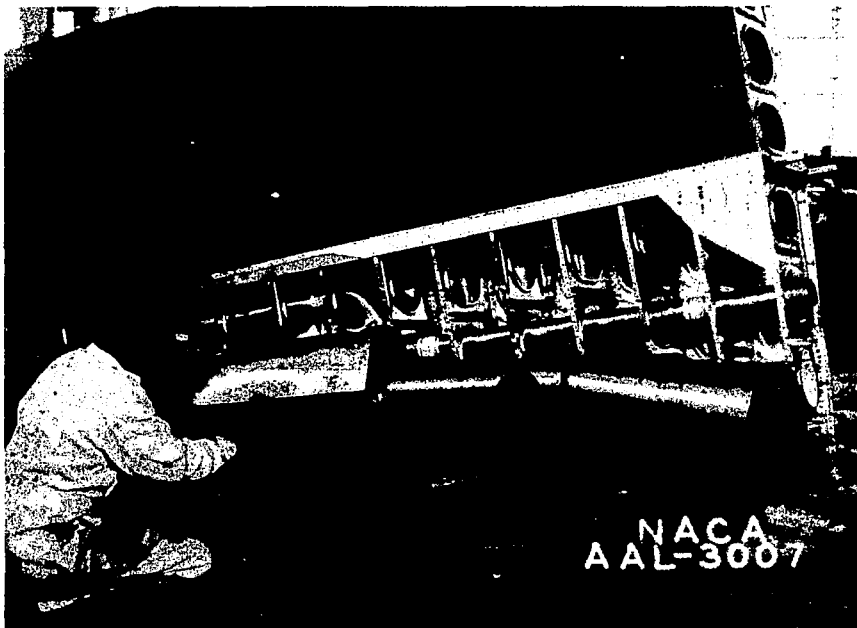
Figure 15.- Heated-air supply duct in inboard portion of horizontal stabilizer, B-17F airplane.

spanwise bulkhead aft of the slotted tubes. Details of the stabilizer ice-prevention installation are shown in figures 15 and 16. For the entire empennage design, the outer skin of the leading edge covers approximately the same surface area as that originally occupied by the rubber de-icers.
