Final Report

Demonstration of Base Catalyzed Decomposition Process, Navy Public Works Center, Guam, Mariana Islands

February 1996

PNNL-10972

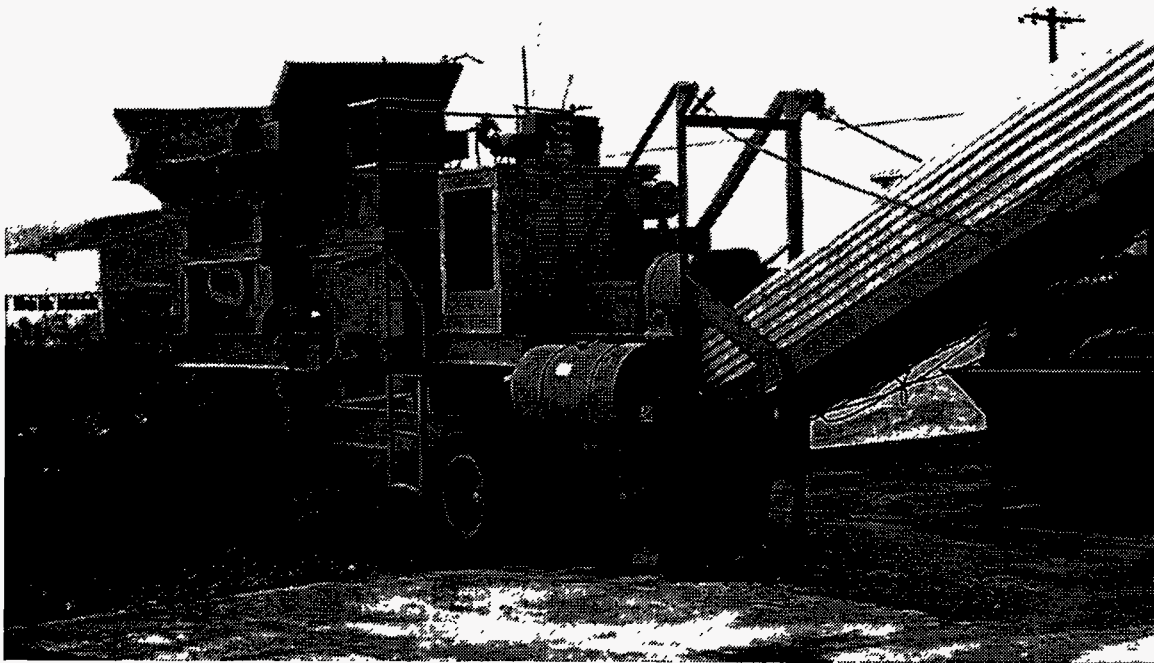
Figure 4.2. Portable Crushing Plant

Generally, the crushing plant worked as designed without excessive maintenance. However, when the moisture content of the feed was too high, the crushing chamber had a tendency to clog. Also, there was a higher fraction of +5.1 cm (+2-in.) material than desired, but this larger material did not cause any major materials handling problems for the rest of the equipment.

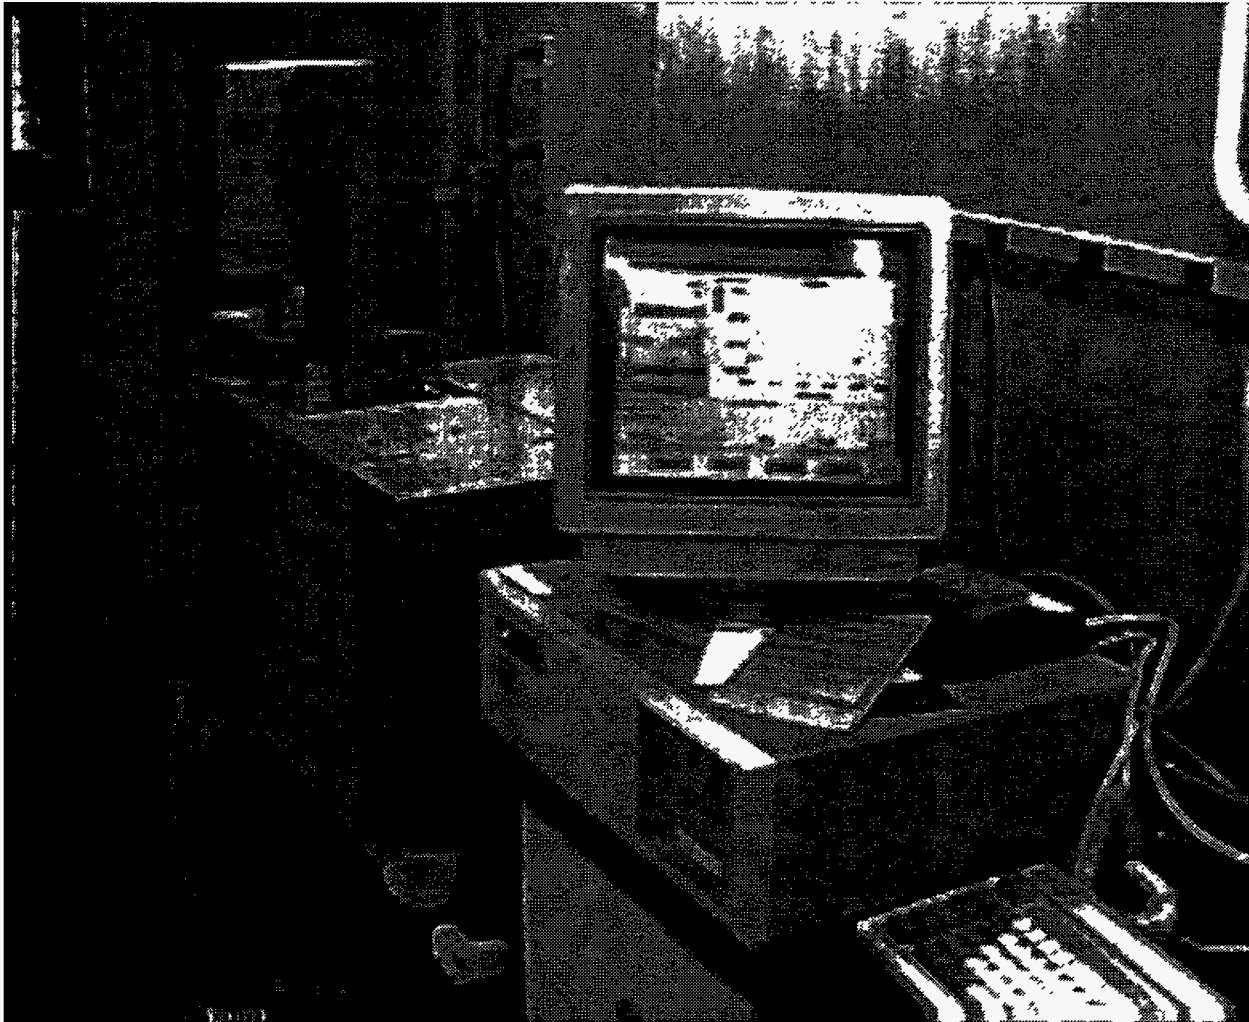
Figure 4.19. GC-MS System in Onsite Portable Analytical Laboratory

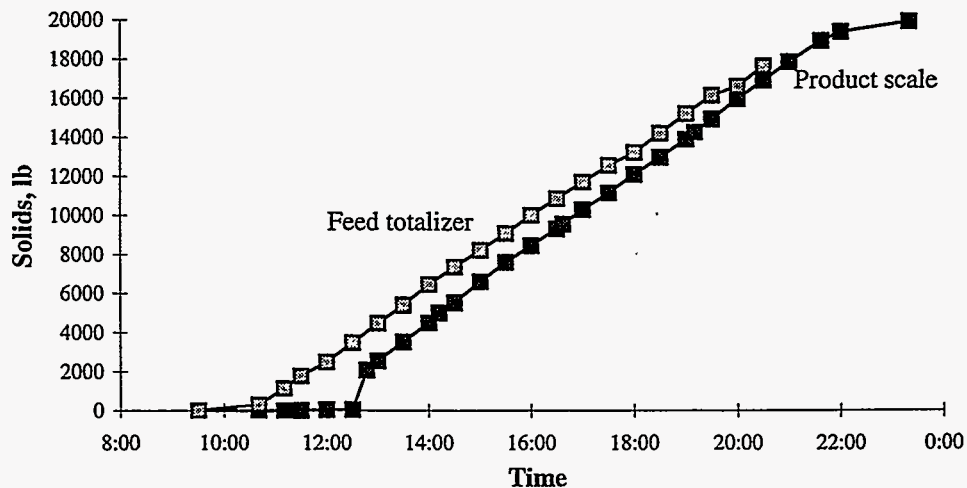
Figure 5.4. Soil Feed and Discharge Rate During 5 February 1994 Hot Run

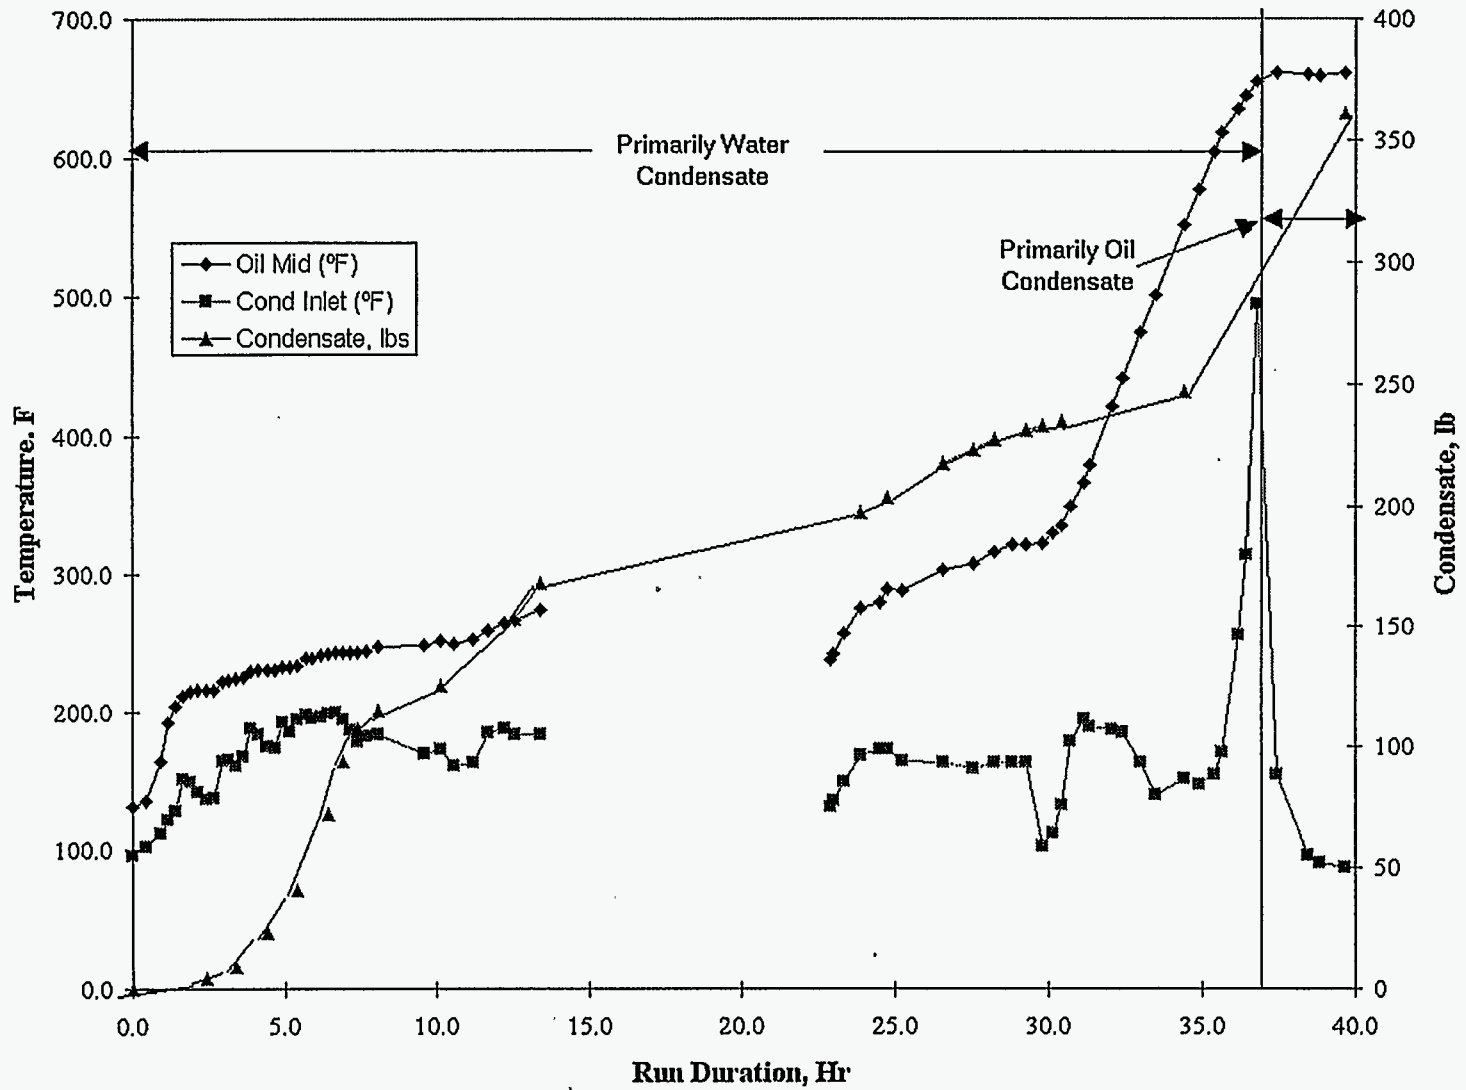
Figure 5.17. STR Temperatures and Condensate Generation for 28 November 1994
