**Mechanical Properties of Aluminized CoCrAlY Coatings
in Advanced Gas Turbine Blades**

J. Kameda⁺, T. E. Bloomer⁺, Y. Sugita^{*}, A. Ito^{*} and S. Sakurai[#]

⁺Ames Laboratory and Center for Advanced Technology Development, Iowa State University, Ames, IA 50011

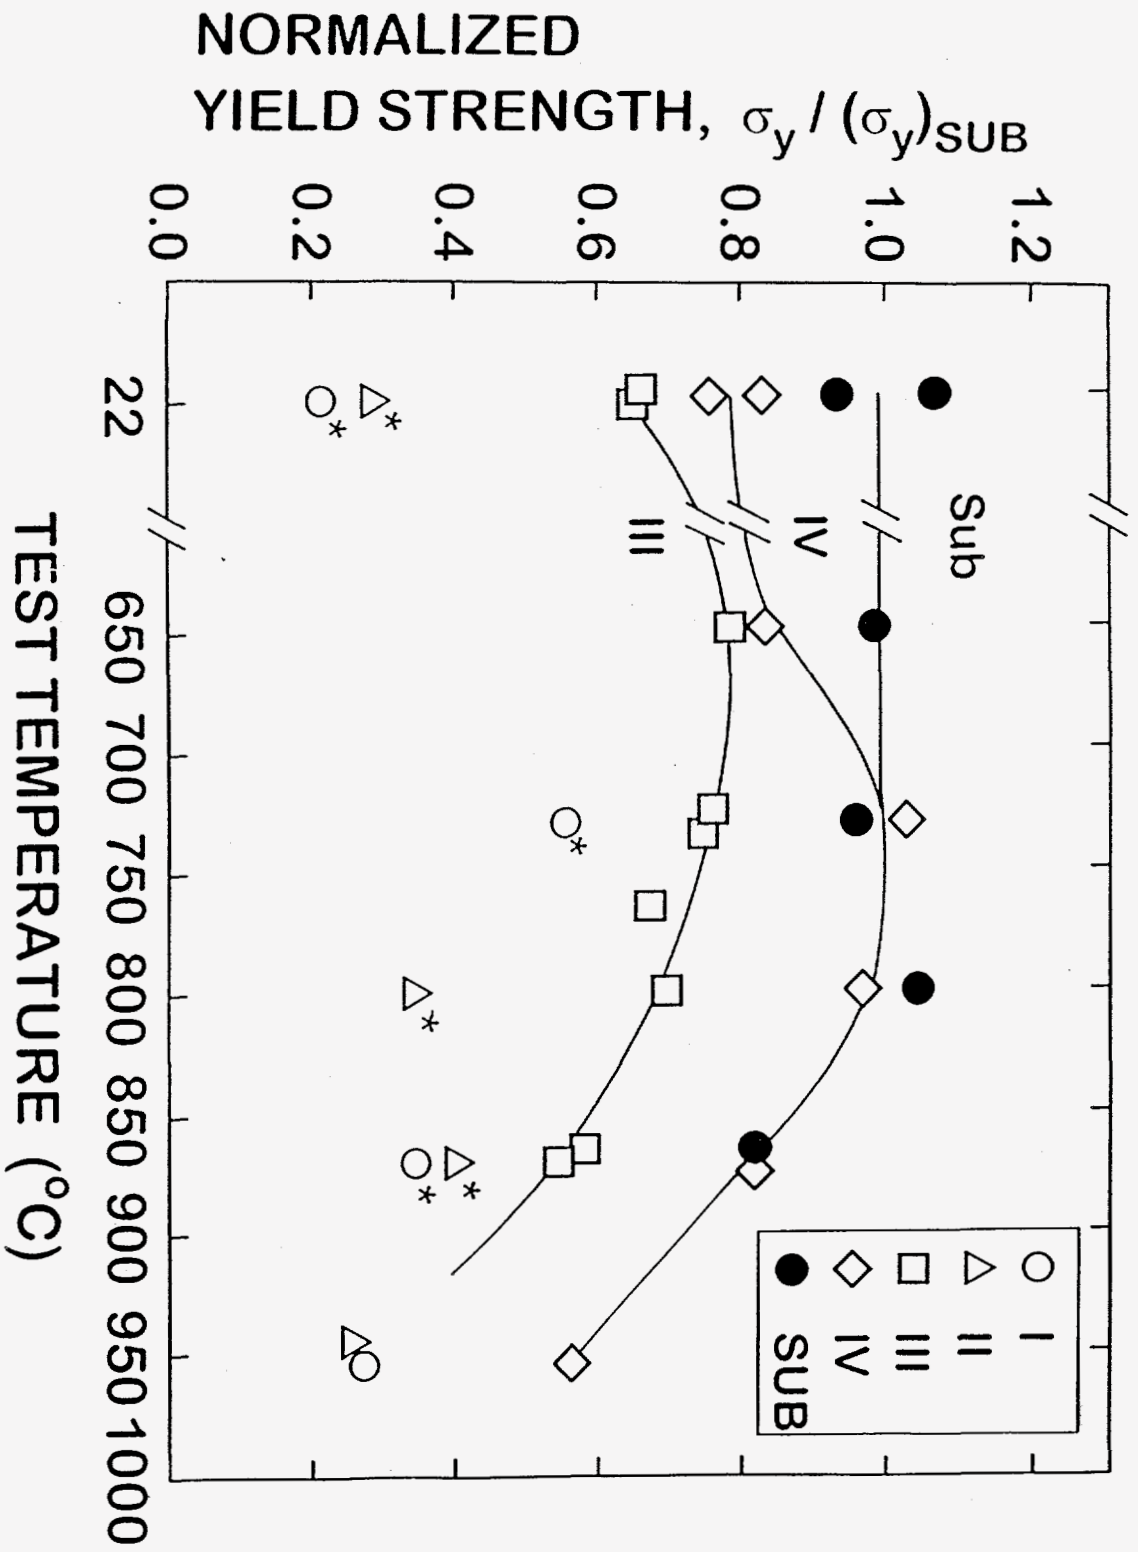
Fig. 3

Figure 3. Temperature dependence of yield strength (σ_y) in coatings III and IV and substrate. An asterisk mark indicates the fracture strength for coatings I and II. The yield and fracture strength are normalized by σ_y in substrate at RT.

The mechanical properties of the various coating regimes were studied using the SP testing method. The yield strength was estimated from the yield load observed in the flow curve [7,9]. The temperature dependence of σ_y , normalized by that in the substrate at RT, for the various coating regimes and substrate is shown in Fig. 3. In the substrate, the yield strength remained constant up to 800 °C and then started to drop. In the Al enriched coatings I and II, brittle cracks easily formed prior to the occurrence of plastic deformation. The fracture strength of the coatings I and II (indicated by asterisk marks) is plotted in Fig. 3. It also must be pointed out that the near surface Al enriched coatings had much higher microhardness compared with the other coating regimes [9]. Coated SP specimens (III and IV) indicated lower yield strength than substrate ones. The coating IV had higher yield strength than the regime III. The coatings III and IV showed hardening at 650-730 °C and 730-800 °C, respectively. The yield strength of the coating IV and substrate converged with each other above 730 °C.
