**Defense Waste Processing Facility Radioactive Operation -
Part 1 Operating Experience (U)**

**Defense Waste Processing Facility
Radioactive Operations - Part I Operating Experience**

David B. Little, James T. Gee, and William M. Barnes
Westinghouse Savannah River Company, Aiken, SC 29808

**Waste Management '97
Tucson, Arizona
March 2 - 7, 1997**

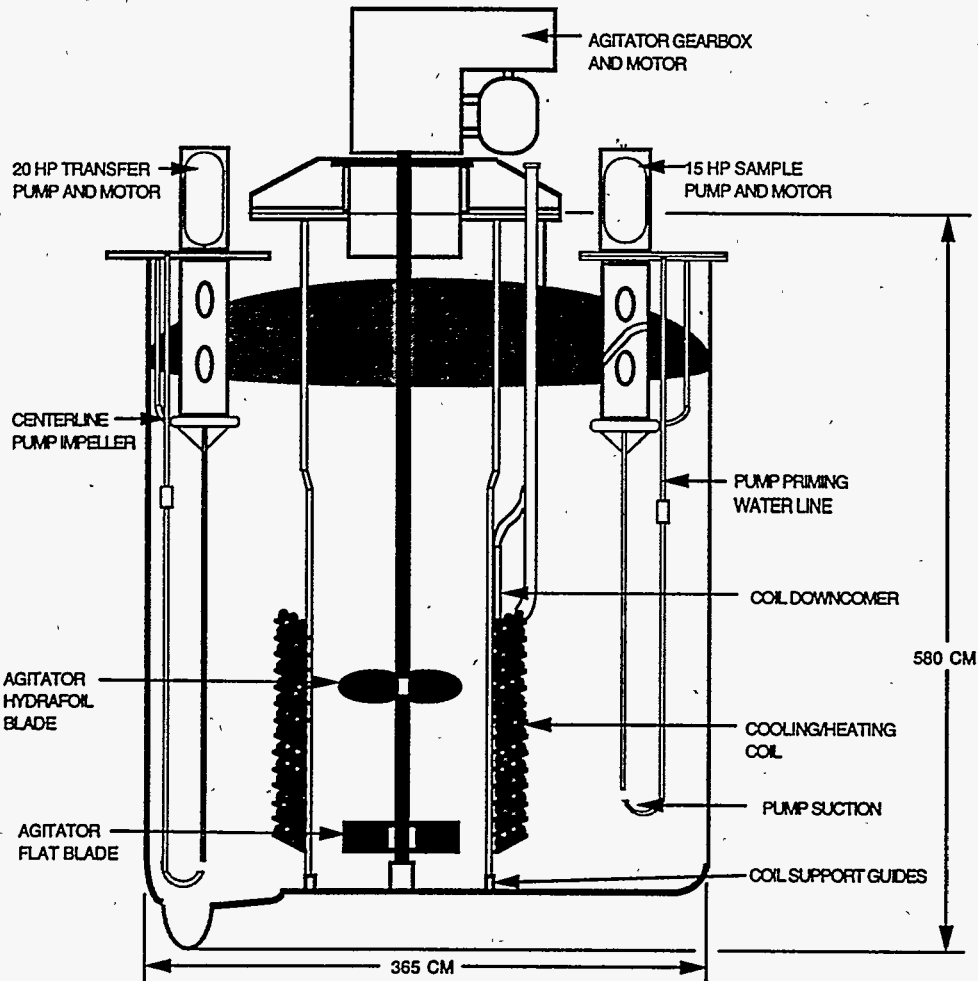
DWPF's process vessels are typically 41,000 liter vertical tanks with only top of tank penetrations (see Figure 1). By only allowing access nozzles on the top of the tank, the potential for loss of radioactive waste due to leaks at tank flanges is minimized. Also, with top only access, the need to de-inventory the tank in order to remove support equipment, such as pumps and agitators, is eliminated. However, this design requirement severely limits the size of the equipment that can be installed on the tank. Tank top space is a premium commodity. Therefore, each piece of remote equipment is assigned a 3 dimensional space envelope. The manufacturer is required to design and construct the equipment to fit in the allowable space while meeting all the design requirements. Thus, many companies must modify their standard design in order to meet the limited space requirements.

FIGURE 1 - Typical remote tank with tank top components

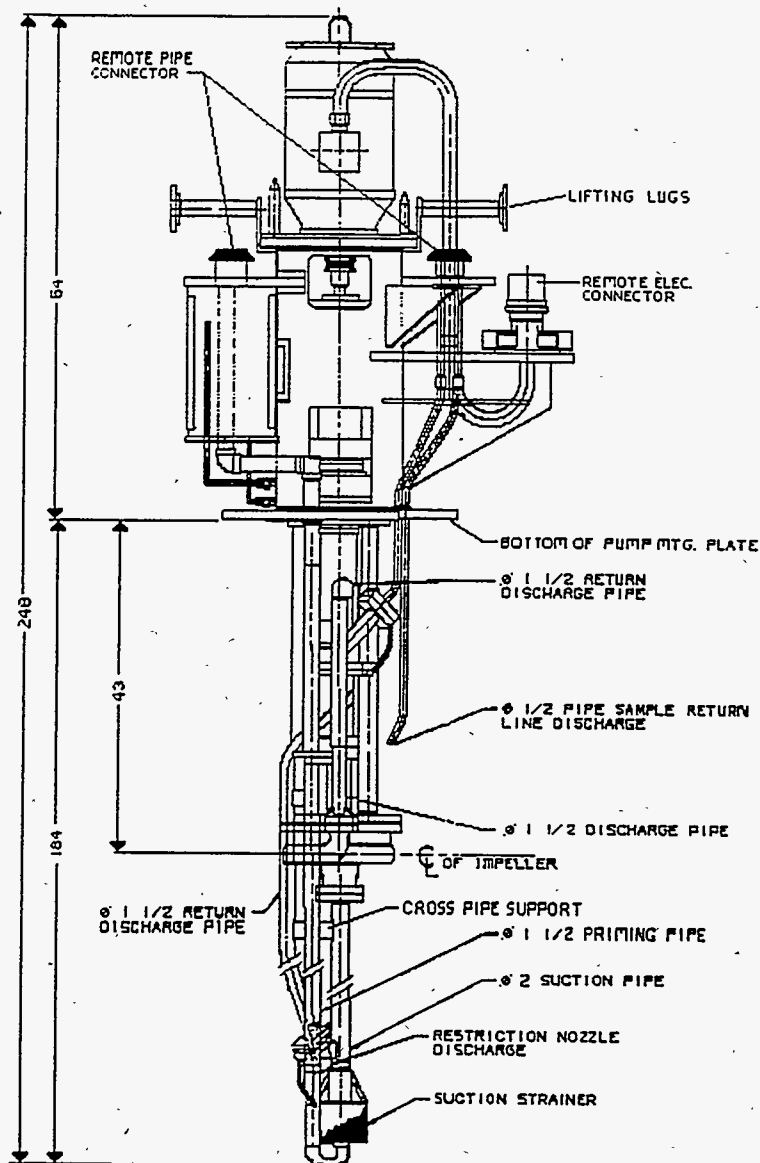
The DWPF utilizes Vertical Cantilever Centrifugal (VCC) pumps to sample, transfer and feed radioactive materials within the process cells (see Figure 2). Overall pump performance has been very good. Forty pumps are currently operating as part of the sludge only flow sheet. Several of these pumps are in continuous operation with almost 100,000 hours of trouble free operations. The remaining pumps are used for sampling or batch transfer with between 500 and 1000 hours of successful operation. However, two generic problems are currently under evaluation in order to improve the reliability of the pumps.

FIGURE 2 - Typical cantilever centrifugal remote pump

The transfer pumps will lose suction lift prematurely due to air entrainment from agitation (causes foaming at the fluid surface). This problem was initially identified during the non-radioactive test program. Testing at various fluid levels and agitator speeds confirmed that air entrainment as high as 11% by volume could occur in DWPF's tanks. A typical VCC pump can lose suction lift when pumping a fluid with as little as 2 or 3 percent air by volume. Therefore, to minimize air entrainment, operating procedures were modified to specify tank levels at which agitator speed is reduced or the agitator stopped. [2]

However, at the start of radioactive operations, a second phenomenon was detected that resulted in pump suction lift loss. DWPF personnel determined that small changes in tank fluid temperature (less than 10 degrees Celsius) significantly affect the transfer pump's performance. Attempts to transfer the Sludge Receipt and Adjustment Tank (SRAT) contents to the Slurry Mix Evaporator (SME) were unsuccessful immediately after a process change had been implemented. The process change centered around cooling the vessel's contents during

non-processing periods. The fluid's properties changed at the lower temperature which stabilized the existing foam. Over time, the foam was entrained in the fluid so that, regardless of agitator speed, the pump could not maintain a suction lift. In the SRAT, the suction lift was lost within one minute of starting the transfer pump. This problem has been eliminated by increasing the fluid's temperature prior to initiating a transfer.

The second problem experienced was failure of the priming and suction line on one of the continuous operating pumps. The loads induced by tank agitation (20 Hp agitators) on the approximately 3.5 meter long assembly was greater than calculated by the manufacturer. This resulted in a fatigue failure of the piping at the cross piping supports (See Figure 2). Since these locations are above the fluid level, air in-leakage below the casing and impeller occurred and resulted in a loss of pump suction lift. This problem is limited to only those vessels with 20 Hp agitators since the priming and suction lines for pumps in other tanks are of a different design. Redesign of the support is underway and modifications will be implemented when a pump is removed from the process cell due to failure.

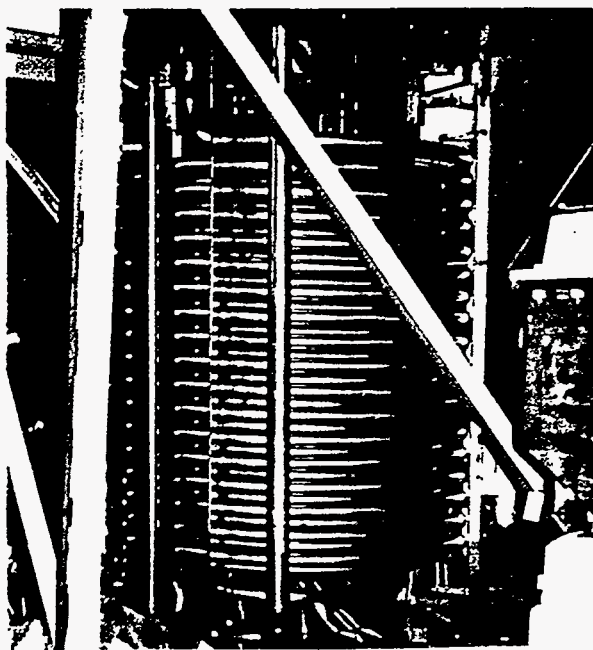
Significant erosion on the SME coil assembly occurred in two general areas. The first area was at the bottom portion of the downcomer pipes (which extends below the coil itself). The downcomers were worn smooth with a high degree of polish. Wall thinning of up to 40% was measured ultrasonically on the downcomer pipe for the inner coil. Similar measurements on the MFT downcomer pipe revealed 15% wall thinning. The second area was the lower coil support structures (4 locations) for all three coils. The support structures had significant erosion patterns with a loss of 50% or more of the support member cross section in some places (see Figure 3).

FIGURE 3 - Lower portion of the SME coil assembly showing coils, downcomer pipes and support structure.

The observed wear patterns on the SME and MFT coil assemblies are consistent with the predominant flow patterns in these tanks. An agitator located inside the coils provides constant mixing of the tank contents. The lower blades are oriented vertically to drive the slurry outward, while the upper blades are positioned to establish a downward flow. Together, the upper and lower blades set up a circulation pattern that includes rotation around the tank, upward motion outside the coils, and downward motion inside the coils. With the lower agitator blades near the bottom of the cooling coils, the downcomers and lower support structures are located in a region of relatively high flow velocity and turbulence. The presence of glass frit in the SME and MFT distinguishes these two coil assemblies from the SRAT and SMECT coil assemblies. With no abrasive material present in the other two tanks, those coil assemblies experienced no significant erosion.

Based on the lack of degradation observed on the SRAT and SMECT coils, no significant limitations to their service life were identified. They are expected to continue operating for the life of the facility. Erosion due to the glass frit is expected to limit the service life of the SME and MFT coil assemblies, although implemented repairs should extend the service life of this equipment (i.e., 2-5 years).

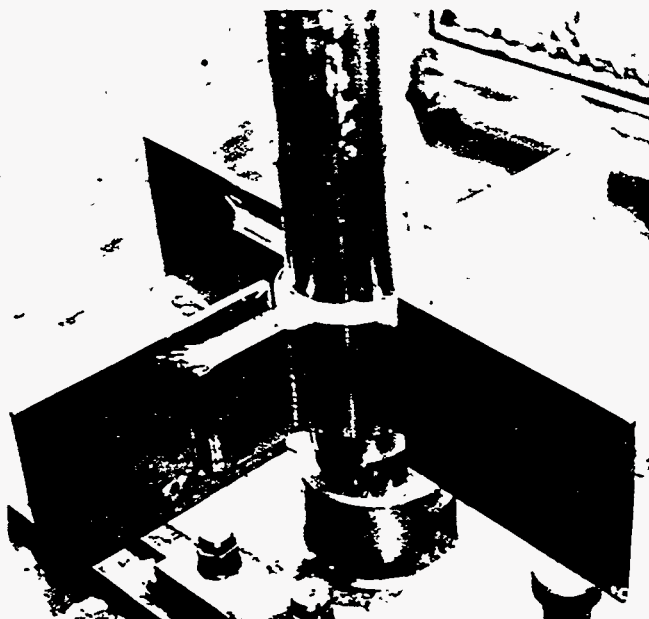
FIGURE 4 - Back side of lower SME agitator blade showing severe wear of the blade at corners and upper edge of the blade near the hub

The SME's mixture is more abrasive than those in the SRAT. Therefore, both erosion and corrosion are of potential concern for the SME agitator. Minor erosion was observed on the leading edge and tip of the upper hydrofoil blades. Deep wear scars, approximately 50% through wall, were observed on the back sides of the lower agitator blades (see Figure 4). Severe erosion of the blades was observed at the corners of the attachment tabs. Only a slight rounding of the edges was visible on the front sides of the lower blades. No evidence of cracking or significant corrosion was observed on any of the blades. The SME agitator blade, as originally designed, experienced severe degradation and will not survive more than two years of continuous operation. Erosion of the SME agitator as a result of the glass frit slurry had been expected, based on inspection of similar equipment at pilot testing facilities. A spare unit with a new blade design (i.e., increased use of W73006 hard-face overlay coating to mitigate erosion) had been procured as a contingency and was installed prior to radioactive operations.
