Human Factors Assessment Report

Porter-Cable Circular Saw OENHP #: 2001-04, Version A

Report Issued: January 2002

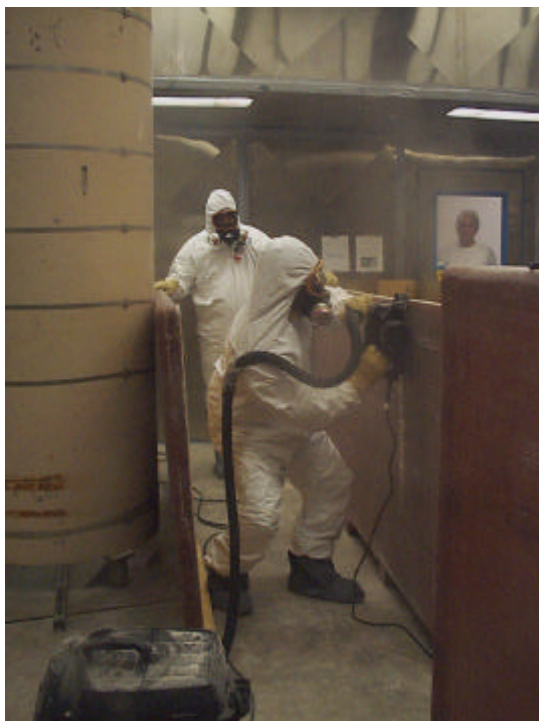
Figure 1. An operator making a vertical cut with the Porter-Cable Circular Saw. For this demonstration, the optional vacuum was attached to the directional nozzle.
