Interim Barrier at Hanford's TY Farm to Protect Groundwater at the Hanford Site, Washington, USA

To Be Presented at
Waste Management 2011

**Interim Barrier in Hanford's TY Farm to Protect Groundwater
at the Hanford Site, Washington, USA – 11282**

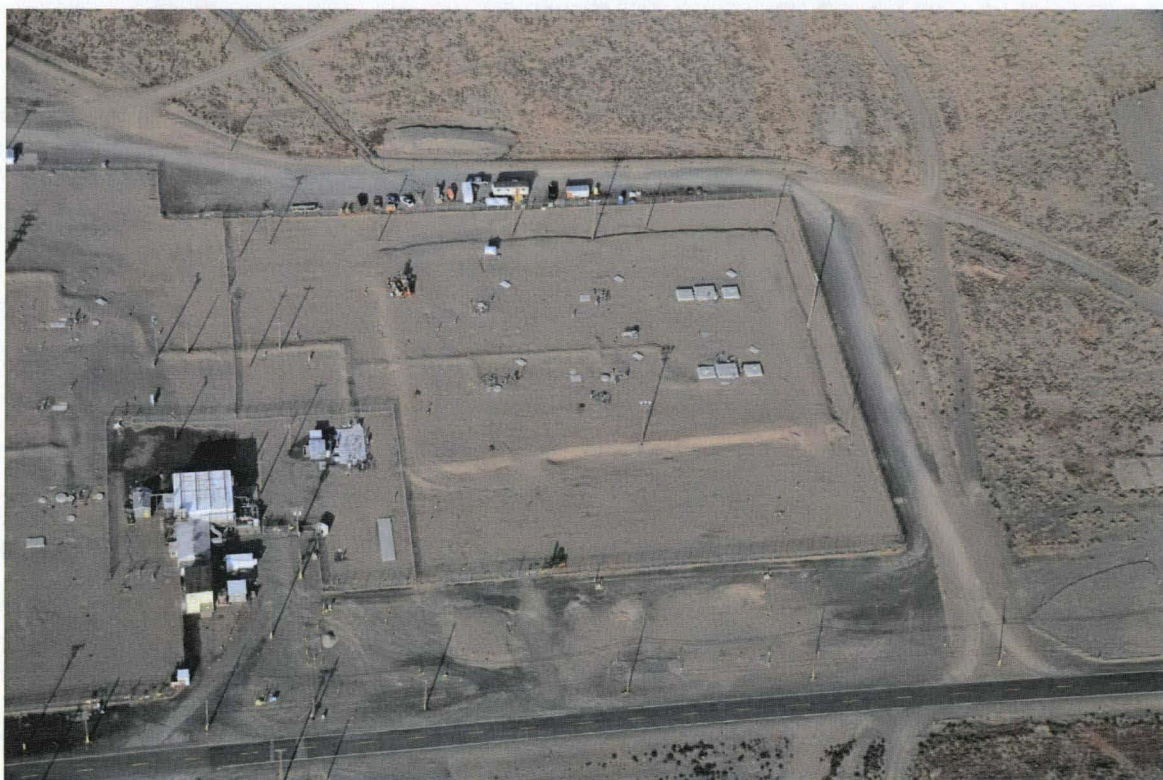
Fig. 1. Aerial photograph of TY barrier before barrier.

In addition, TY Tank Farm was classified as “controlled, clean, and stable.” The controlled clean and stable process included steps to reduce worker exposure to hazards [4], and applied at TY Tank Farm resulted in a relatively clean level gravel surface within the farm. This clean, level, gravel surface allowed the emplacement of an interim barrier with a minimum of leveling of the farm, as well as with a minimum of radiological hazards to contend with during construction.

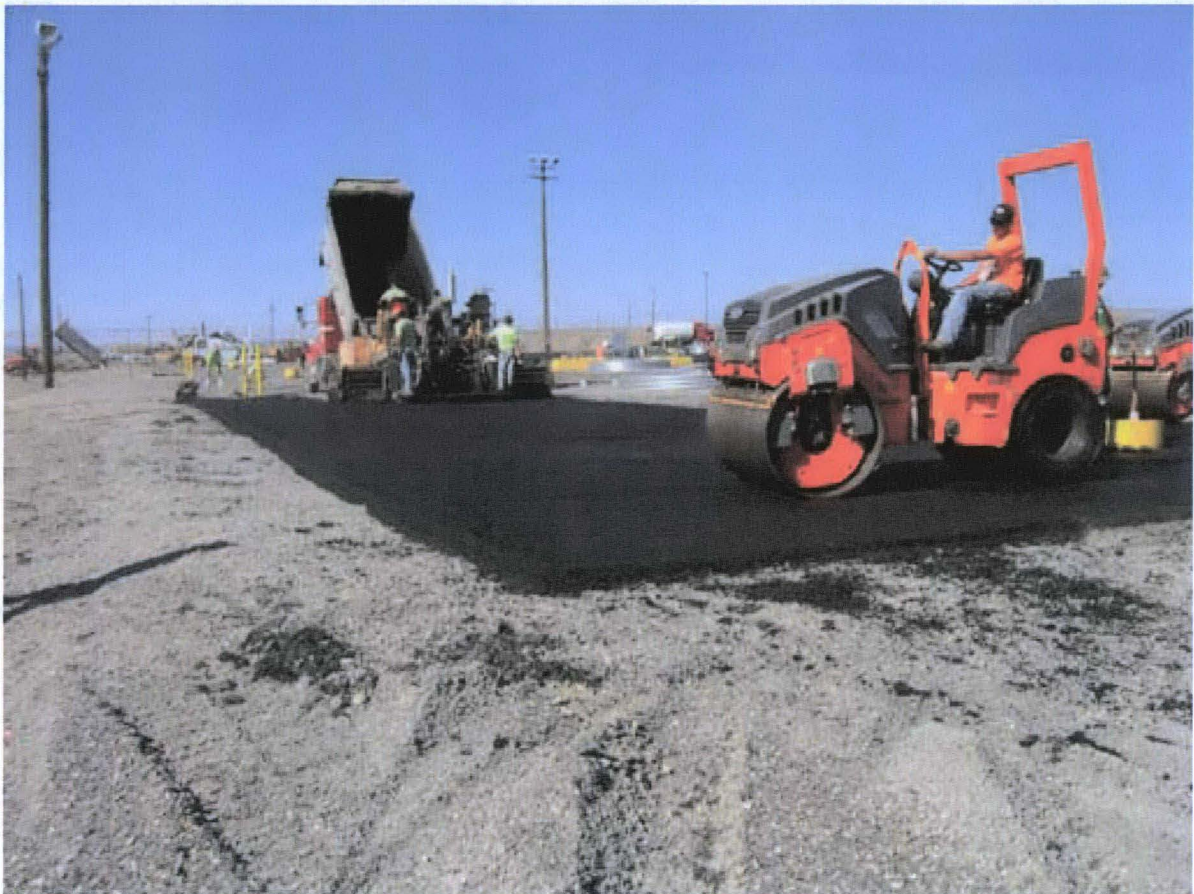
Fig. 7. Photograph of asphaltting.

Asphalt placement was through the use of standard commercial asphalt equipment. This allowed for rapid completion of the barrier which is a significant advantage over other materials that require significant amount of handwork or time to install. Again, spotters were used to ensure there was no damage to tank farm equipment, and to ensure personnel safety.

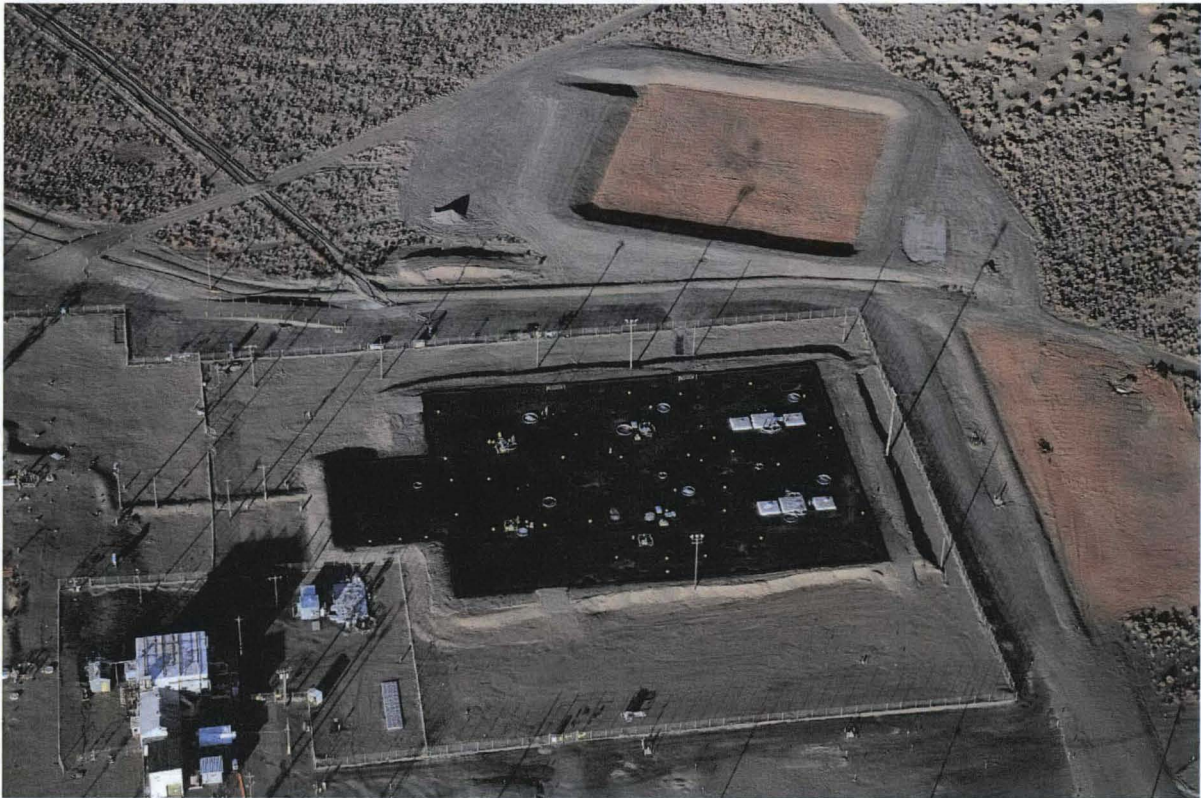
Fig. 8. Photograph of final barrier.
