Wind Turbine Gearbox Condition Monitoring Round Robin Study – Vibration Analysis

S. Sheng, Editor
National Renewable Energy Laboratory

Technical Report
NREL/TP-5000-54530
July 2012

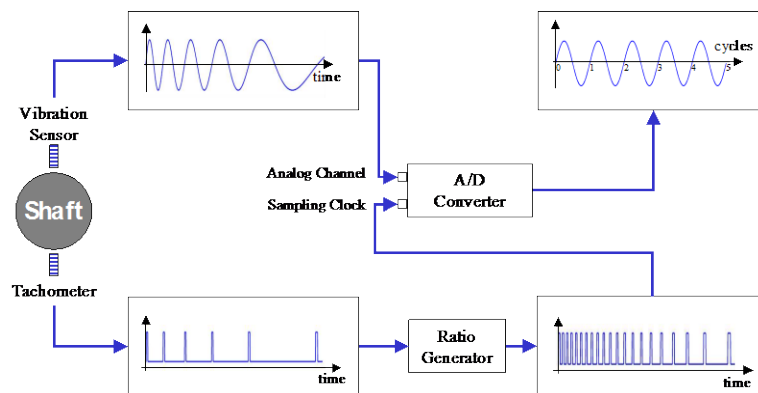
Figure 3.1. Synchronous sampling – analog approach

In the digital approach, or synthesized synchronous sampling [9], both vibration and encoder signals are discretized simultaneously, preferably at high speed. Different signal processing techniques can be used to resample the data and convert time domain data into shaft cycle domain data, with the help of an encoder signal from the shaft (refer to Figure 3.2). In this approach, both the encoder and key phaser can be used as a shaft speed reference. Regardless, the availability of the shaft encoder/key phaser is crucial to both analog and digital synchronous sampling approaches.

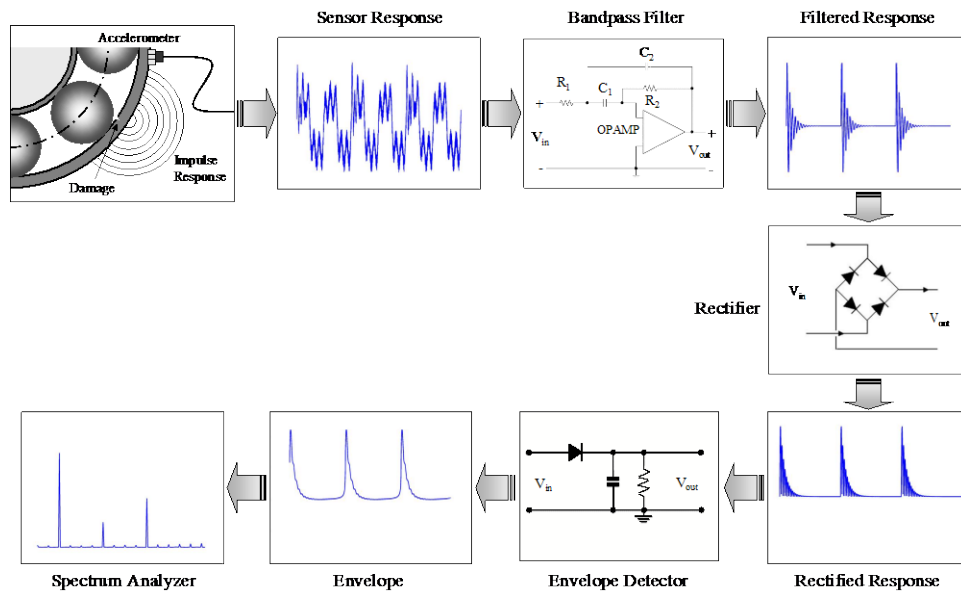
Figure 3.5. Analog devices-based approach

The process shown in Figure 3.5 works well, if all the analog devices are appropriately designed for a particular application. However, a different application may require different parameter settings of the analog devices. For example, the bearing support system may have a different resonant structure; thus, it requires a different cut-off frequency design for the band-pass filter to isolate the damage impulse response. For different structural damping, the envelope detector needs a different time constant design to match the impulse response decay rate, so that the bearing damage-related high frequency and low amplitude vibration signals can be maximized. More importantly, the bearing damage detection is usually conducted in a harsh environment. An increased number of electronic components involved in the bearing defect detection process will usually decrease the overall system reliability.

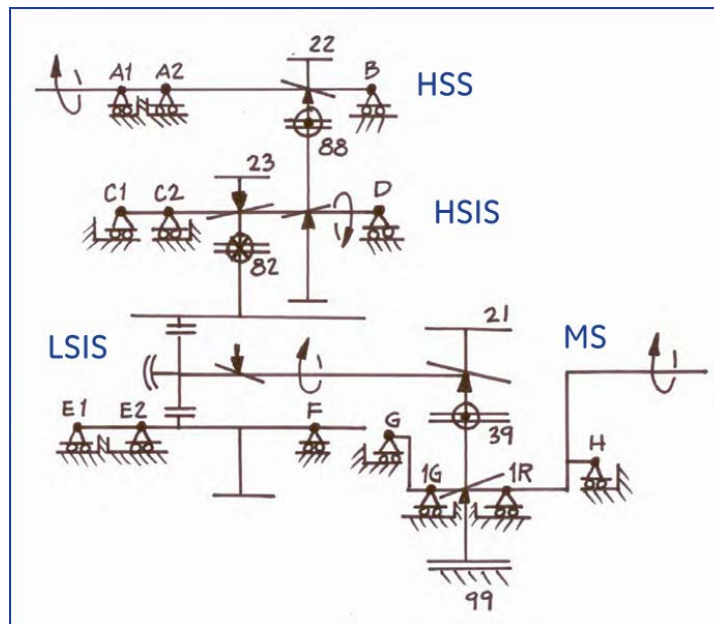
Figure 3.7. Gearbox power flow

Based on the gear configuration data given by NREL, the gear damage features were calculated and listed in Table 3.1. Similarly, the bearing damage features were calculated and listed in Table 3.2. In both tables, MS stands for Main Shaft. The bearing notations used in Table 3.2 is the same as those used in the test gearbox failure analysis report [4] and illustrated in Figure 3.7. The numbers of gear mesh teeth count are also marked in Figure 3.7.

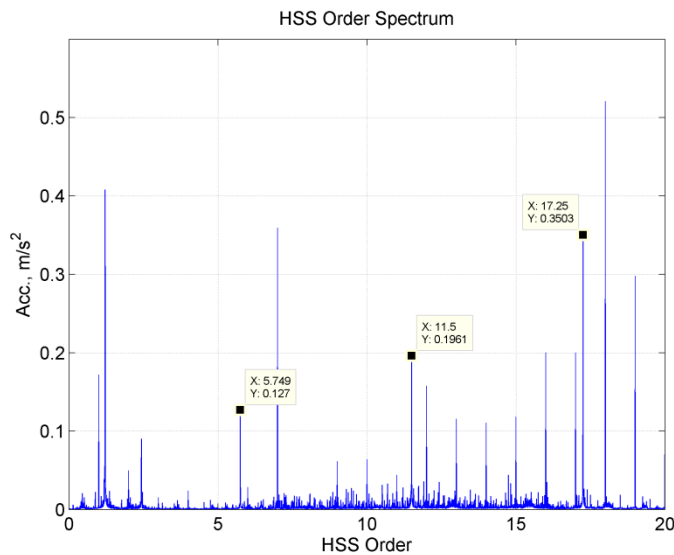
Figure 3.14. ISGM and higher order harmonics

Damage signatures related to the ISGM were not shown in the vibration analysis. As seen in Figure 3.14 though, the ISGM and higher order harmonics do exist. However, the shaft modulations are too small to draw any conclusion regarding the gear damage. The post-test examinations revealed fretting corrosion, polishing wear, and scuffing damage in the ISGM pinion; however, the damage was imprinted on all teeth because the gear-set had a hunting tooth gear ratio, which has potentially smoothed out the damages and reduced vibration responses incurred by the damage.

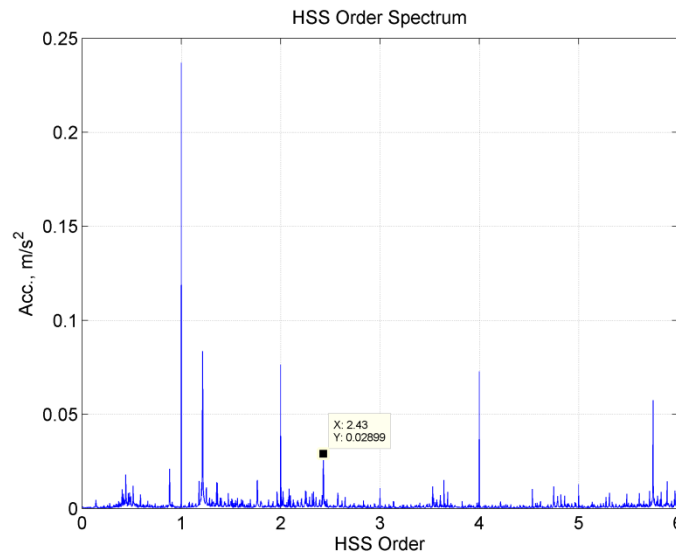
Figure 3.23. Possible bearing D BPF1

was very difficult to draw a conclusion about the bearing D BPF1 damage signature at the current stage.
