FABRICATION OF THE HEAT EXCHANGER
TUBE BUNDLE FOR THE ^{MSRE}MOLTEN-SALT

REACTOR EXPERIMENT

R. G. Donnelly
G. M. Slaughter

ORNL-3500

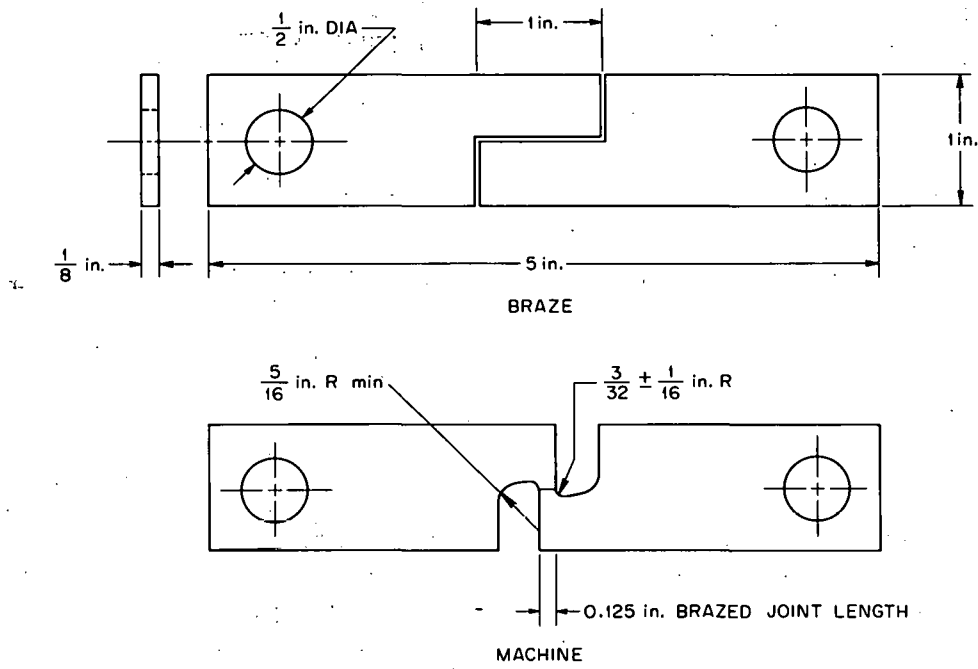
UNCLASSIFIED
ORNL-LR-DWG 78478

Fig. 3. Miller-Peaslee-Type Shear-Test Specimen.

In order to obtain strength information on this type of joint, Miller-Peaslee-type shear-test specimens,⁸ as shown in Figs. 3 and 4, were furnace brazed and tested at room temperature and at the reactor operating temperature of 1300°F. The results of these tests are listed in Table 3.

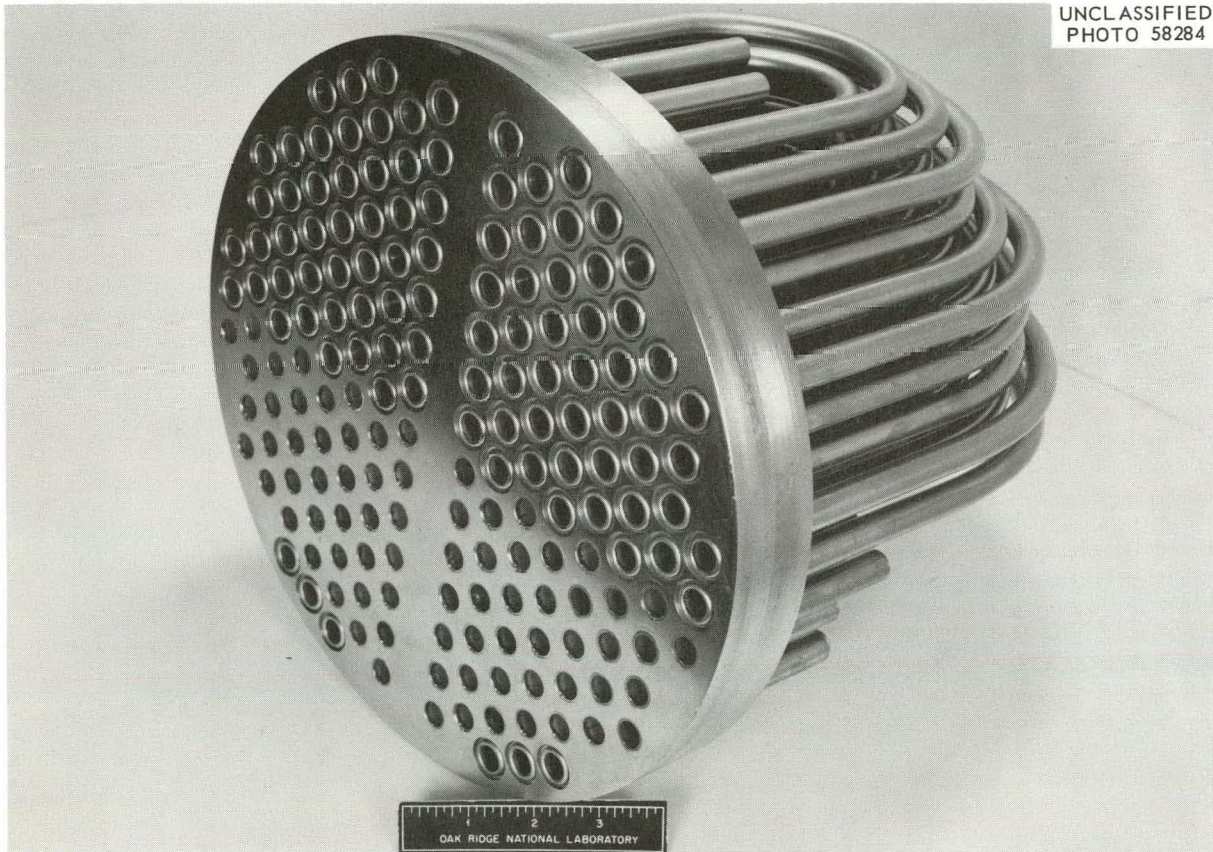
Fig. 7. Proof-Test Assembly Containing Short U-Tubes.

A proof test of all welding, brazing, and assembly conditions and techniques was carried out on a subsize 12-in.-diam assembly containing 98 joints with some short U-tubes. The unit is shown in Fig. 7. The header plate was drilled to the heat exchanger configuration to simulate

actual heat flow conditions during brazing. As an economy measure, the trepanning, drilling of the feeder holes, and application of brazing alloy was limited to only half the tubes. Dummy stainless steel tubes were tack-welded in the remaining holes.

Inspection of the completed assembly revealed no weld defects and excellent brazes in all joints except one, this one joint being completely unbrazed. Metallographic examination of this joint revealed small metal chips in the joint and a complete lack of wetting by the brazing alloy. The apparent cause of this condition was inadequate cleaning of the parts before assembly. Therefore, the importance of cleanliness to the brazing operation was greatly emphasized. Special handling and assembly procedures were instituted, and a full-time inspector was assigned to the job.
