To Be Presented at  
WM Symposium 2009

**Demolishing a Cold-War-Era Fuel-Storage Basin Superstructure  
Laden With Asbestos - 9475**

E.R. Lloyd, J.M. Stevens, L.C. Zinsli, M.A. Green, C.H. Larson  
Fluor Hanford Inc.  
P.O. Box 1000, Richland WA 99352

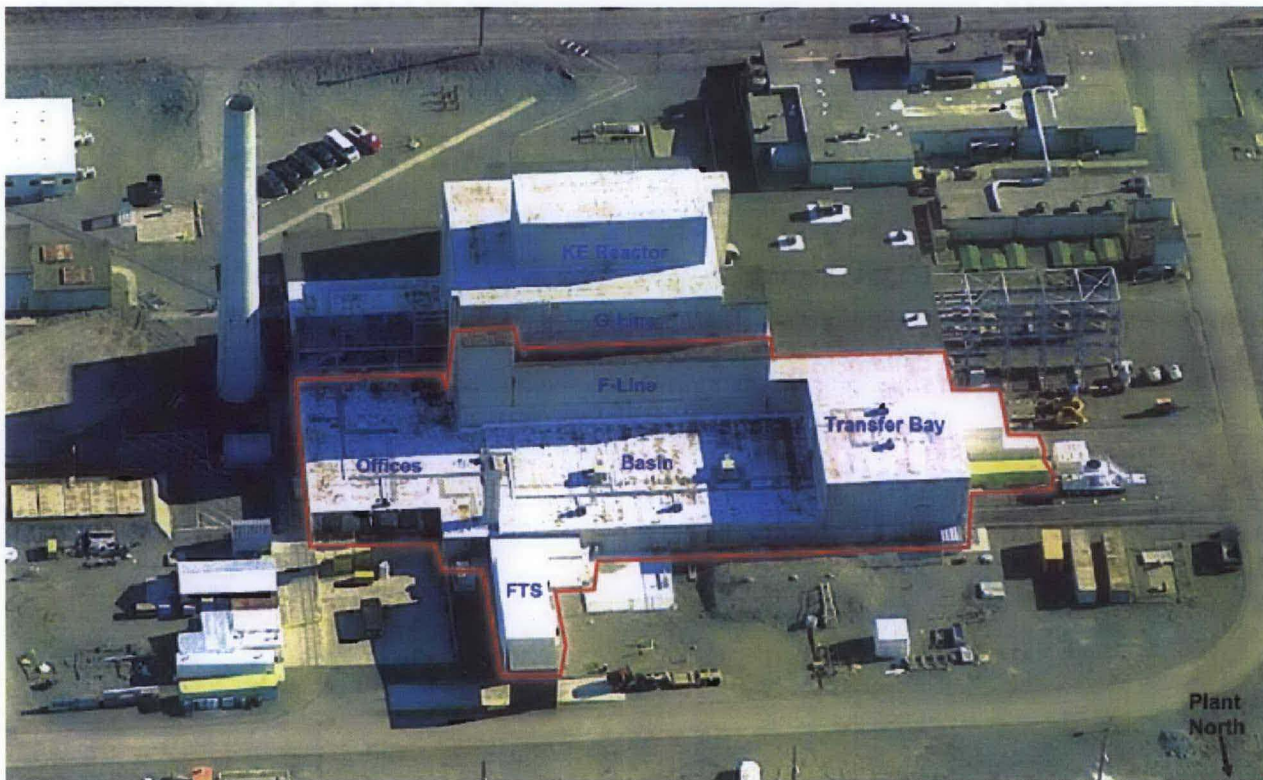
105KE Reactor and Fuel Storage Basin

Fig. 1. K Basin superstructure aerial view

The project scope included the KE Basin superstructure covering of the basin proper, the Fuel Transfer Station (FTS), the office complex, the transfer bay and the F-to-G line portion where the superstructure is attached to the main reactor building. The basin superstructure was primarily steel columns and beams covered with cement asbestos board (CAB) siding and CAB/built up roof. The superstructure built immediately over the basins and transfer bay ranged from 5 meters to 12 meters high and was 23 meters wide and 71 meters long. The F-G Line, or reactor basin interface area, ranged in height from 12 to 22 meters high, 5 meters wide, and 71 meters long. The office area was 5 meters high, 17 meters wide and 22 meters long. The FTS annex was a metal-skinned steel structure built in the early 1980s.

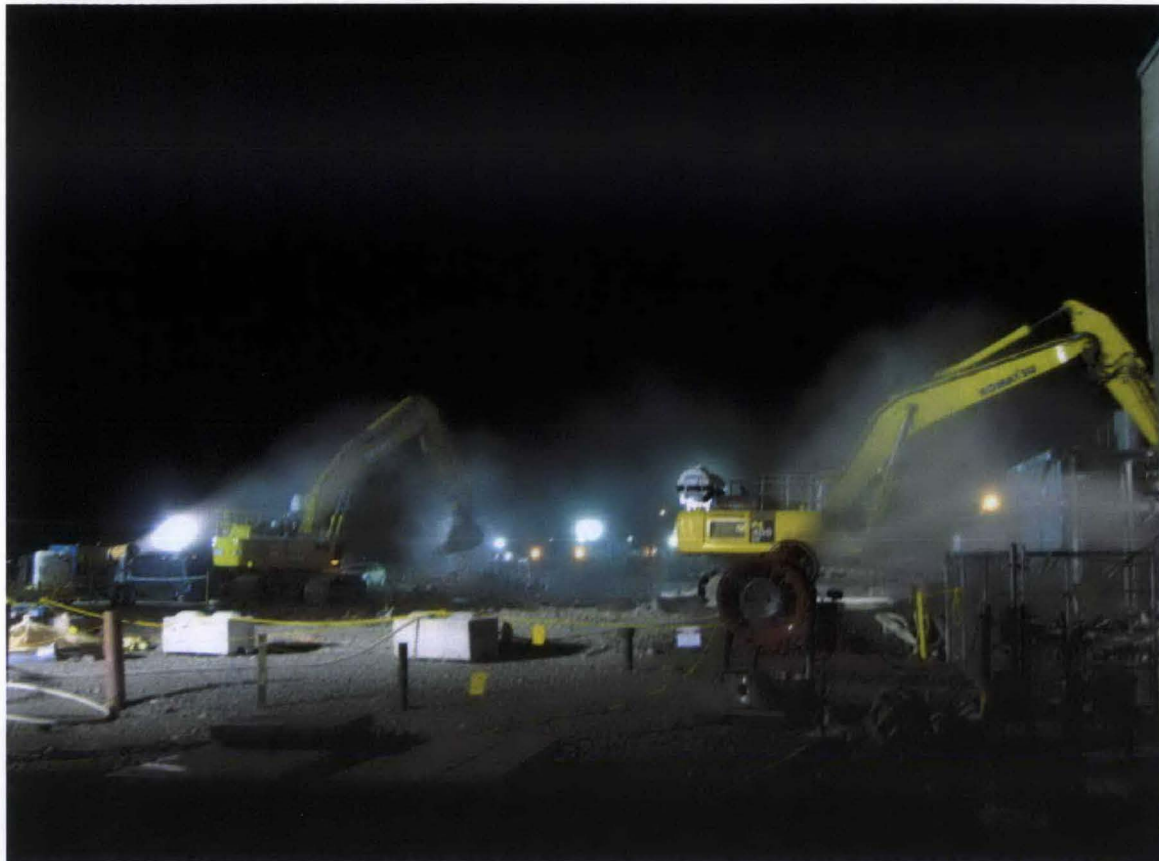
**Fig. 2. Nighttime demolition operations**

The demolition progressed with two 10-hour shifts. The day crew focused on demolition since the lighting provided better working conditions, especially with the high-reach operations. The night shift demolition crew's focus was on removing waste and packaging the material demolished during the day shift (Fig 2)

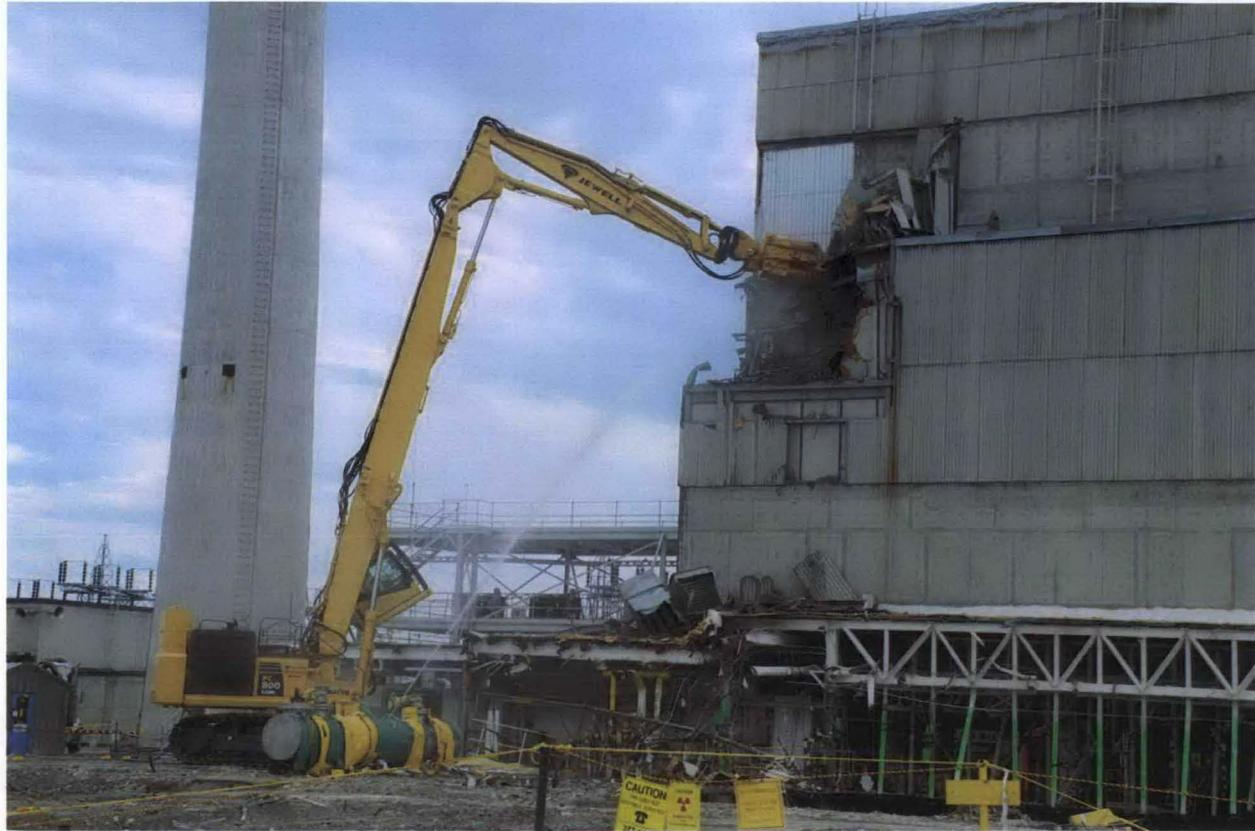
**Fig. 3. High-reach excavator demolishing the F-G (reactor interface area) area**

On the taller sections of the project, a high-reach demolition excavator was used (Fig 3). This equipment provided a safe method to bring the building to the ground while minimizing damage to the reactor wall as the floors were structurally “tied” into the reactor wall. All piping and conduit penetrations of the wall were isolated during demolition preparation activities so there was no concern about damaging the wall or items on the other side of the wall.

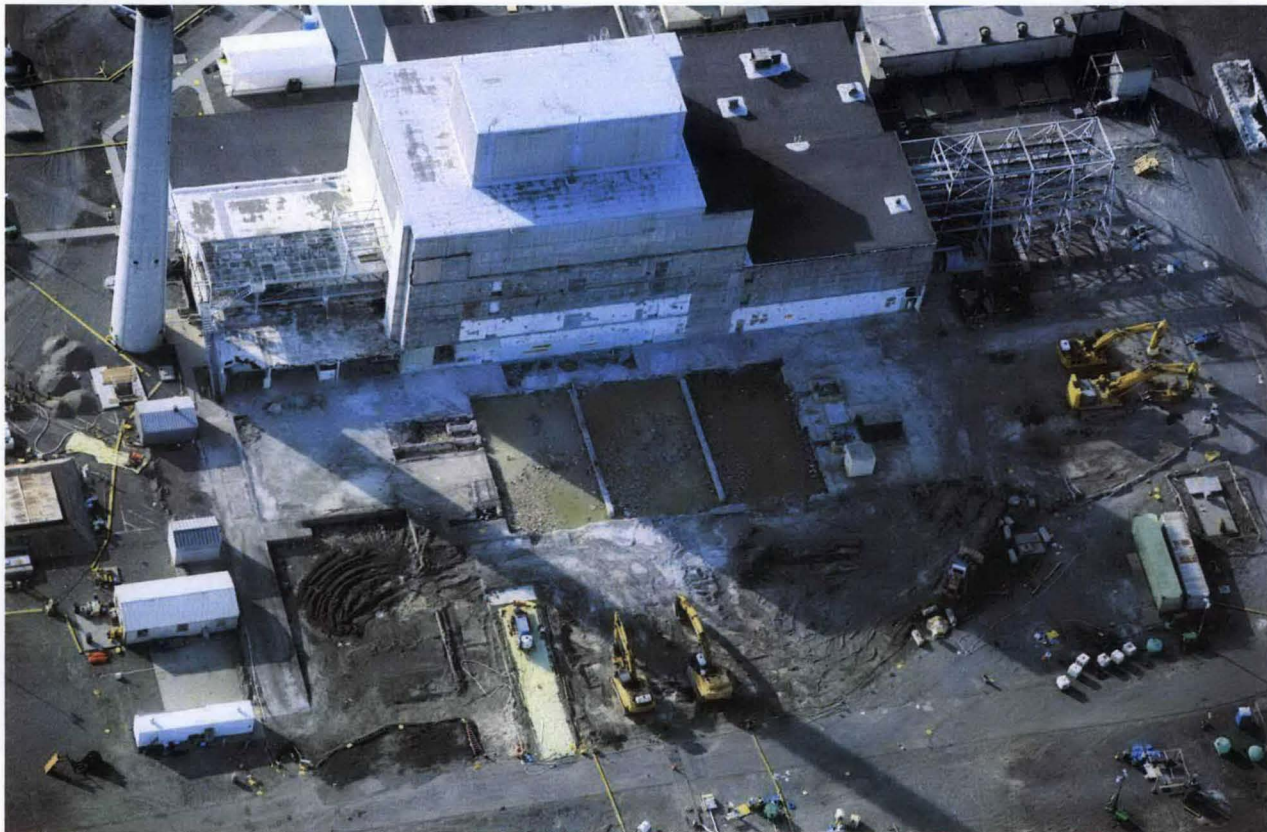
**Fig. 4. Superstructure demolition complete.**

At the conclusion of the basin superstructure demolition activities (Fig 4), the area was prepared for phase three, basin removal.
