TECHNICAL REPORT N-70-10

SURVEY OF GULF COAST STRUCTURAL DAMAGE RESULTING FROM HURRICANE CAMILLE, AUGUST 1969

April 1970

By U. S. Army Engineer Waterways Experiment Station, Vicksburg, Mississippi

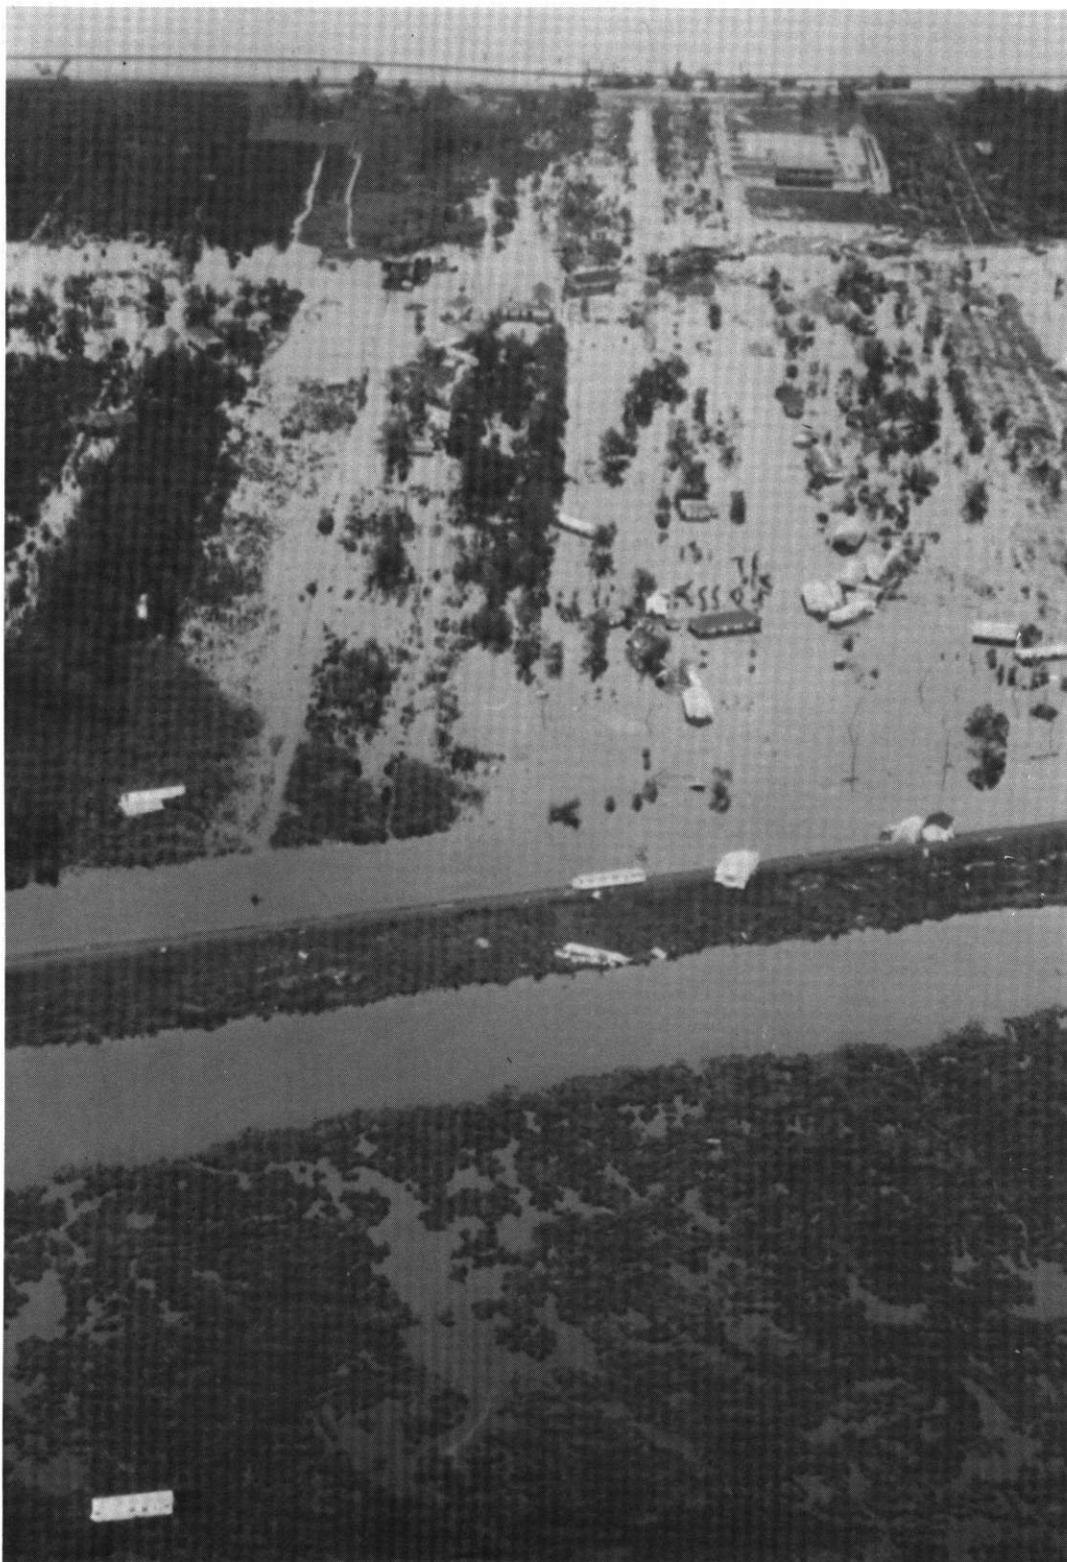
Figure 2.7 Between Empire and Buras, Louisiana.

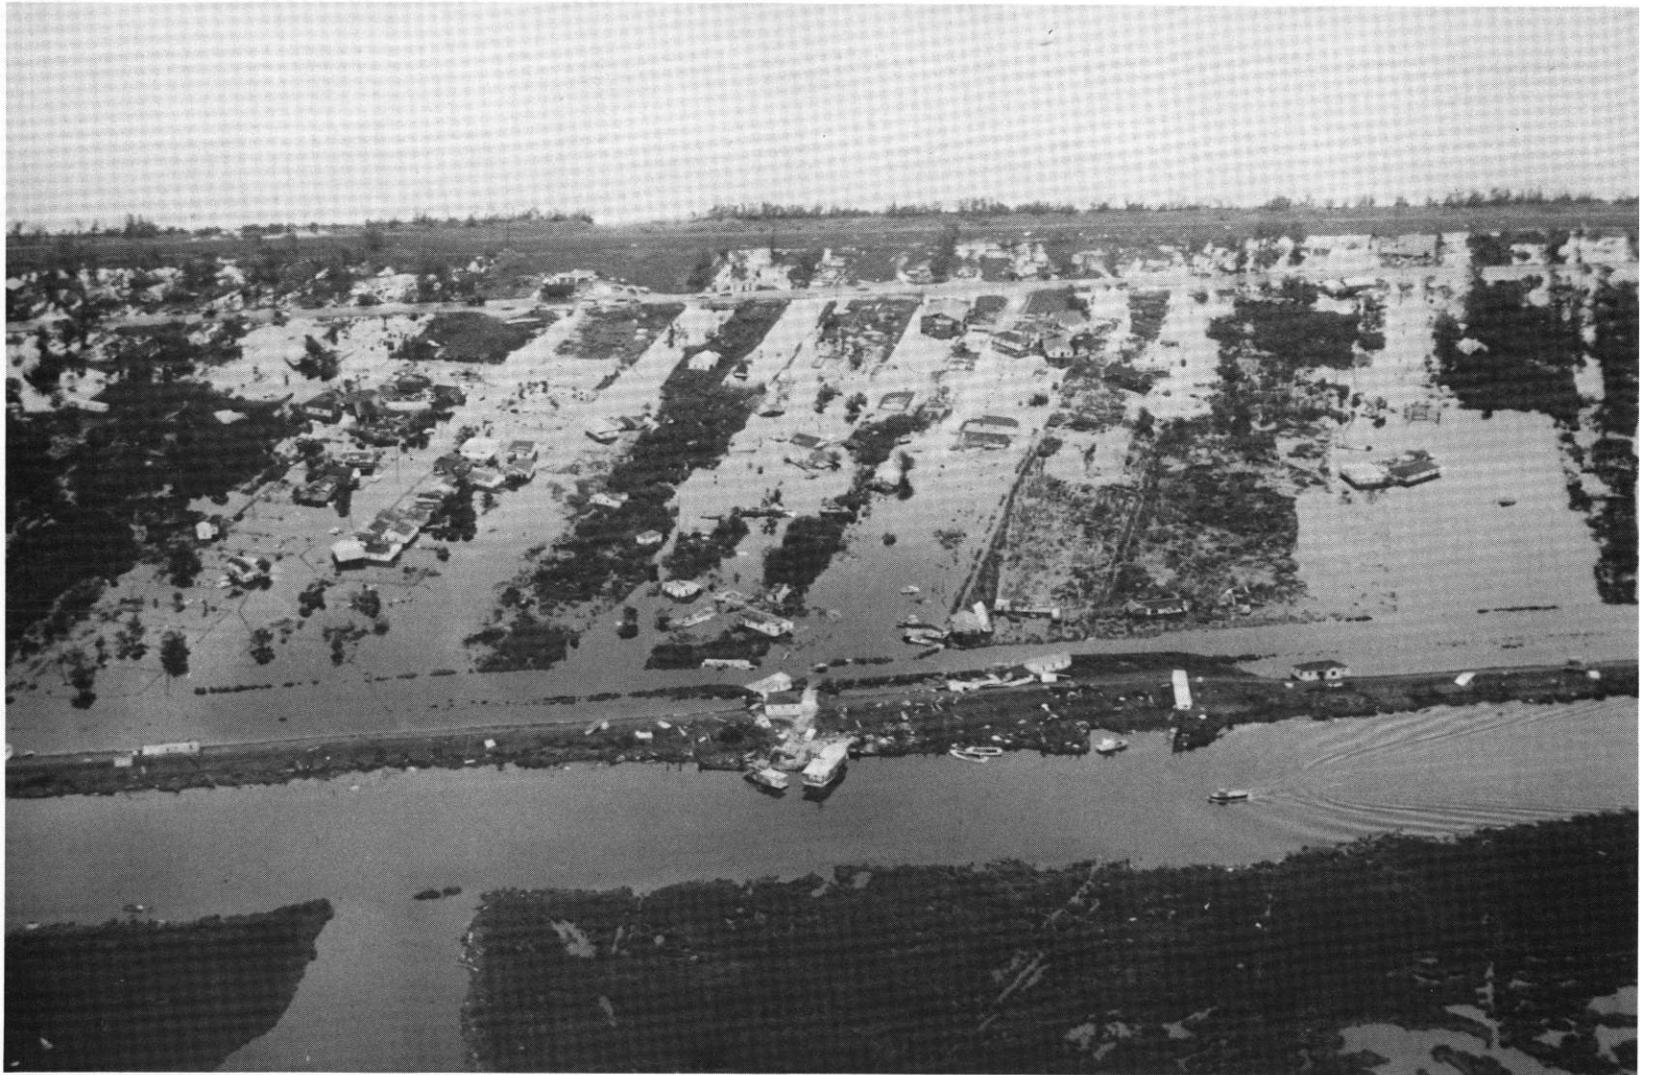
Figure 2.8 Near Buras, Louisiana.

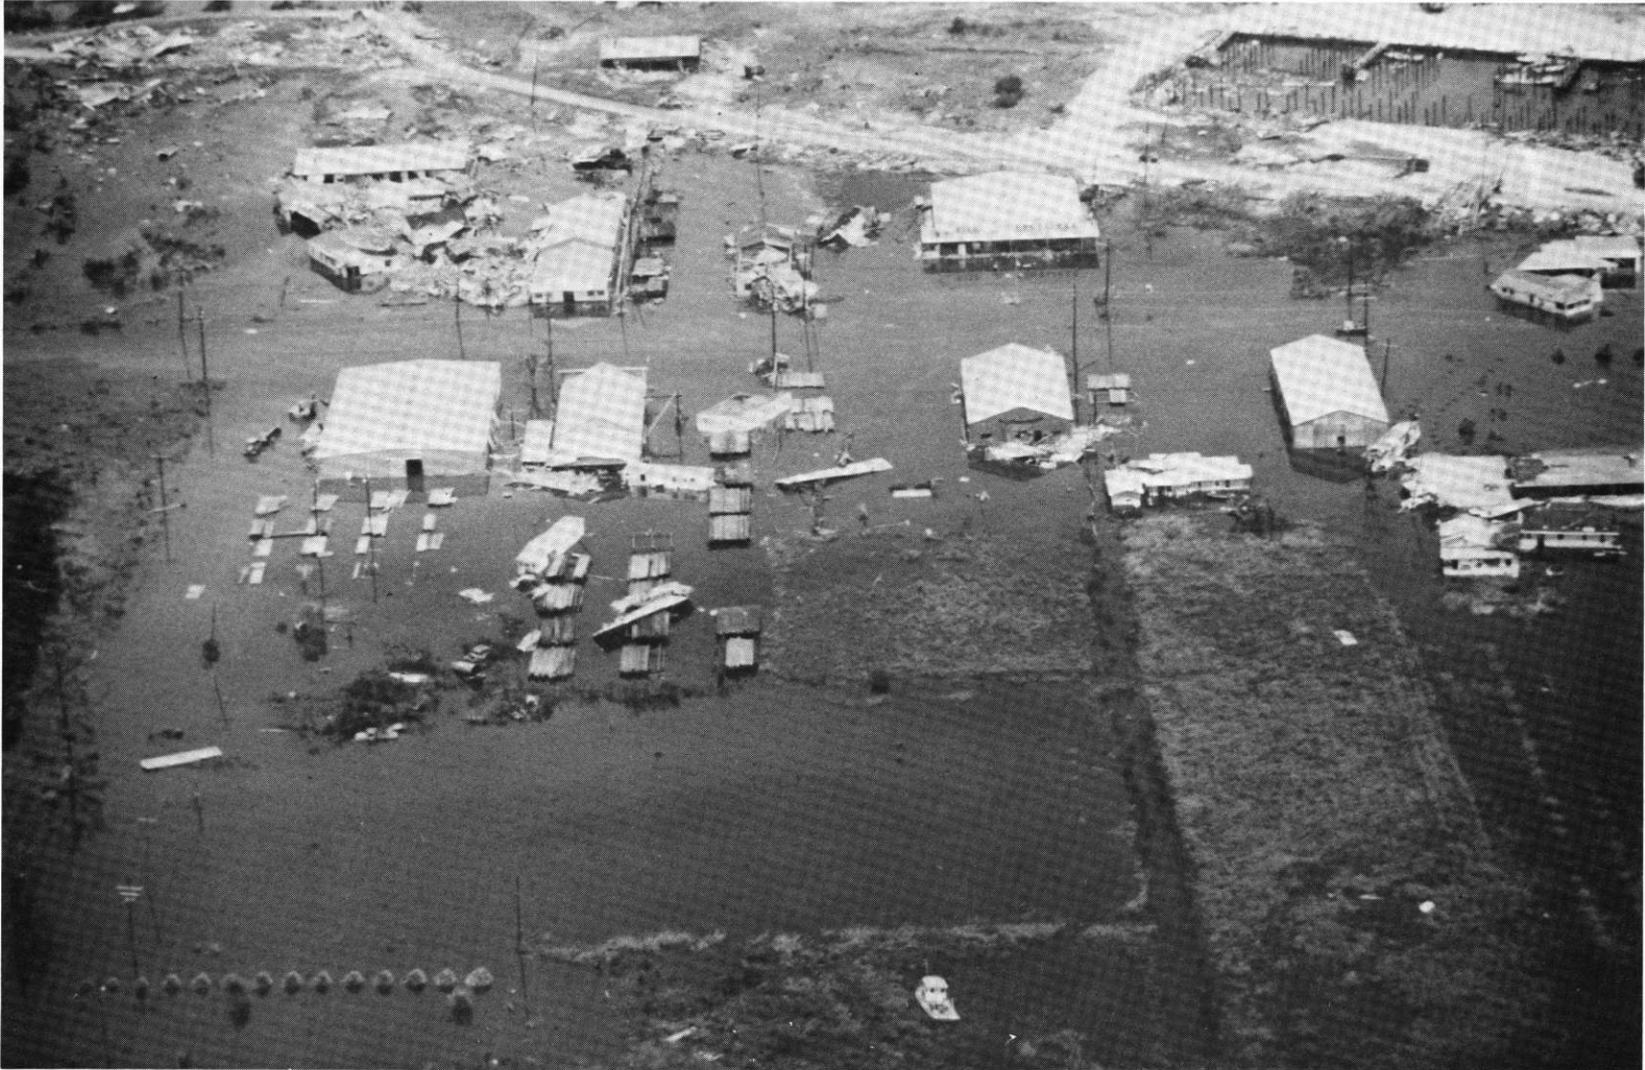
Figure 2.9 Buras area in Louisiana.

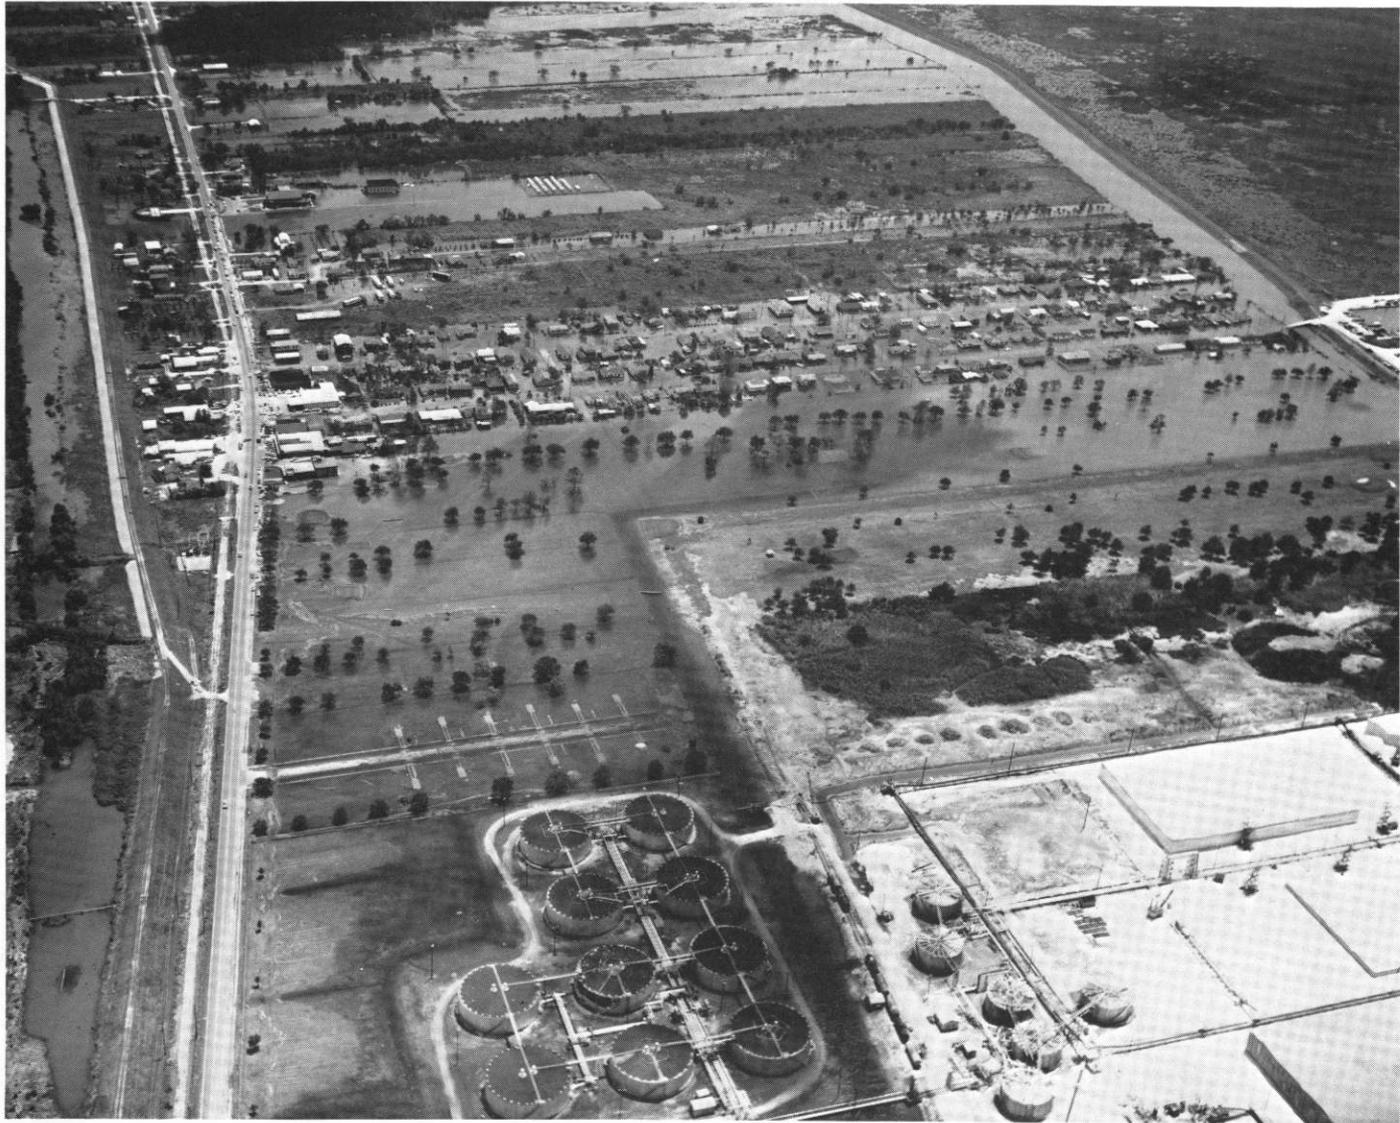
Figure 2.10 Home Place and Port Sulphur, Louisiana.

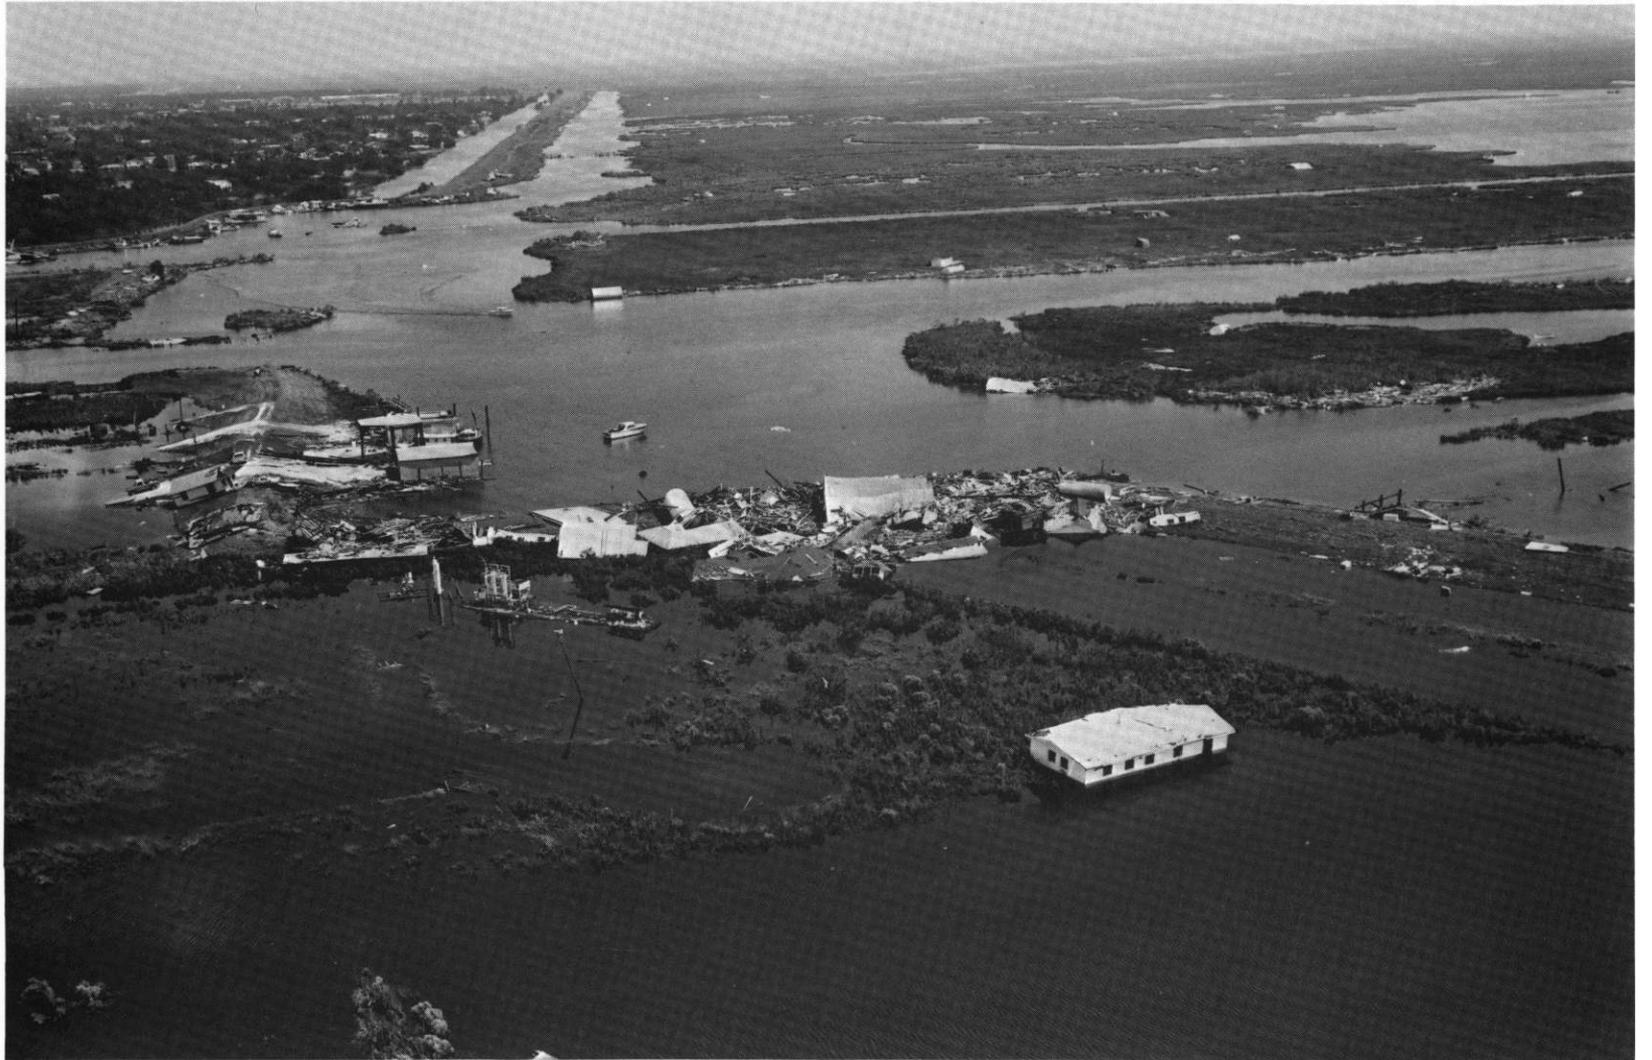
Figure 2.11 Back levee, near Buras, Louisiana.

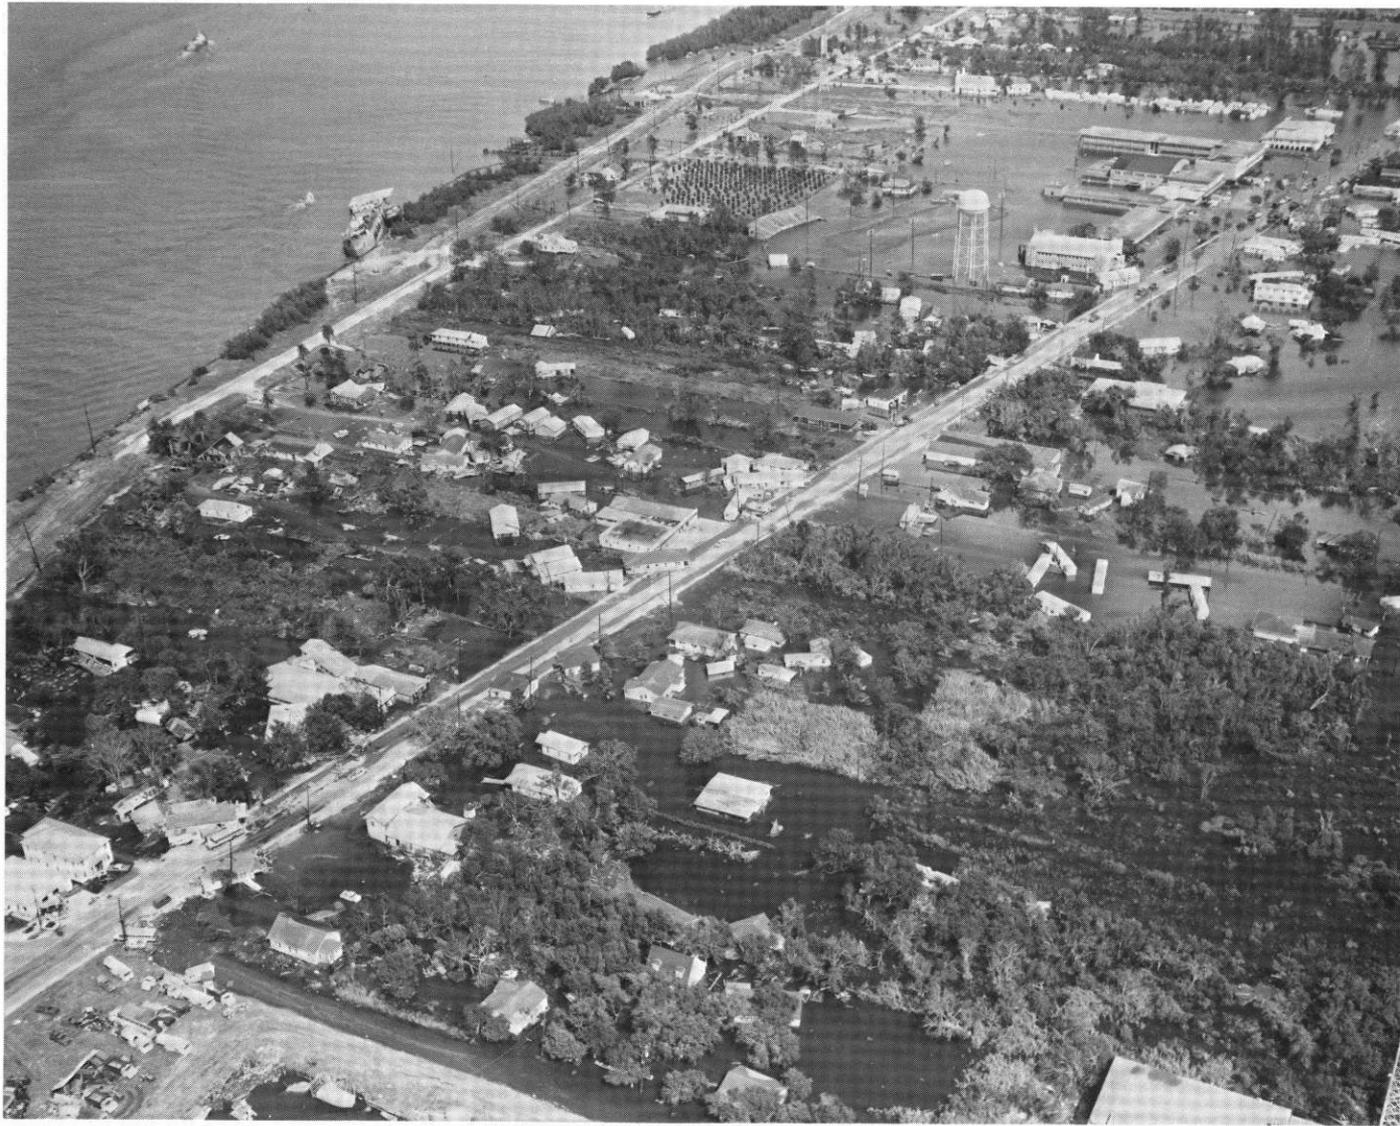
Figure 2.12 Buras, Louisiana.

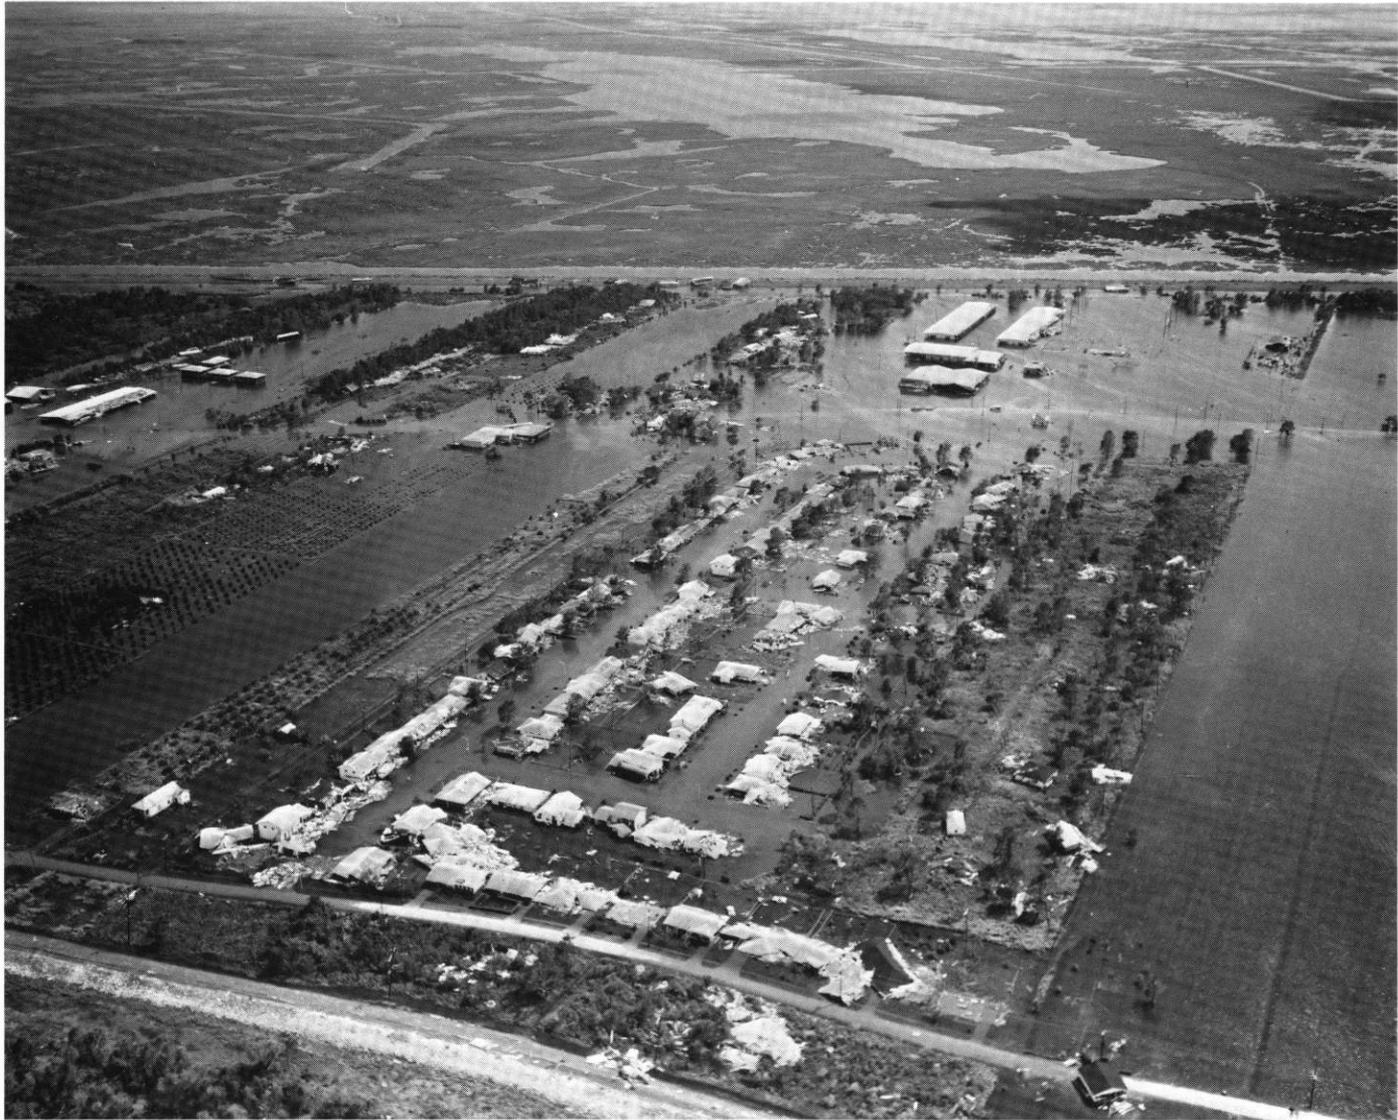
Figure 2.13 Below Buras, Louisiana.

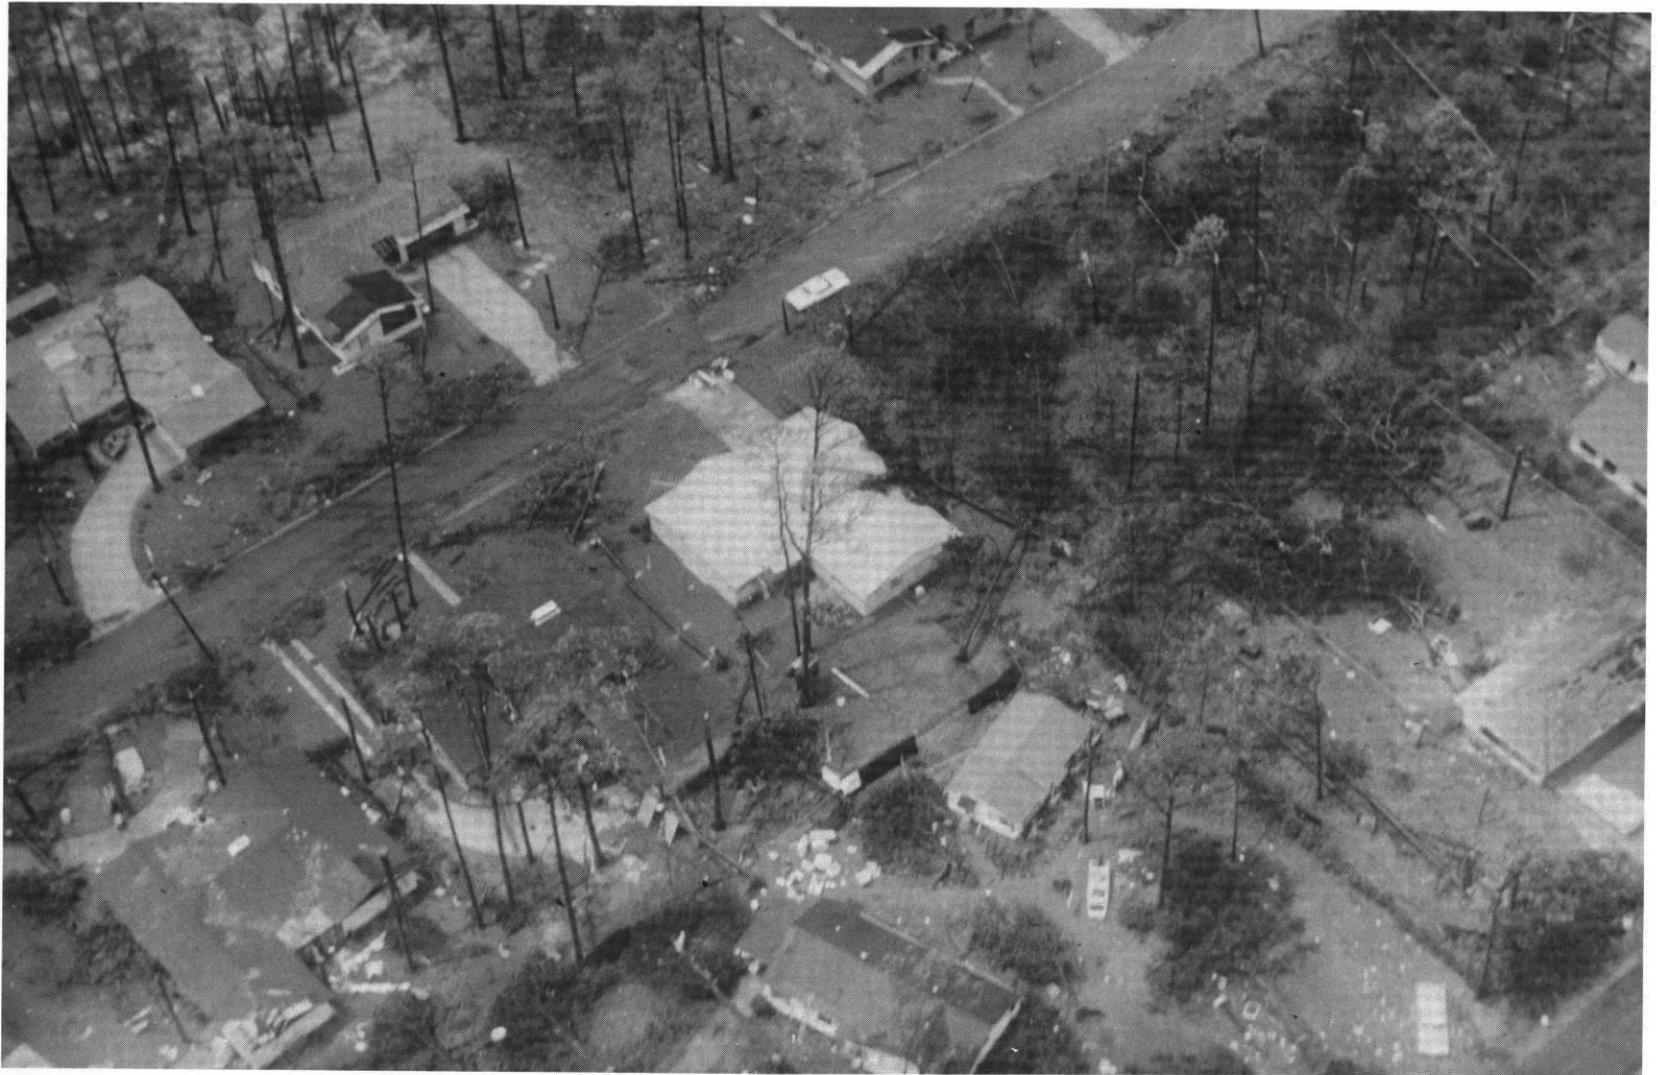
Figure 2.15 Residential area in west Gulfport, Mississippi.

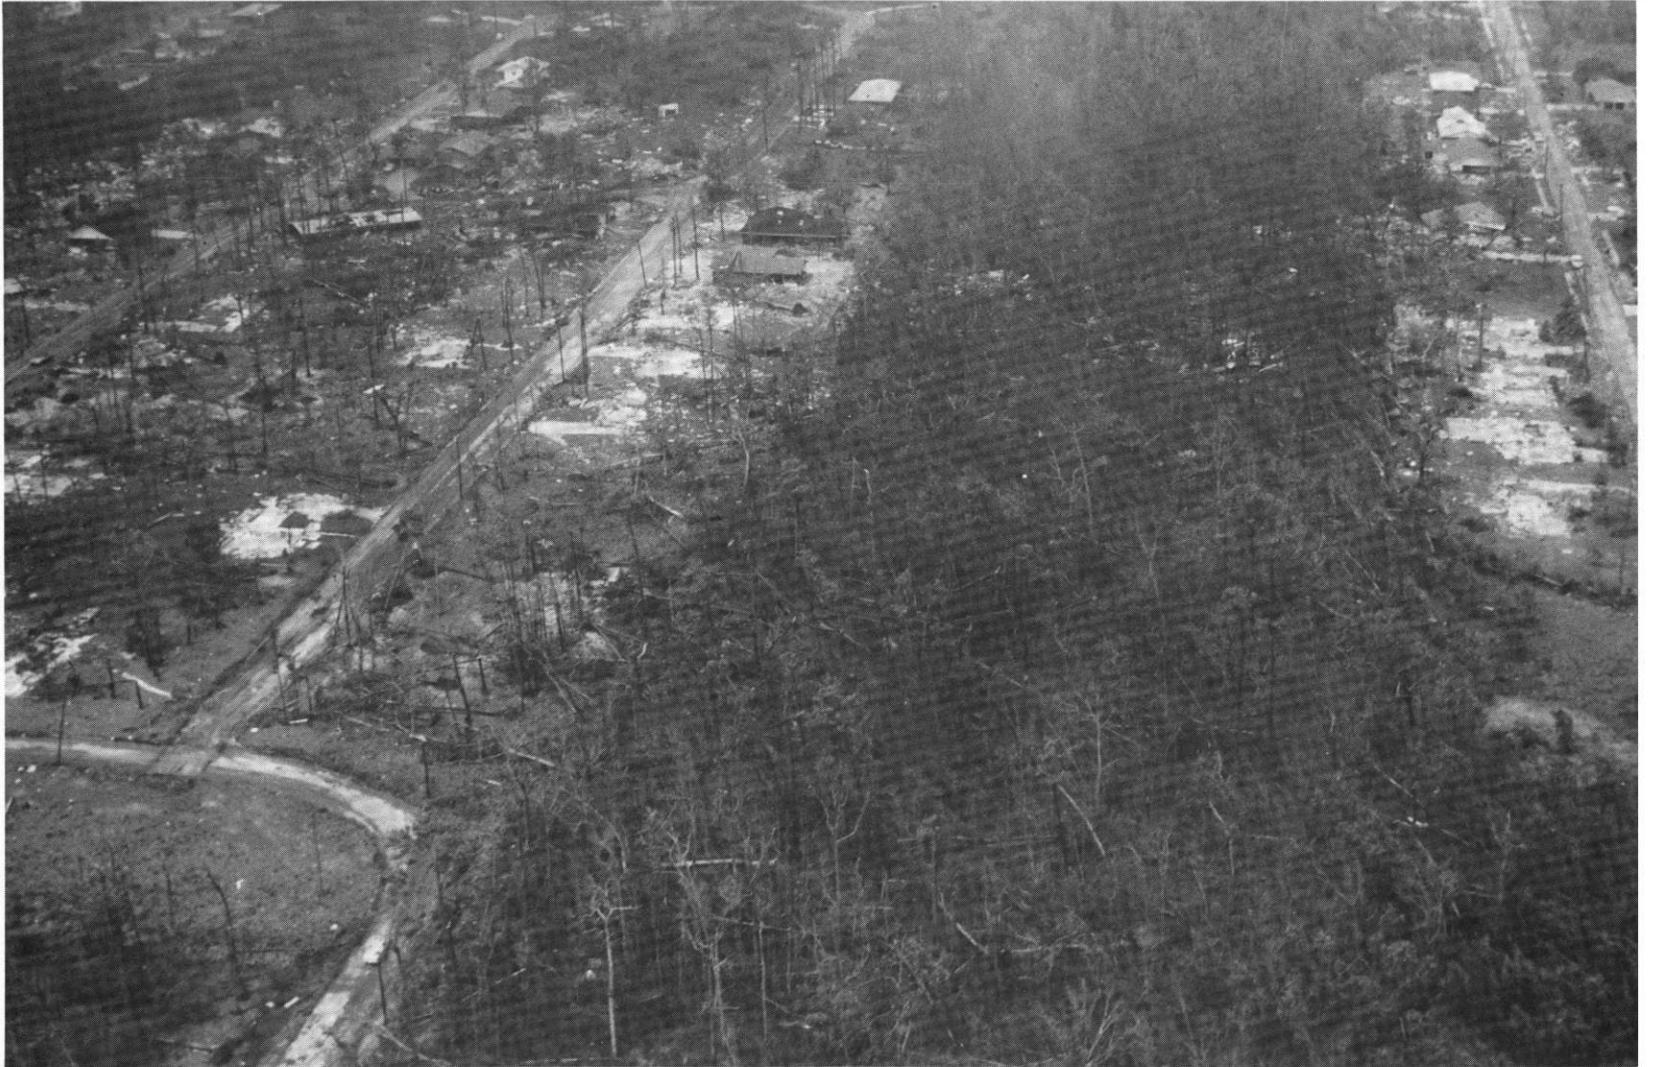
Figure 2.16 Residential district in west Gulfport, Mississippi.

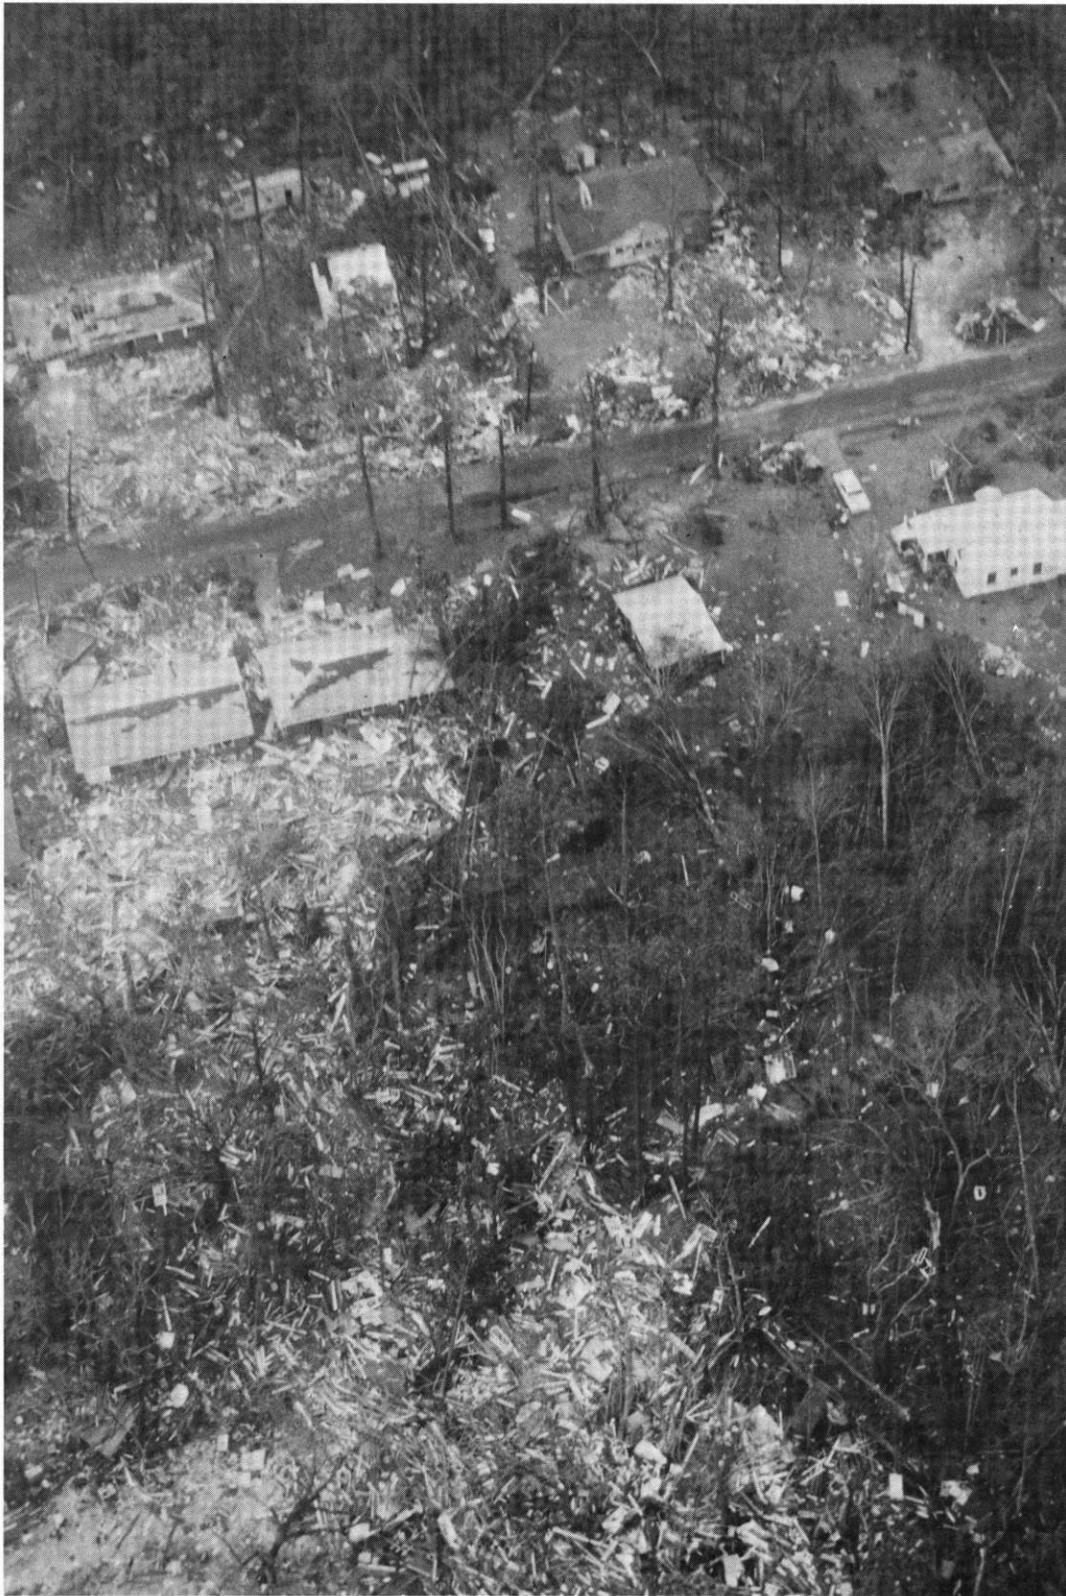
The extent of debris deposited inland marked the limit of greatest tidal action. The debris line is clearly seen in Figure 2.17.

Figure 2.17 Residences and debris line in west Gulfport, Mississippi.

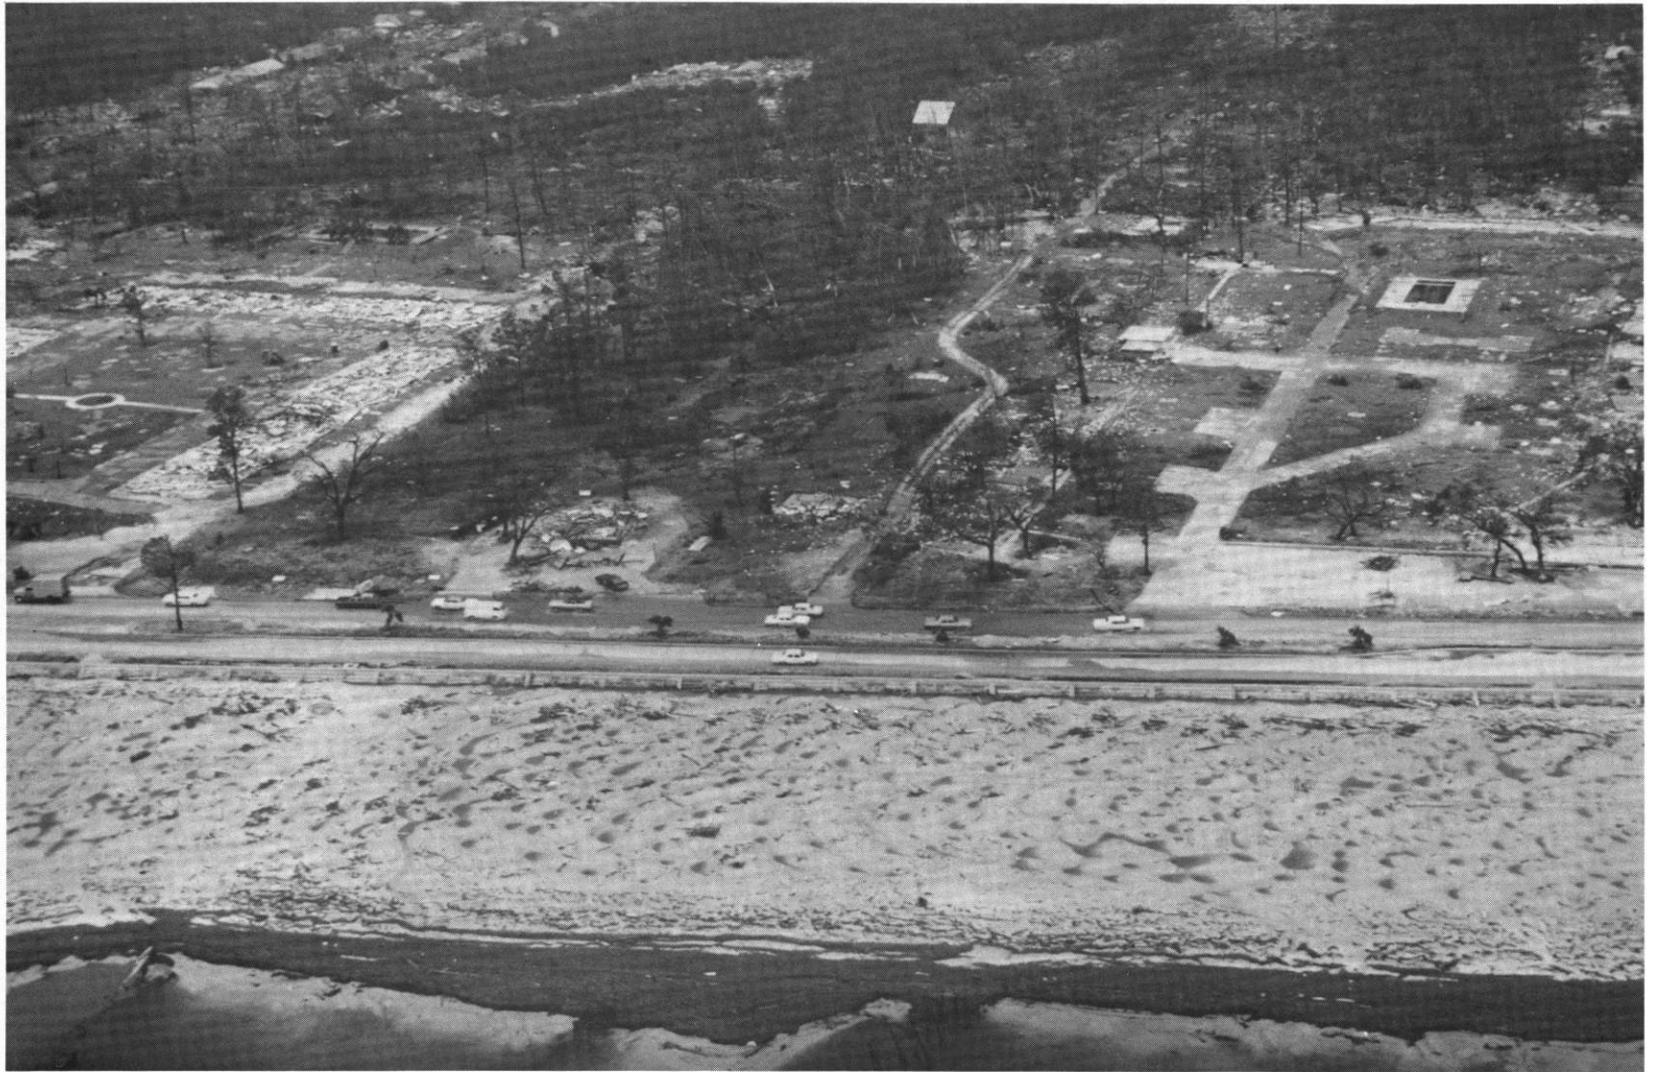
Figure 2.18 Remains of motels and apartments, Long Beach area.

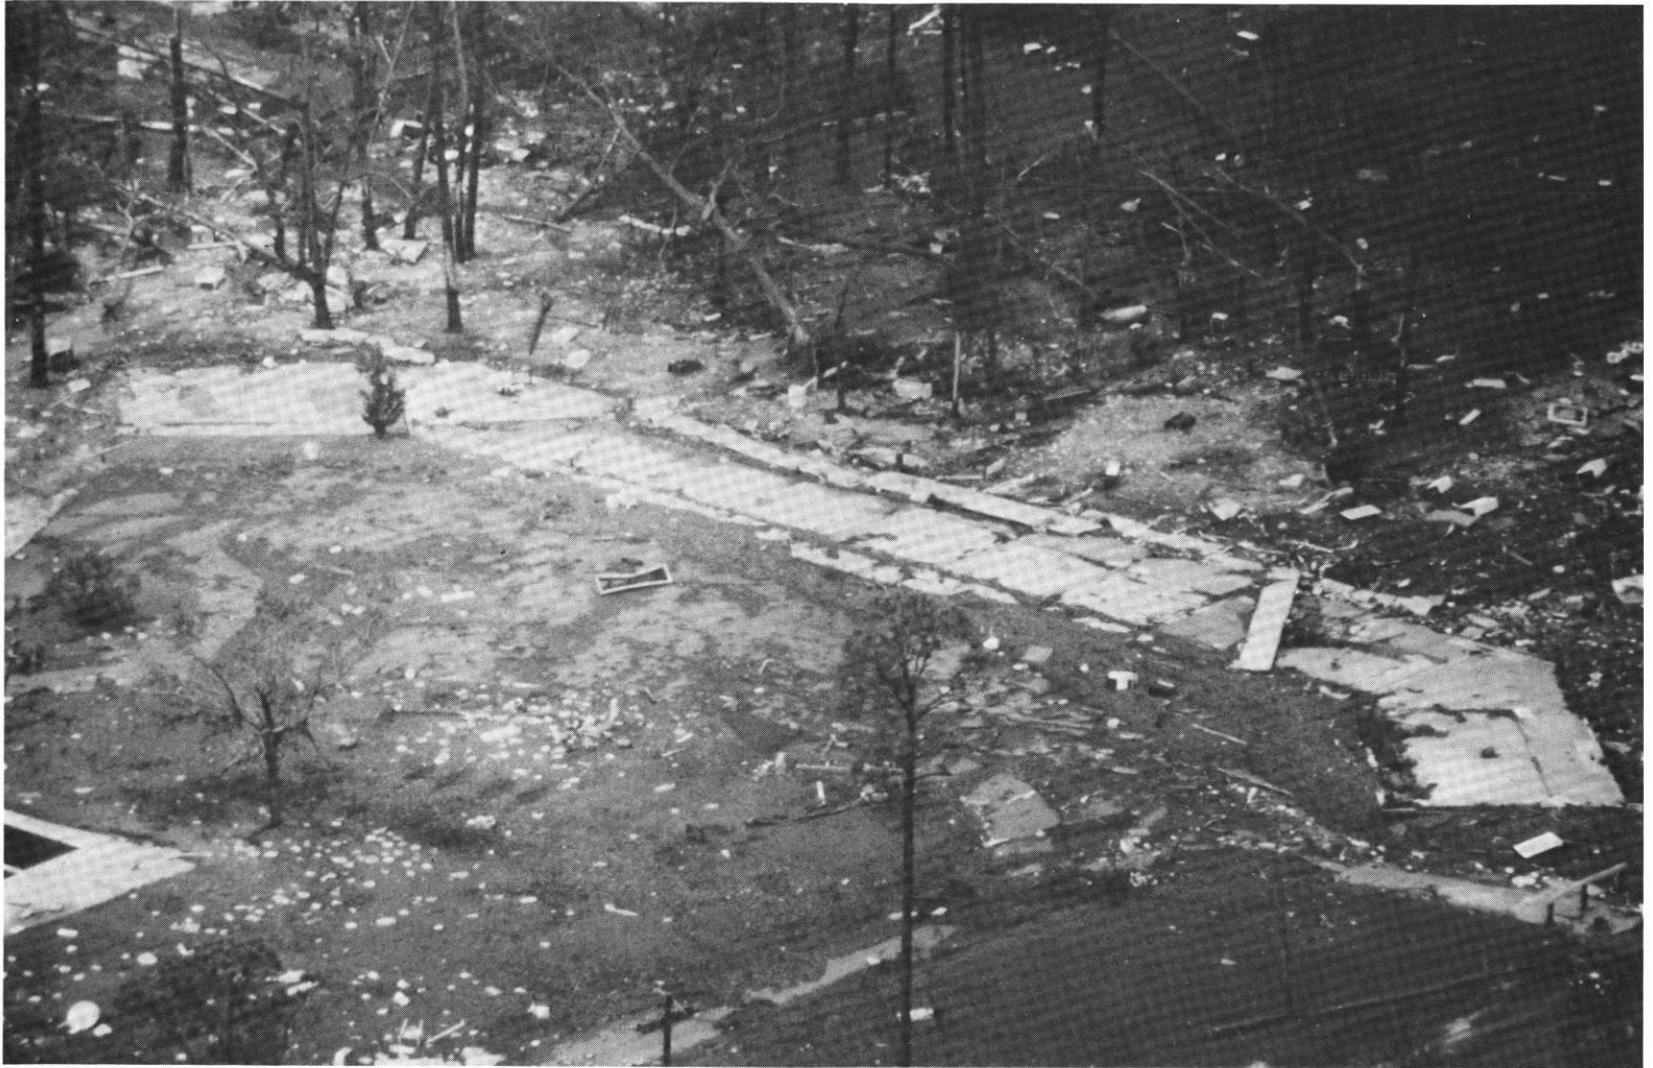
Figure 2.20 Motel building slab, between Pass Christian and Long Beach.

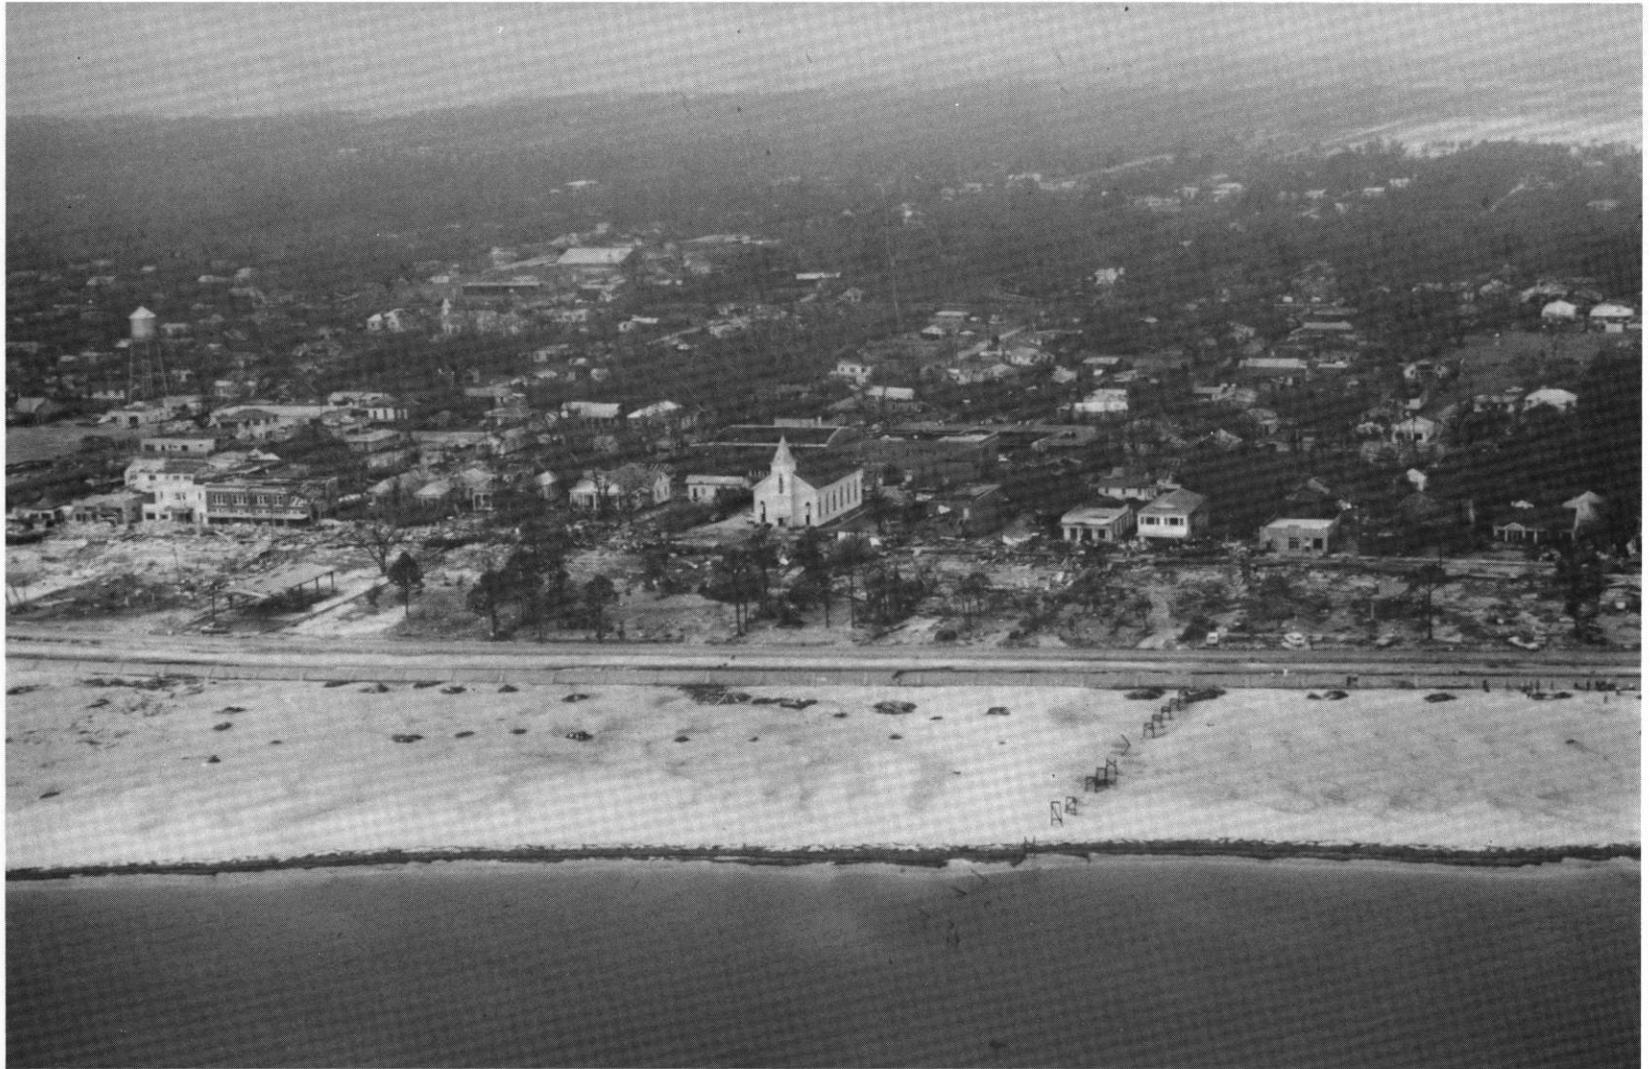
Figure 2.21 East end of Pass Christian downtown area.
