TECHNICAL REPORT N-70-10

SURVEY OF GULF COAST STRUCTURAL DAMAGE RESULTING FROM HURRICANE CAMILLE, AUGUST 1969

April 1970

By U. S. Army Engineer Waterways Experiment Station, Vicksburg, Mississippi

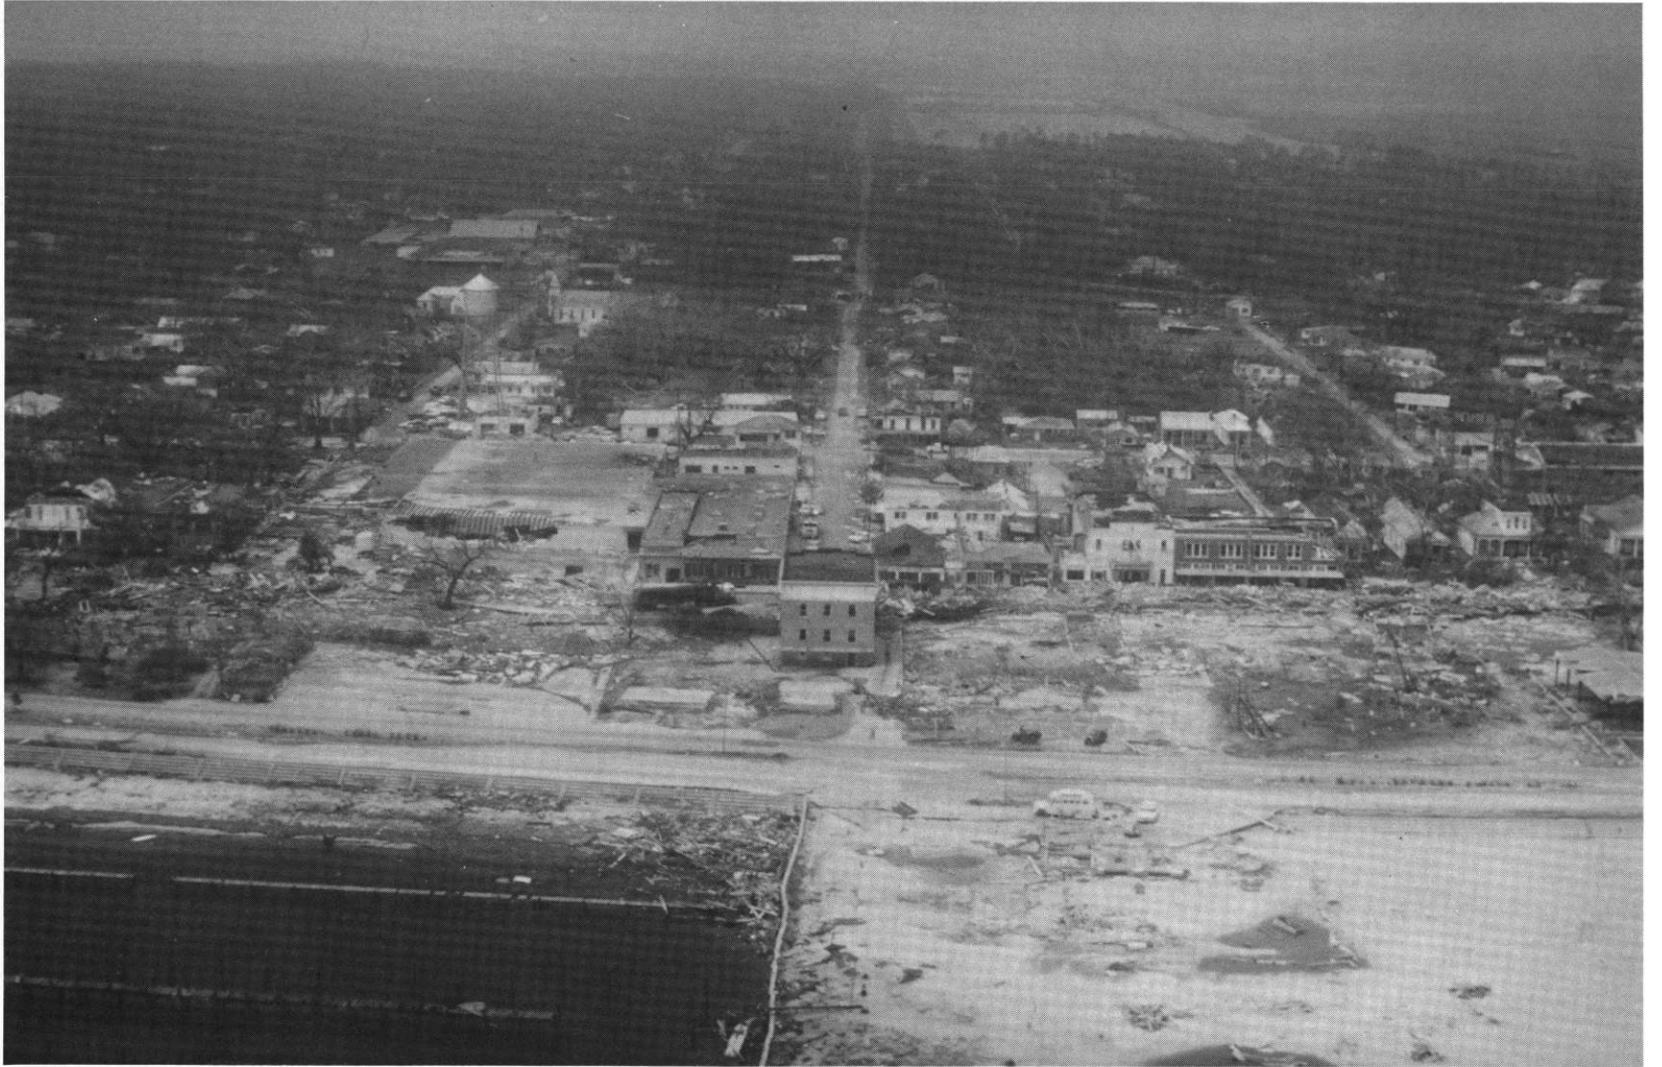
Figure 2.22 Pass Christian, Mississippi.

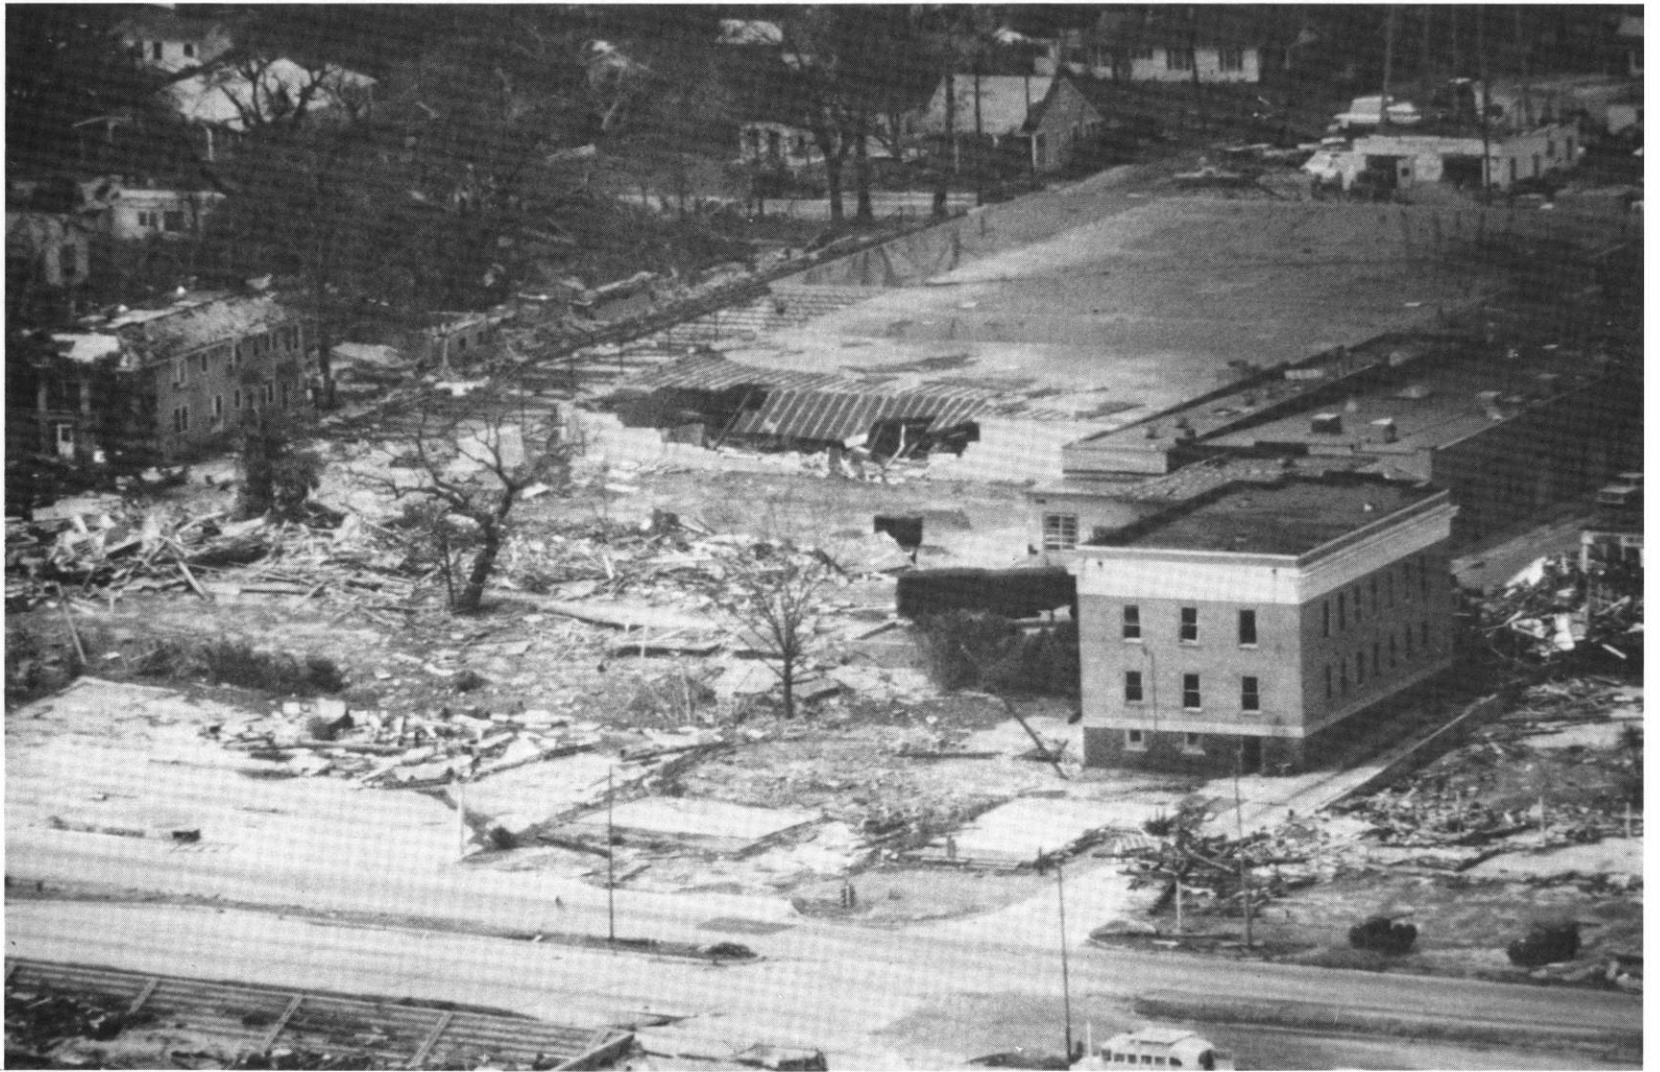
Figure 2.23 Pass Christian, City Hall in foreground.

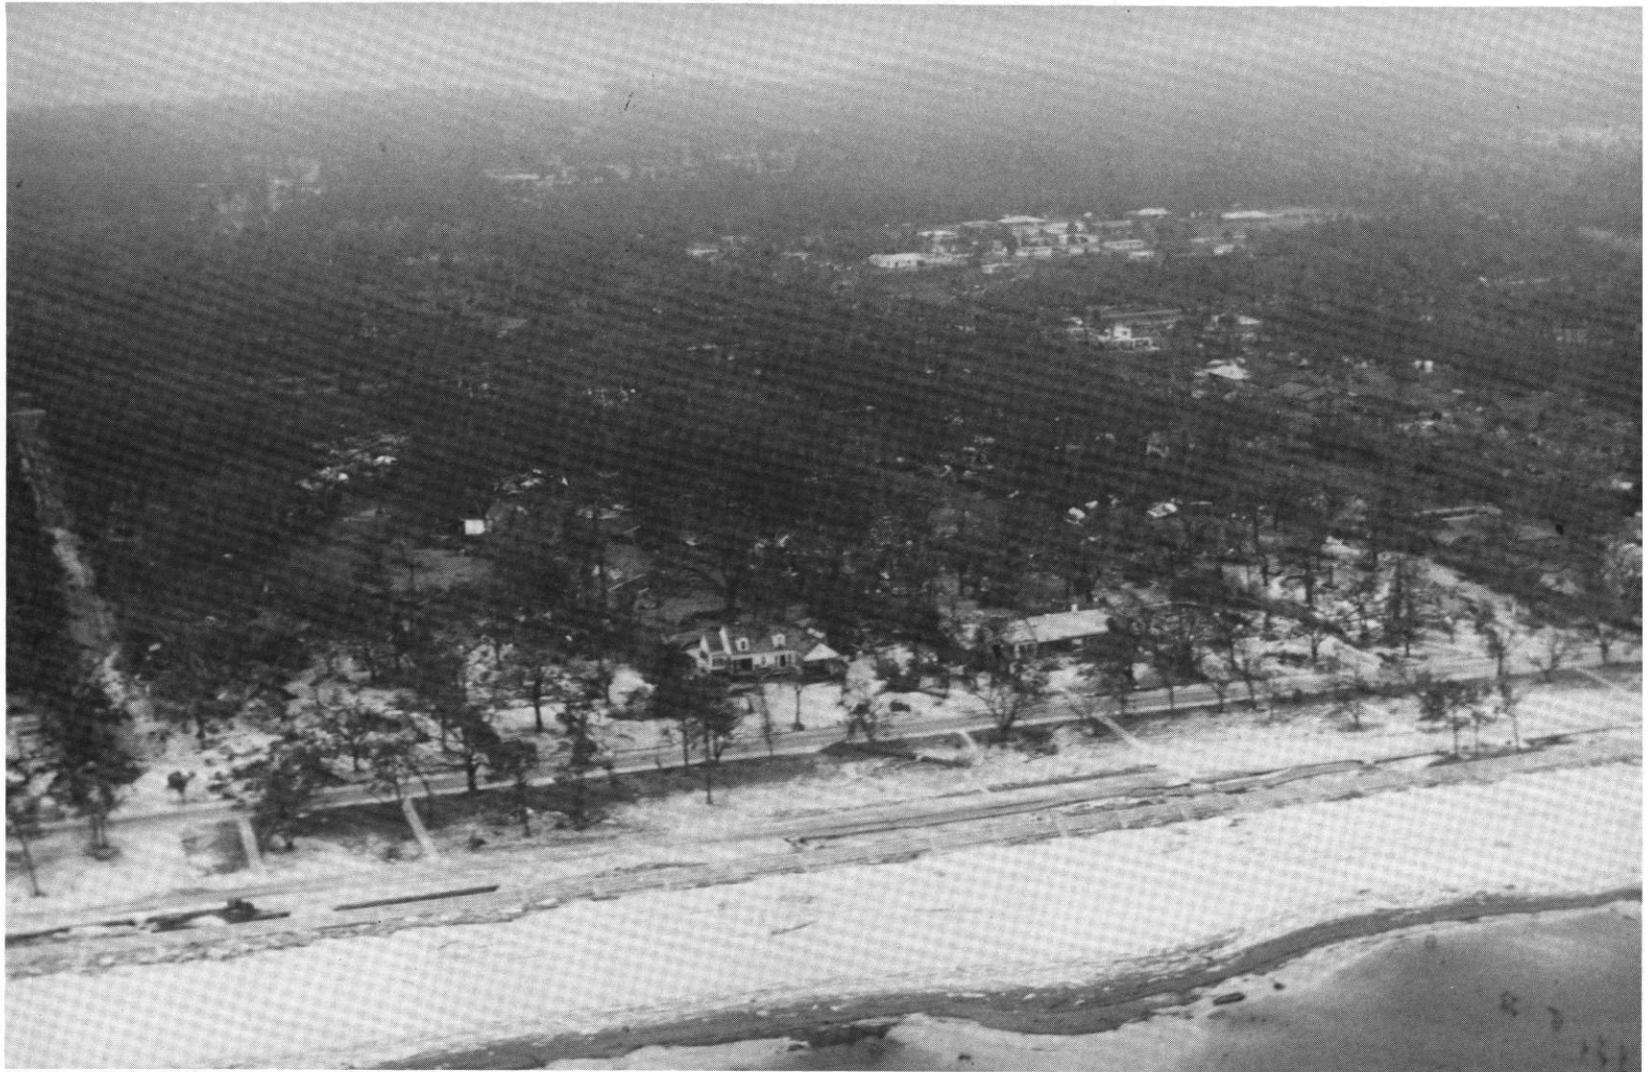
Figure 2.24 West Pass Christian, Mississippi.

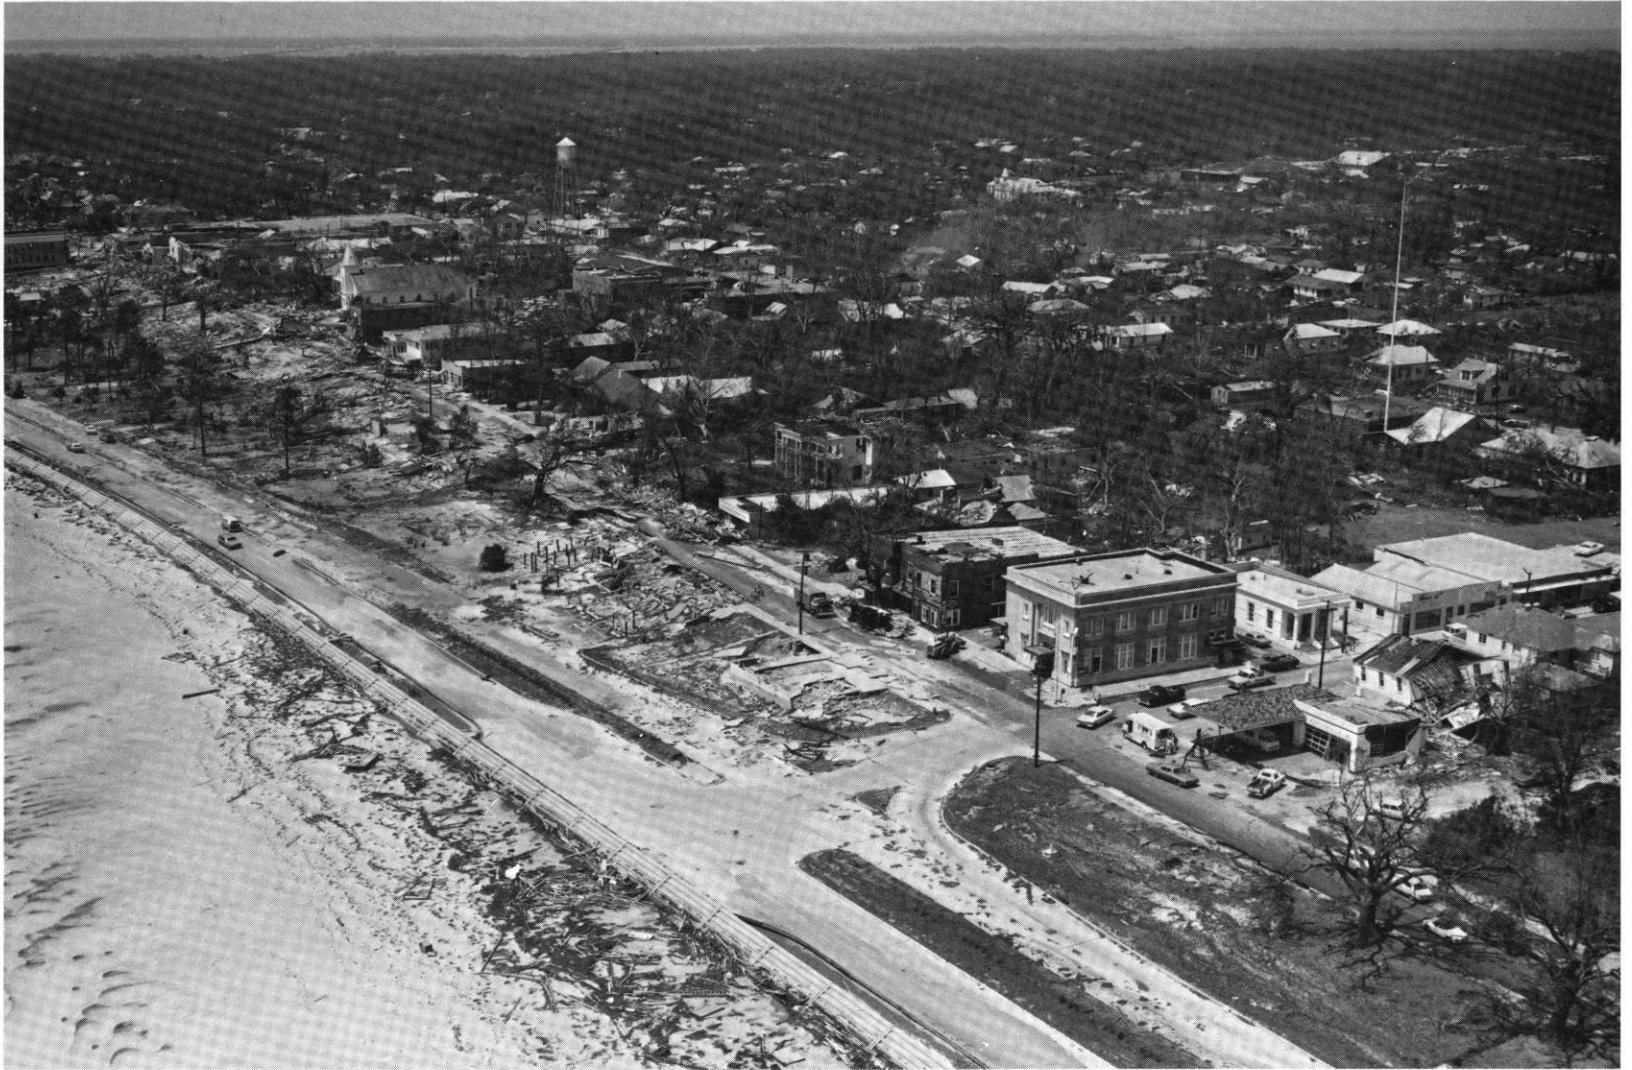
Figure 2.25 Pass Christian, Mississippi.

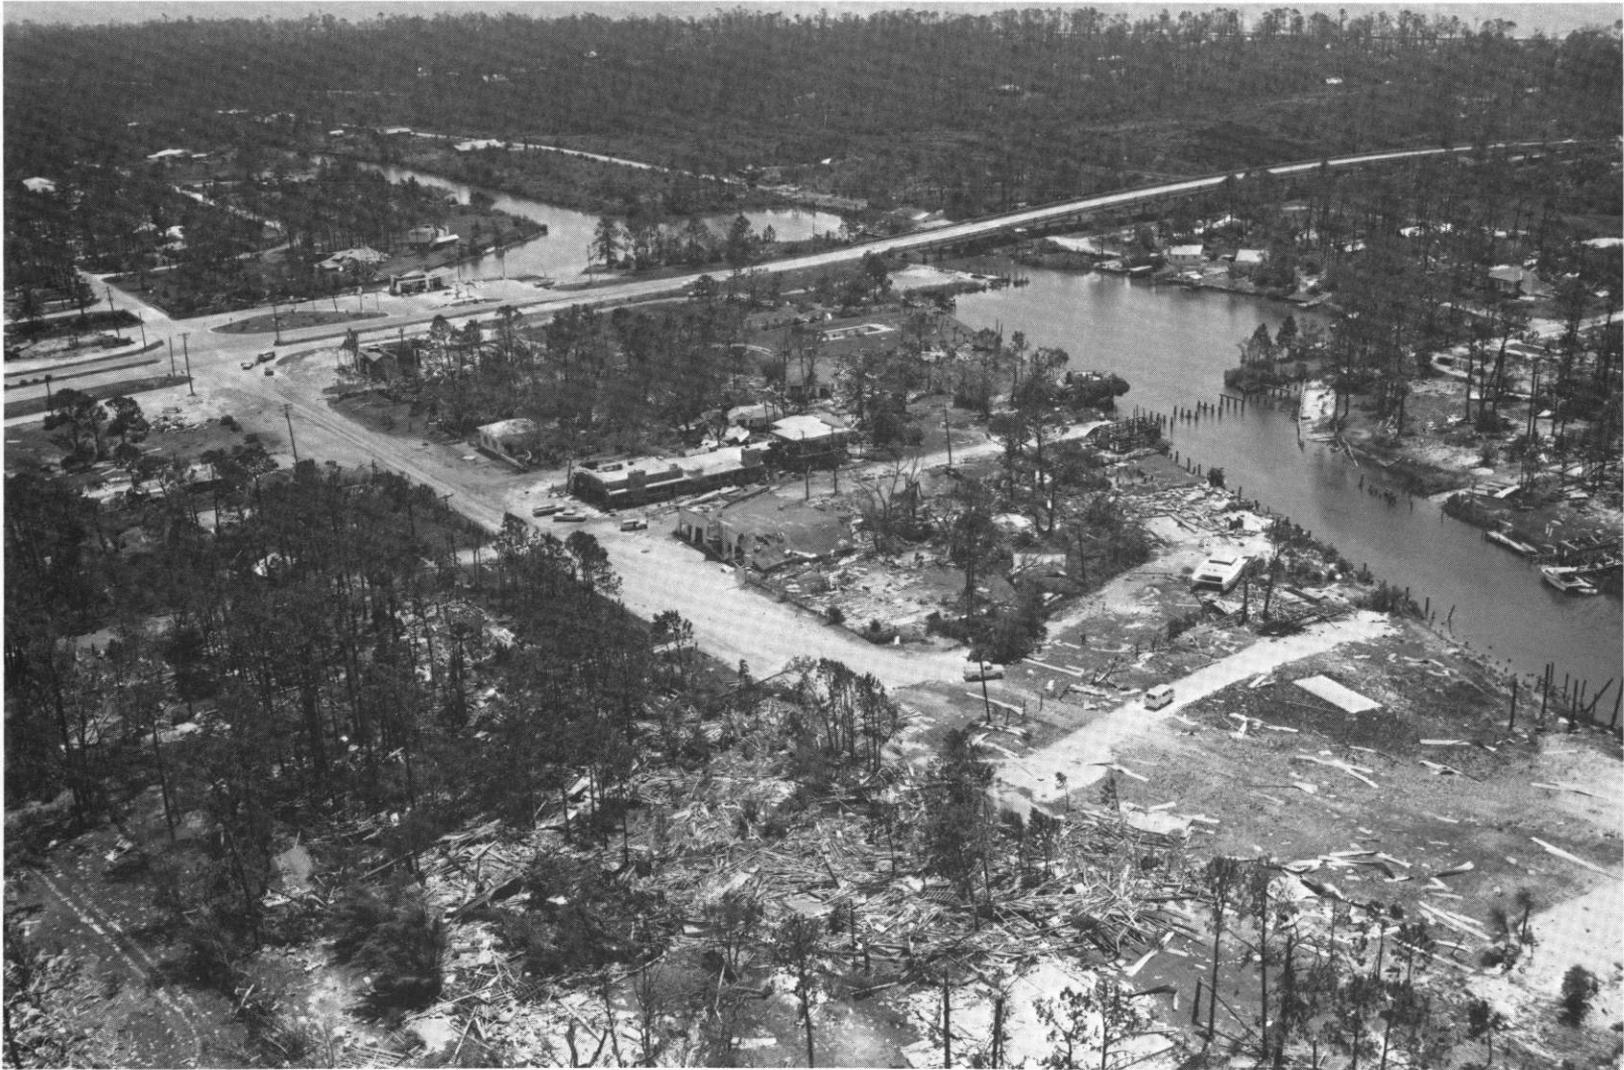
Figure 2.26 Henderson Point, on east shore of Saint Louis Bay, Mississippi.

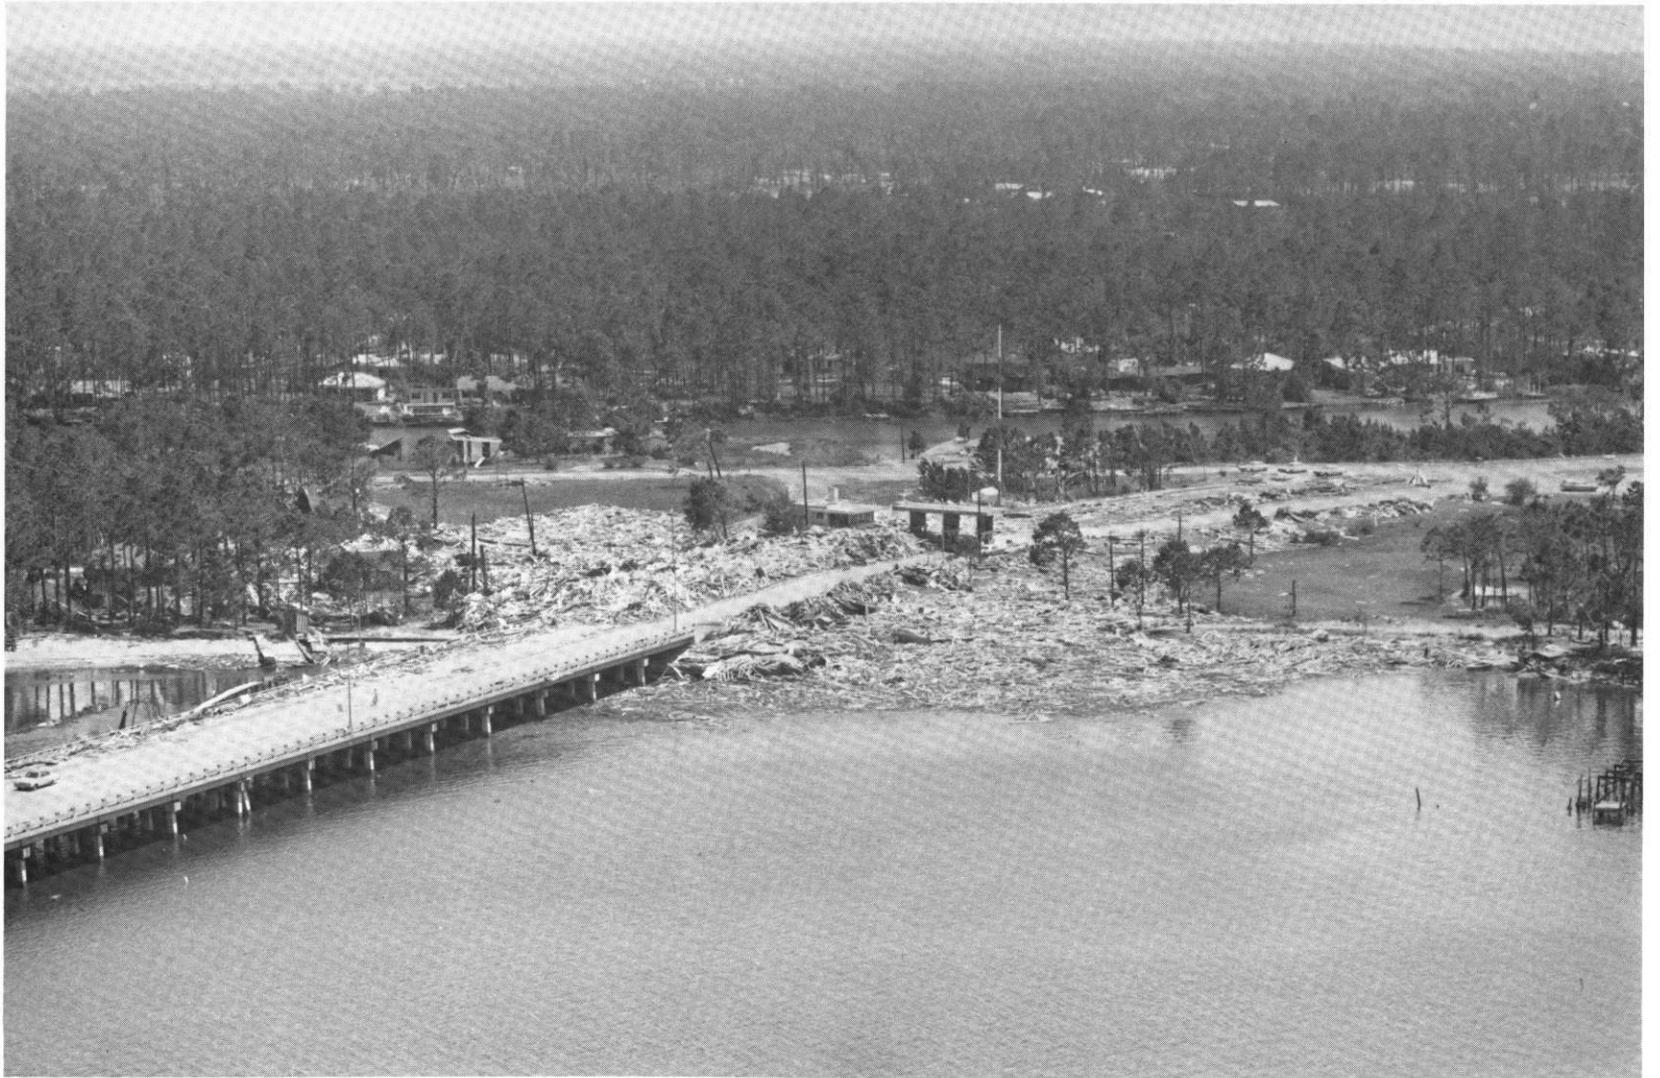
Figure 2.27 Debris at east end of Bay Saint Louis Bridge, Mississippi.

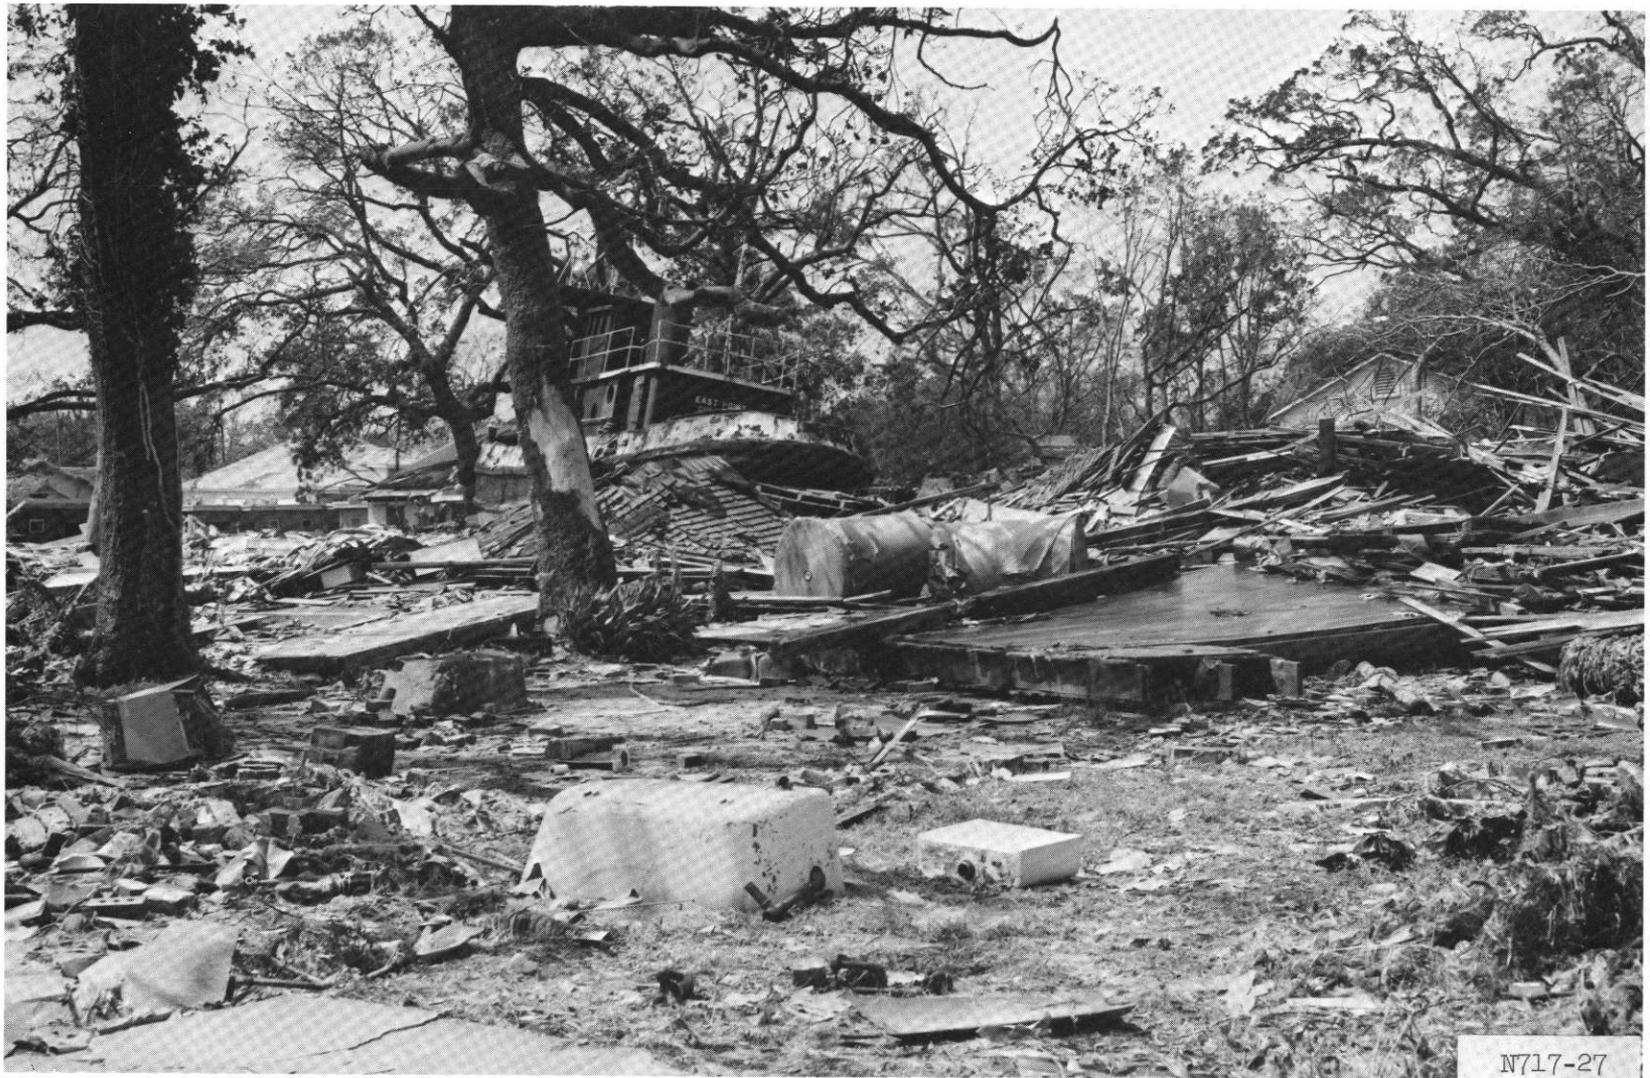
Figure 2.28 Tug and paper rolls in debris, west Gulfport, Mississippi.

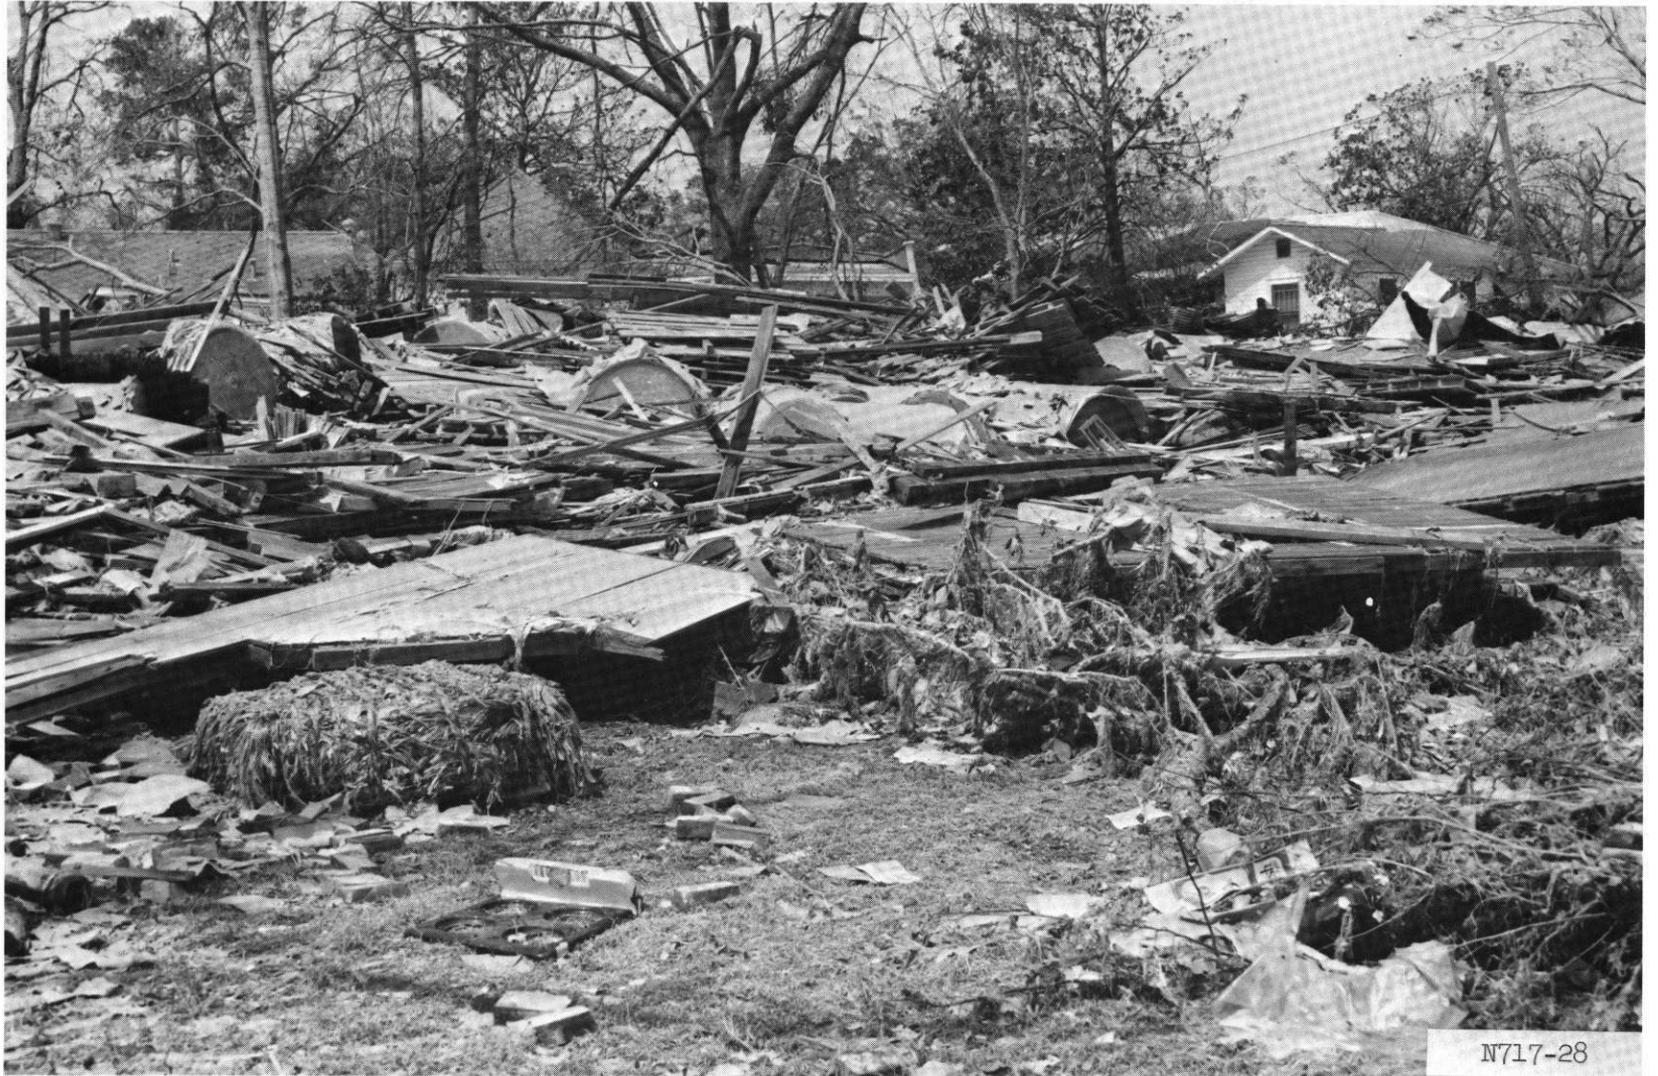
Figure 2.29 Debris from residences and Port facilities, west Gulfport, Mississippi.

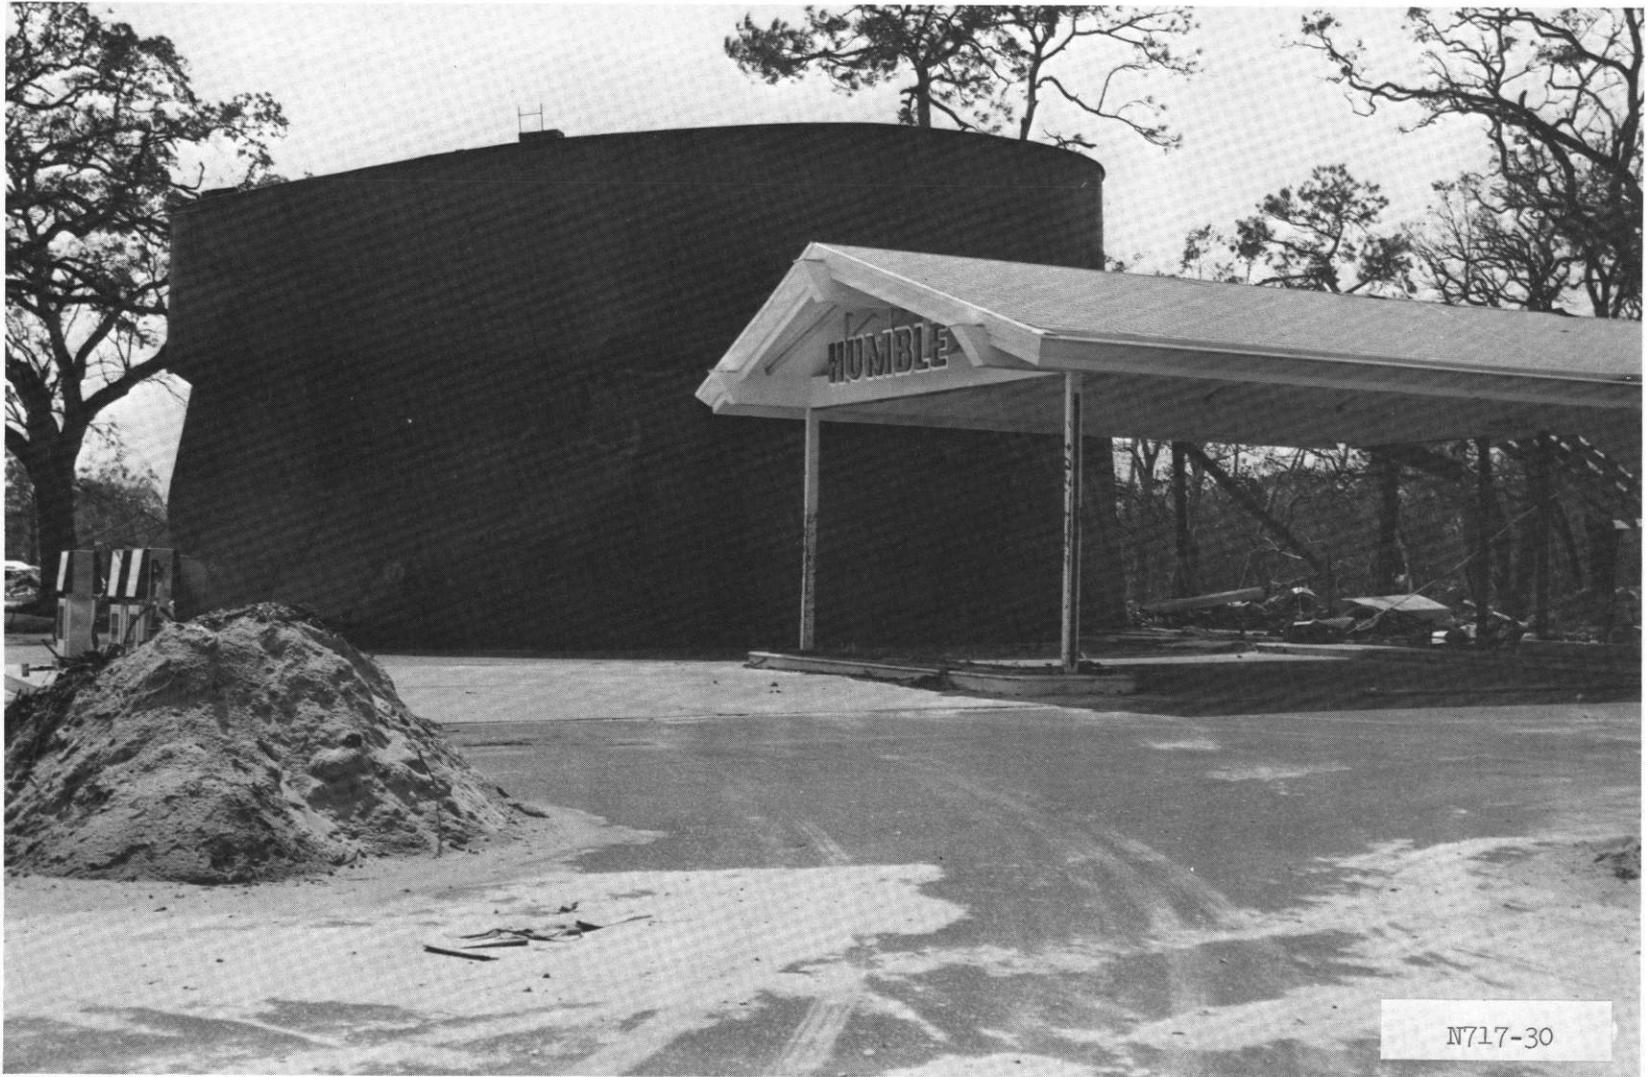
Figure 2.30 Tank floated in from harbor, west Gulfport, Mississippi.

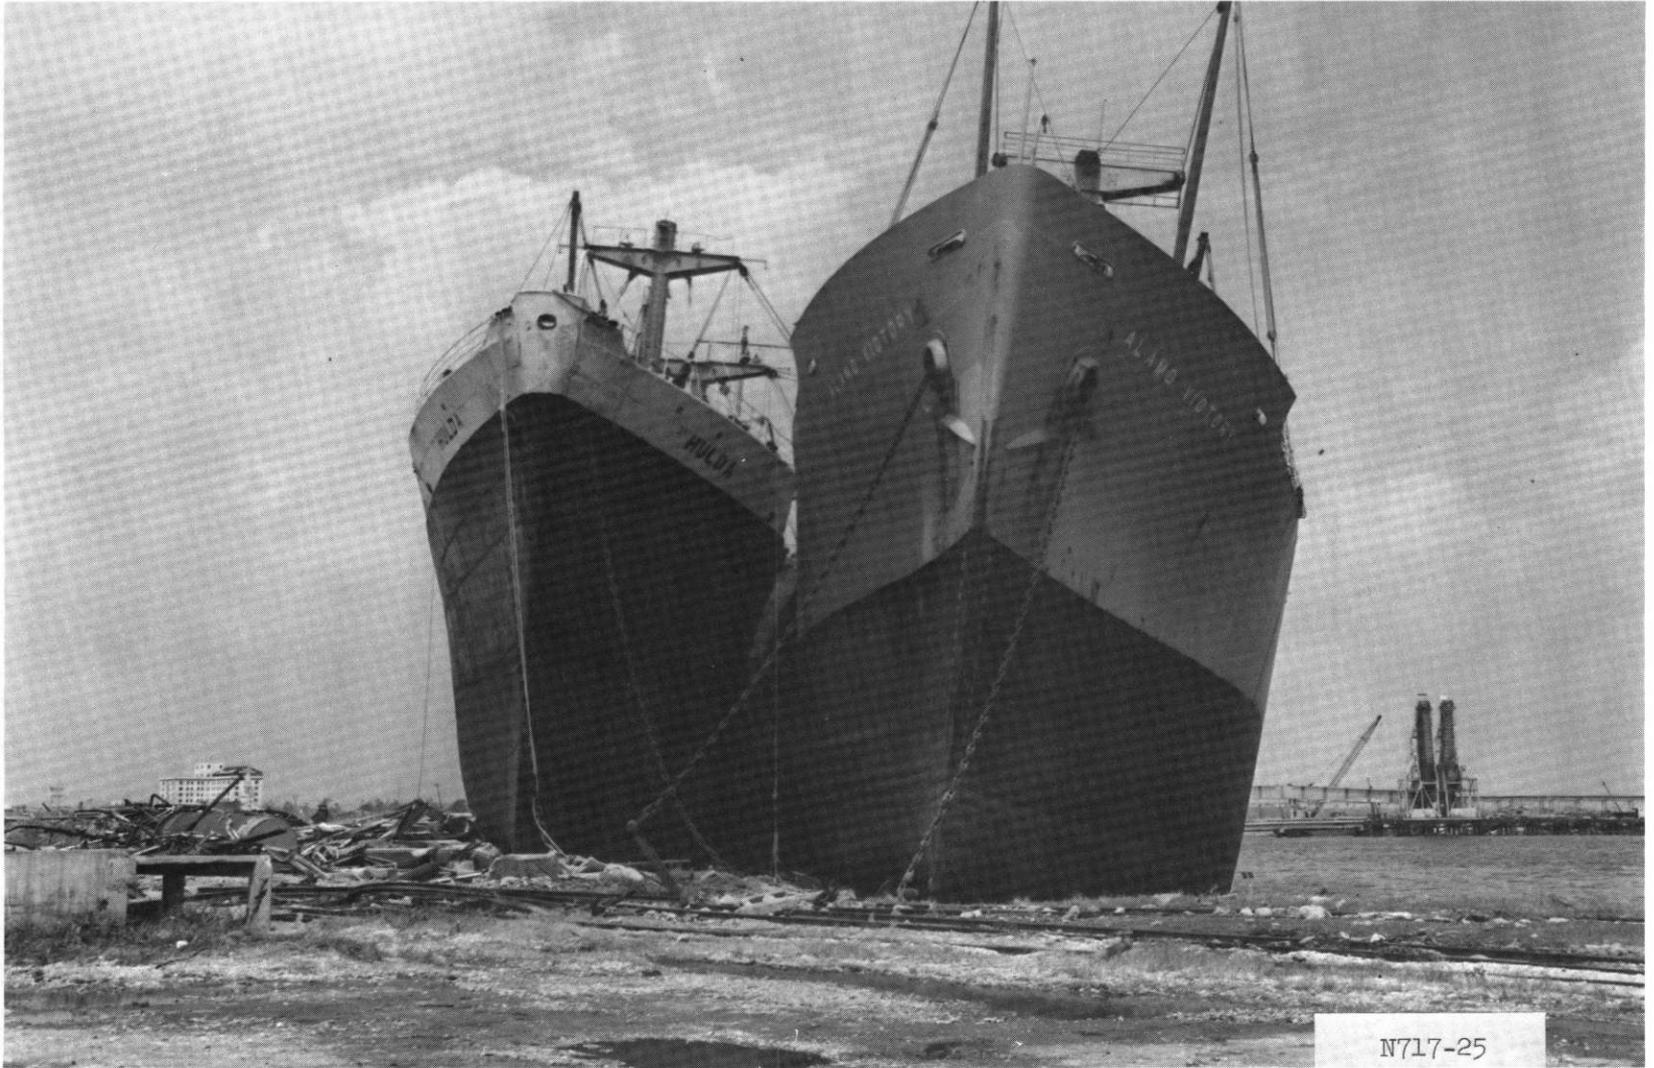
Figure 2.31 Ships aground, Port of Gulfport.

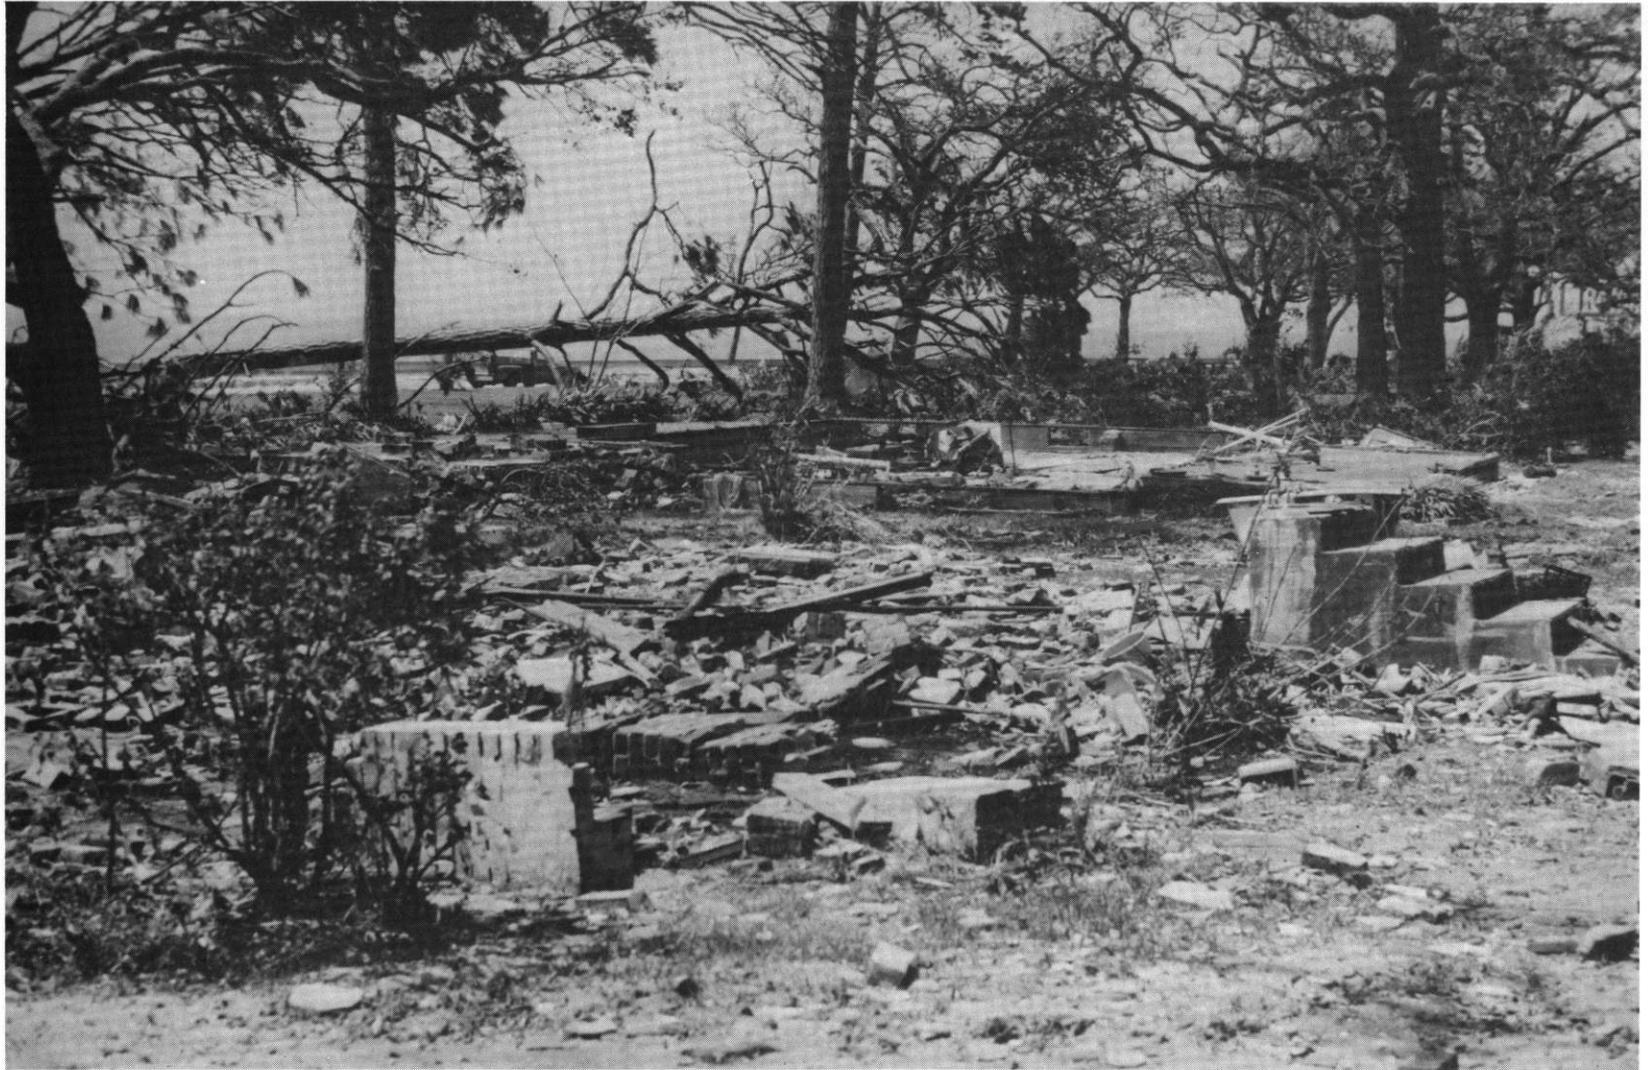
Figure 2.35 Residence near Long Beach, Mississippi.

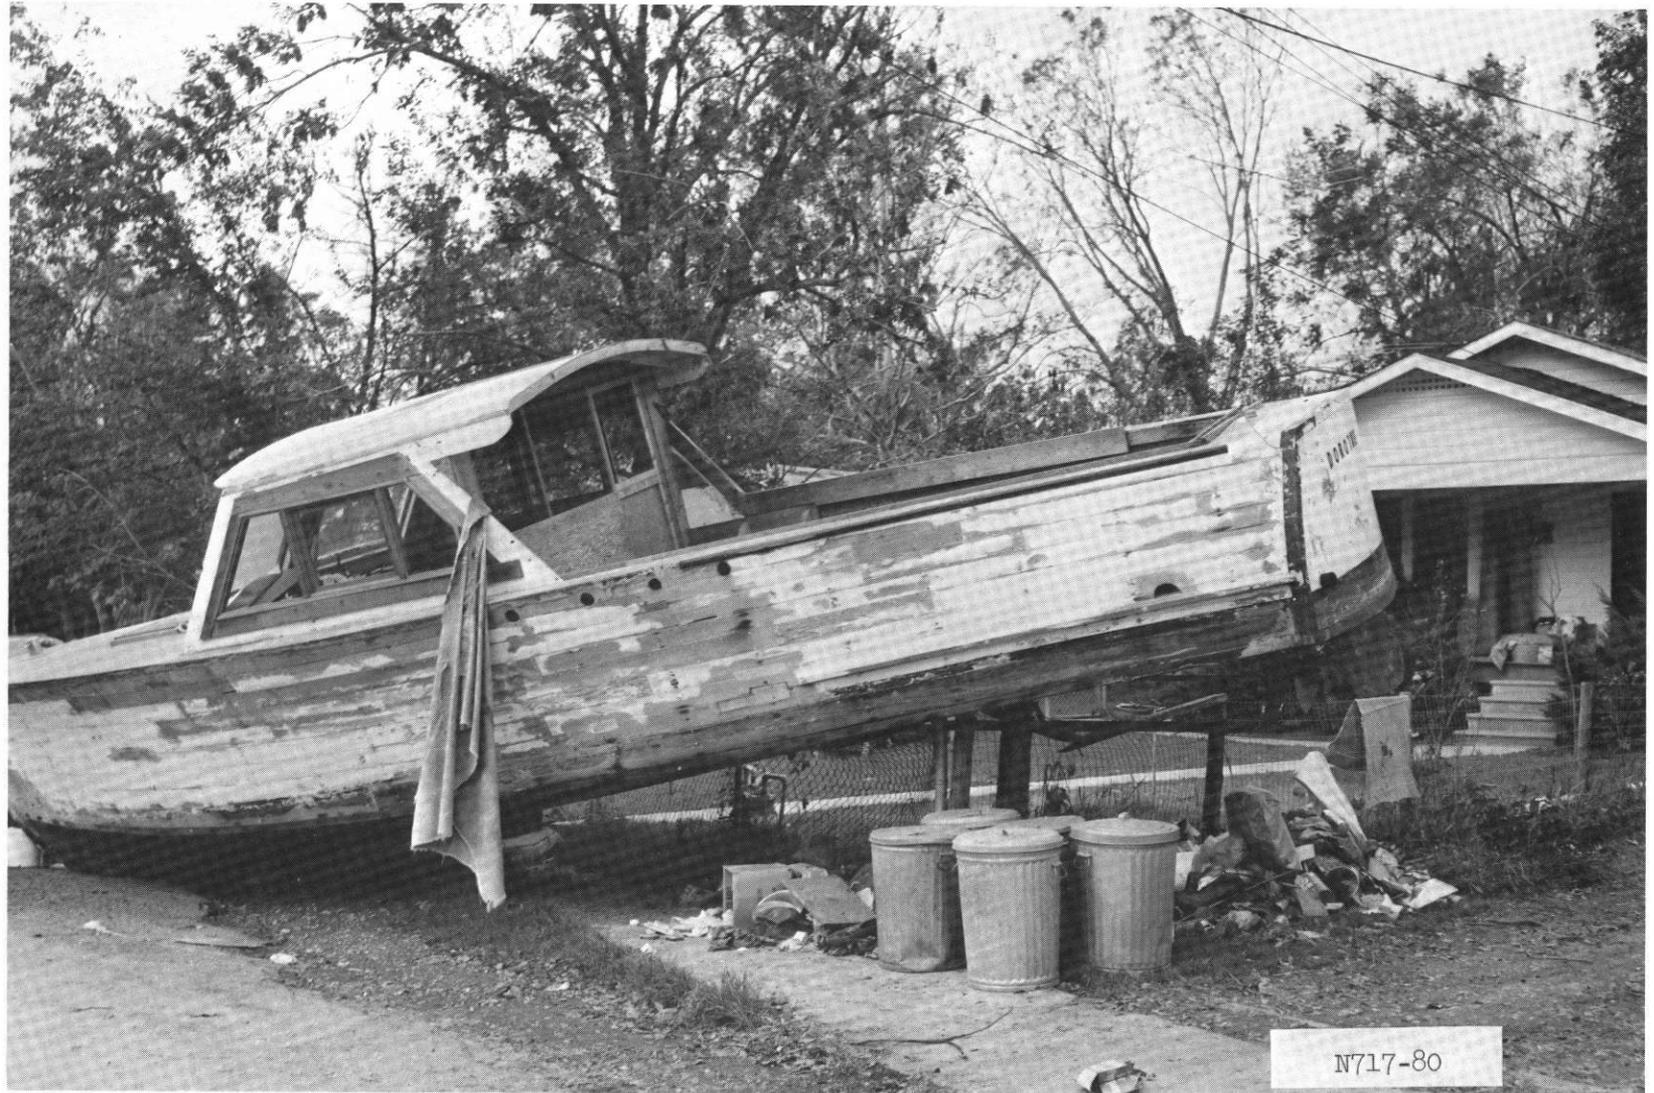
Figure 2.36 Boat ashore, east end of Biloxi, Mississippi.

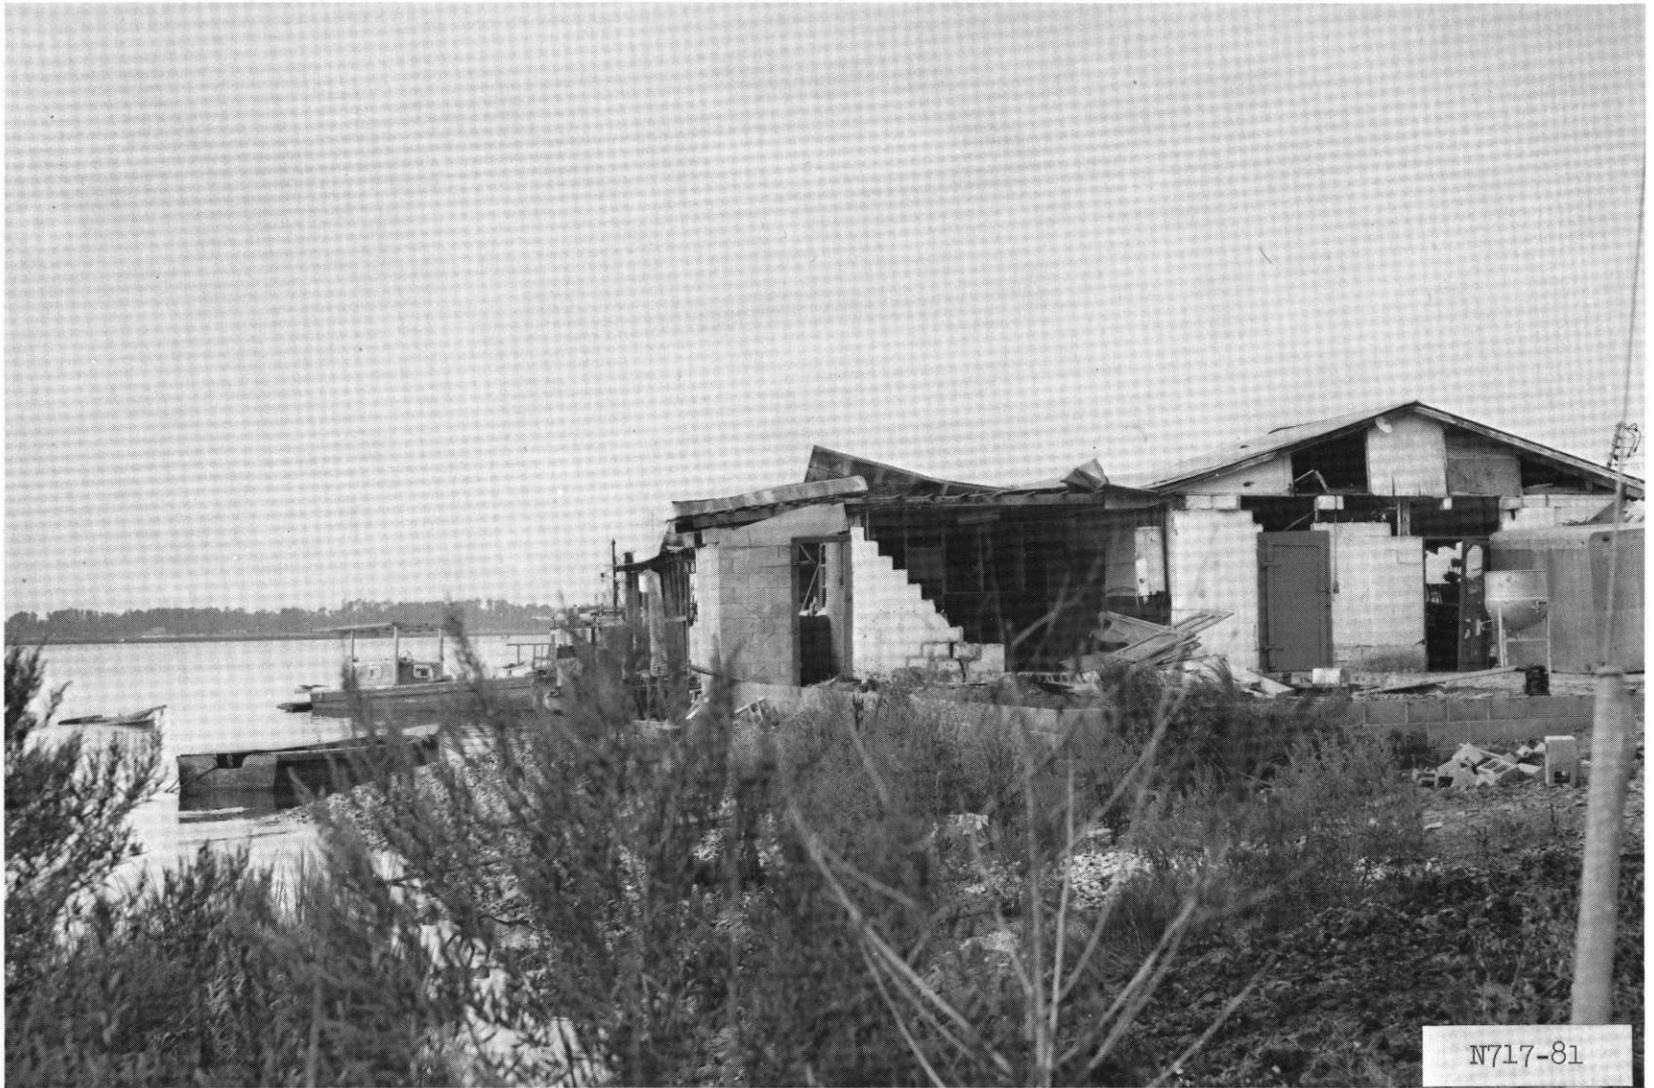
Figure 2.37 Commercial building, Back Bay of Biloxi, Mississippi.
