TECHNICAL REPORT N-70-10

SURVEY OF GULF COAST STRUCTURAL DAMAGE RESULTING FROM HURRICANE CAMILLE, AUGUST 1969

April 1970

By U. S. Army Engineer Waterways Experiment Station, Vicksburg, Mississippi

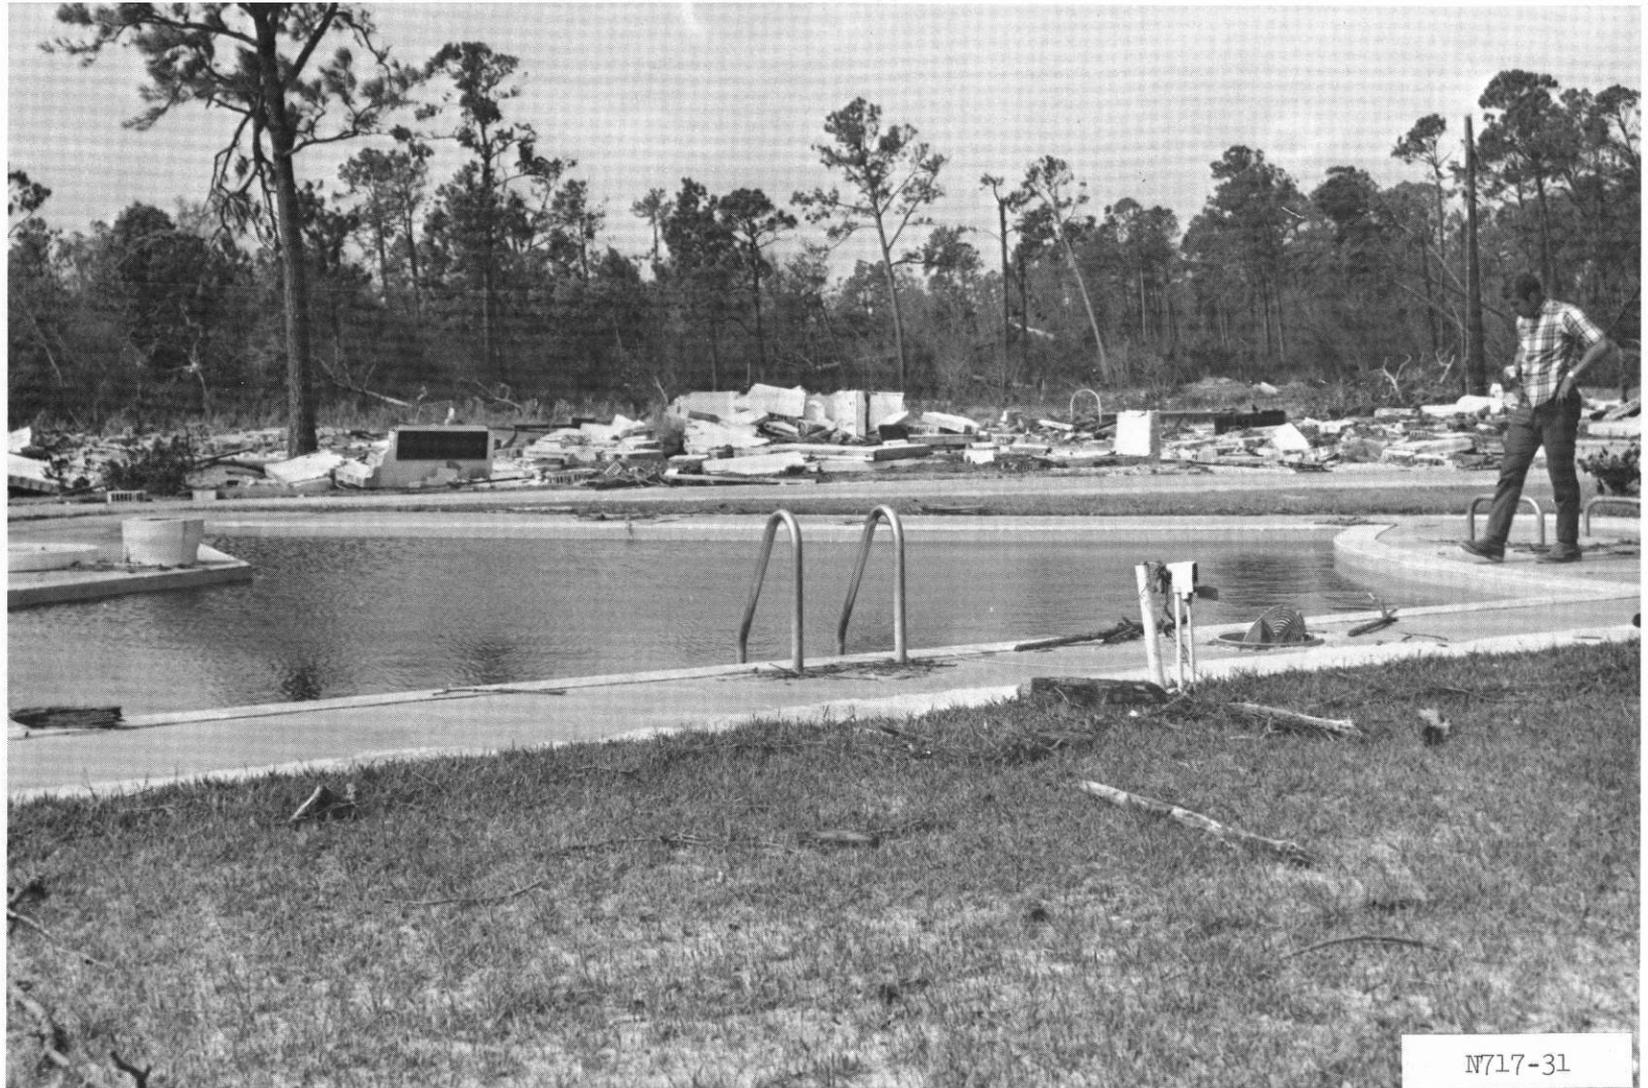
2.3.1 Masonry Block Structures. Many motels, apartments, gasoline stations, and small businesses along the Gulf shoreline were constructed of block and/or brick bearing walls, and these structures generally fared very poorly. An appreciable number collapsed totally with little evidence remaining to indicate how they looked before the storm. Almost all buildings of this type were totally destroyed in the area along the coast from Gulfport to Bay Saint Louis. Figures 2.40 through 2.46 show the remains of some buildings of this type.

Figure 2.42 Motel or apartment house, Long Beach area.

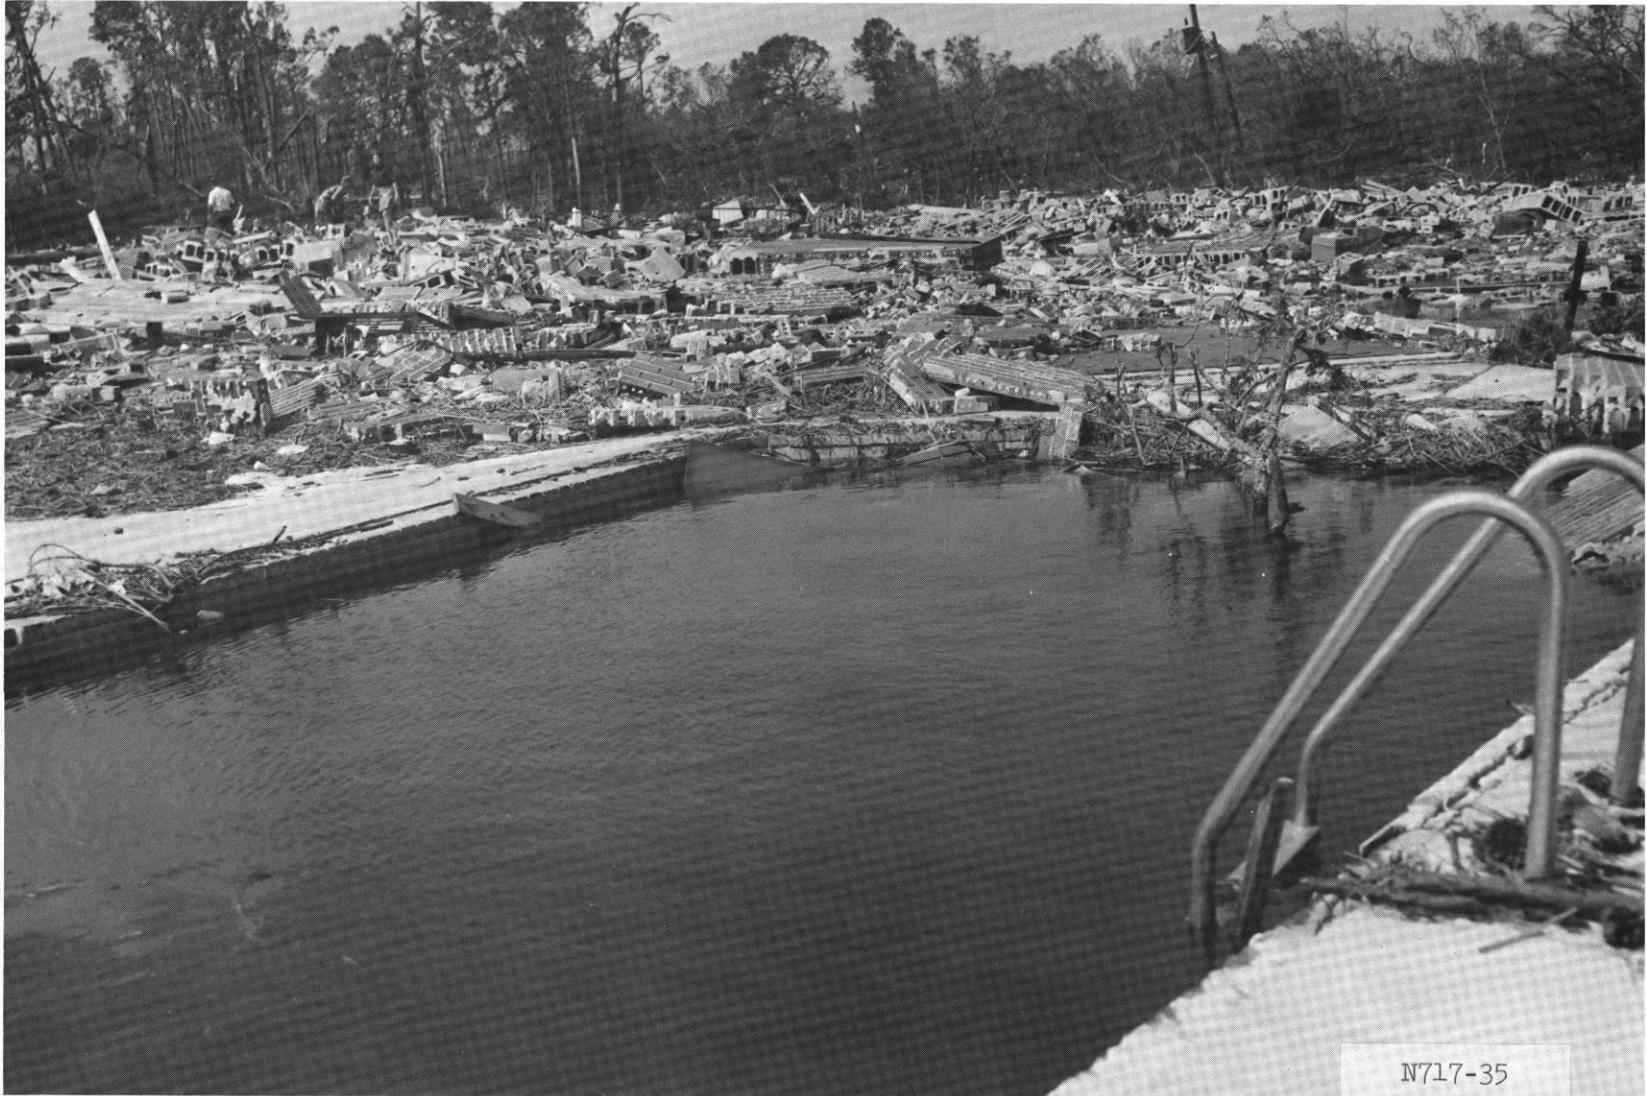
Figure 2.44 Pool area, Gulf Villa Apartments, Long Beach area.

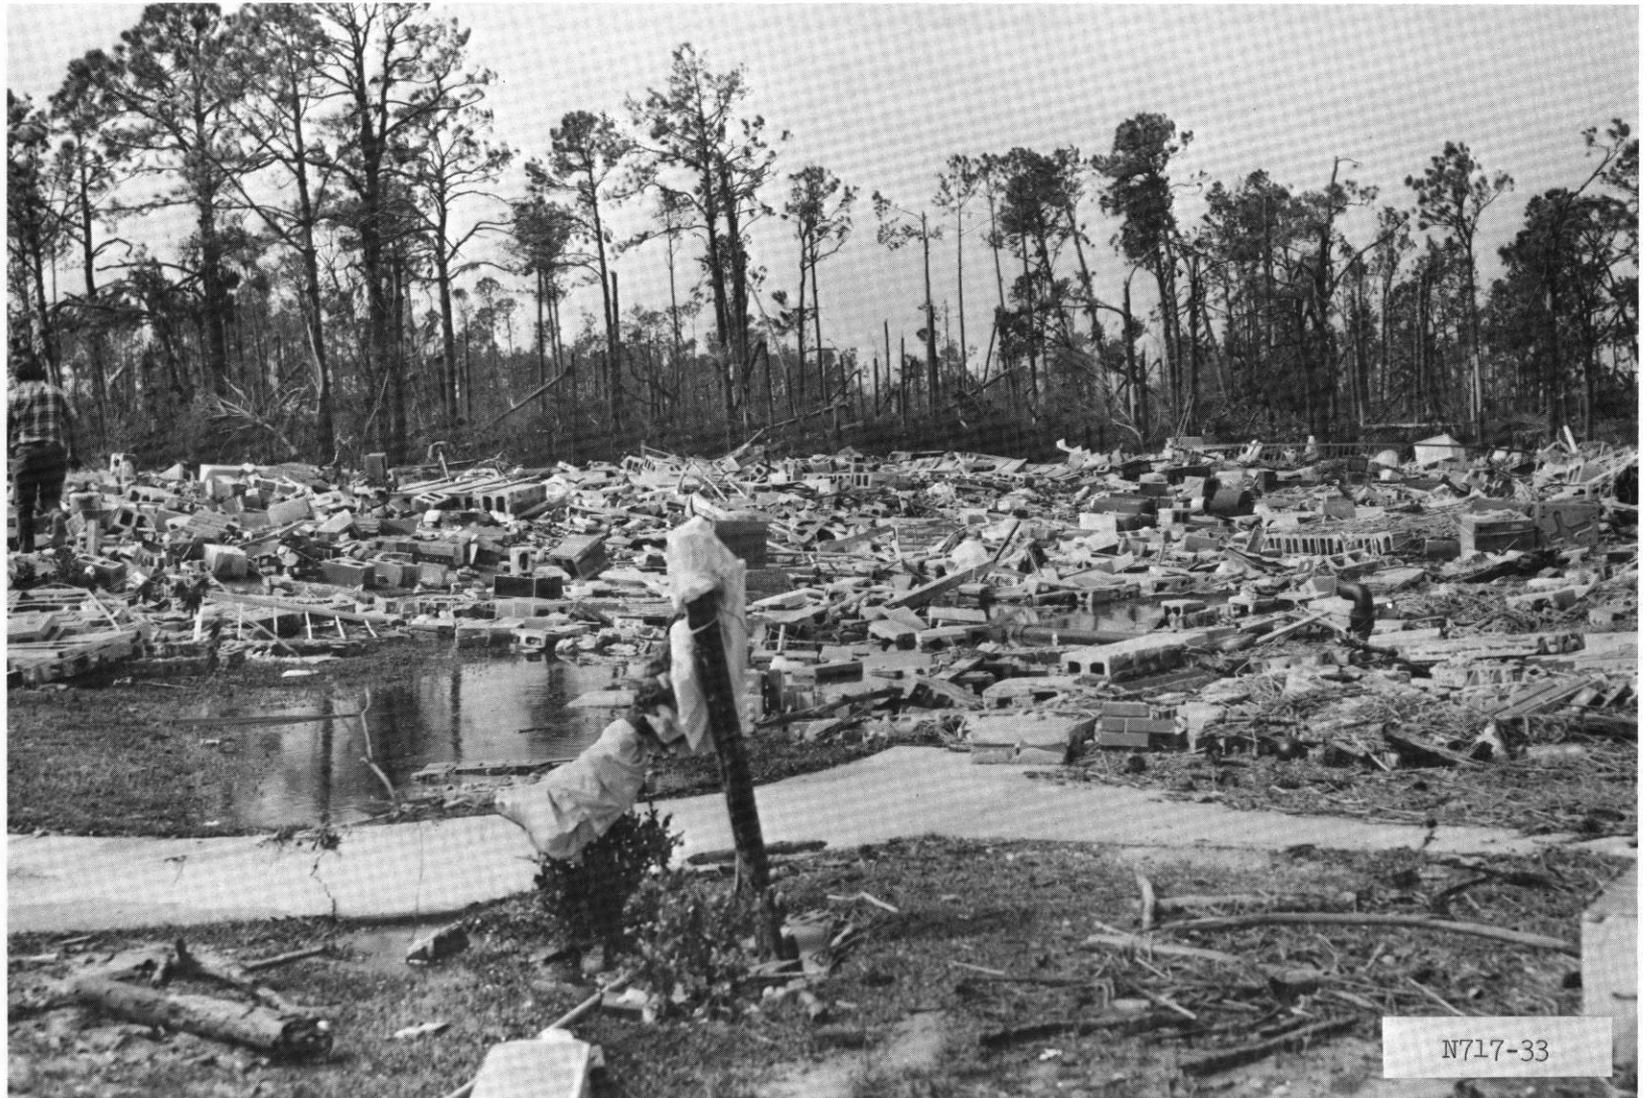
Figure 2.45 Gulf Villa Apartments, Long Beach area.

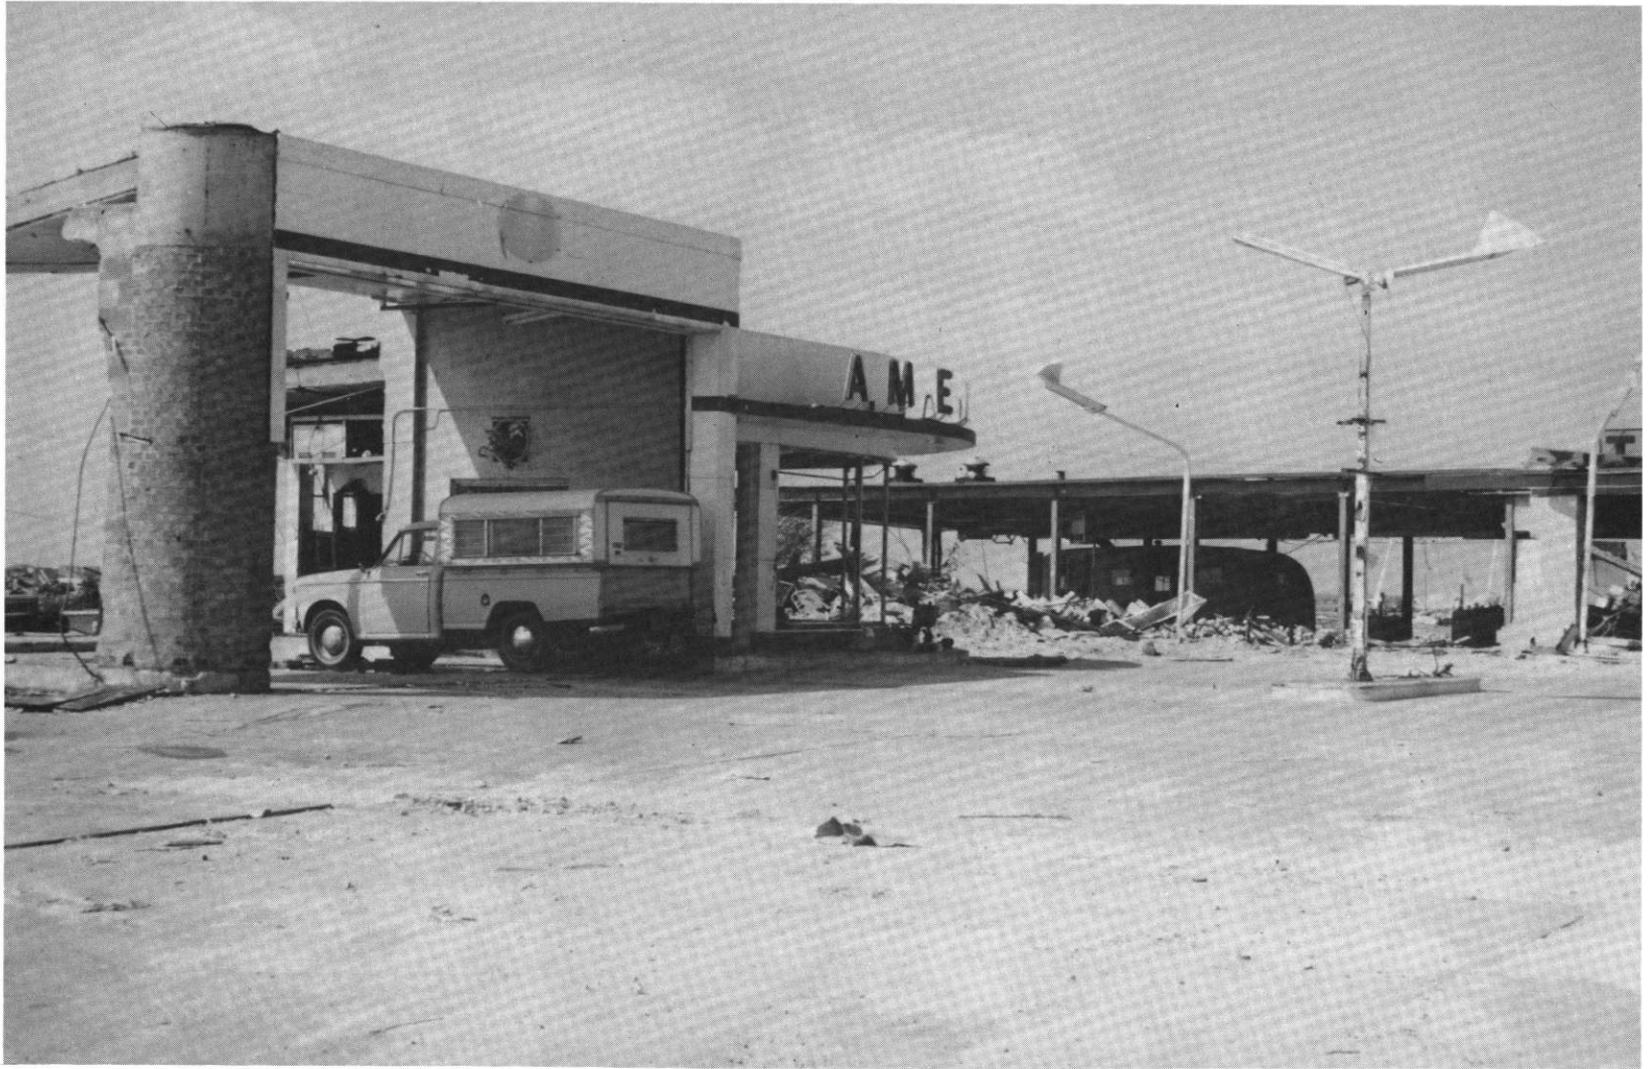
Figure 2.46 Service station, west Gulfport area.

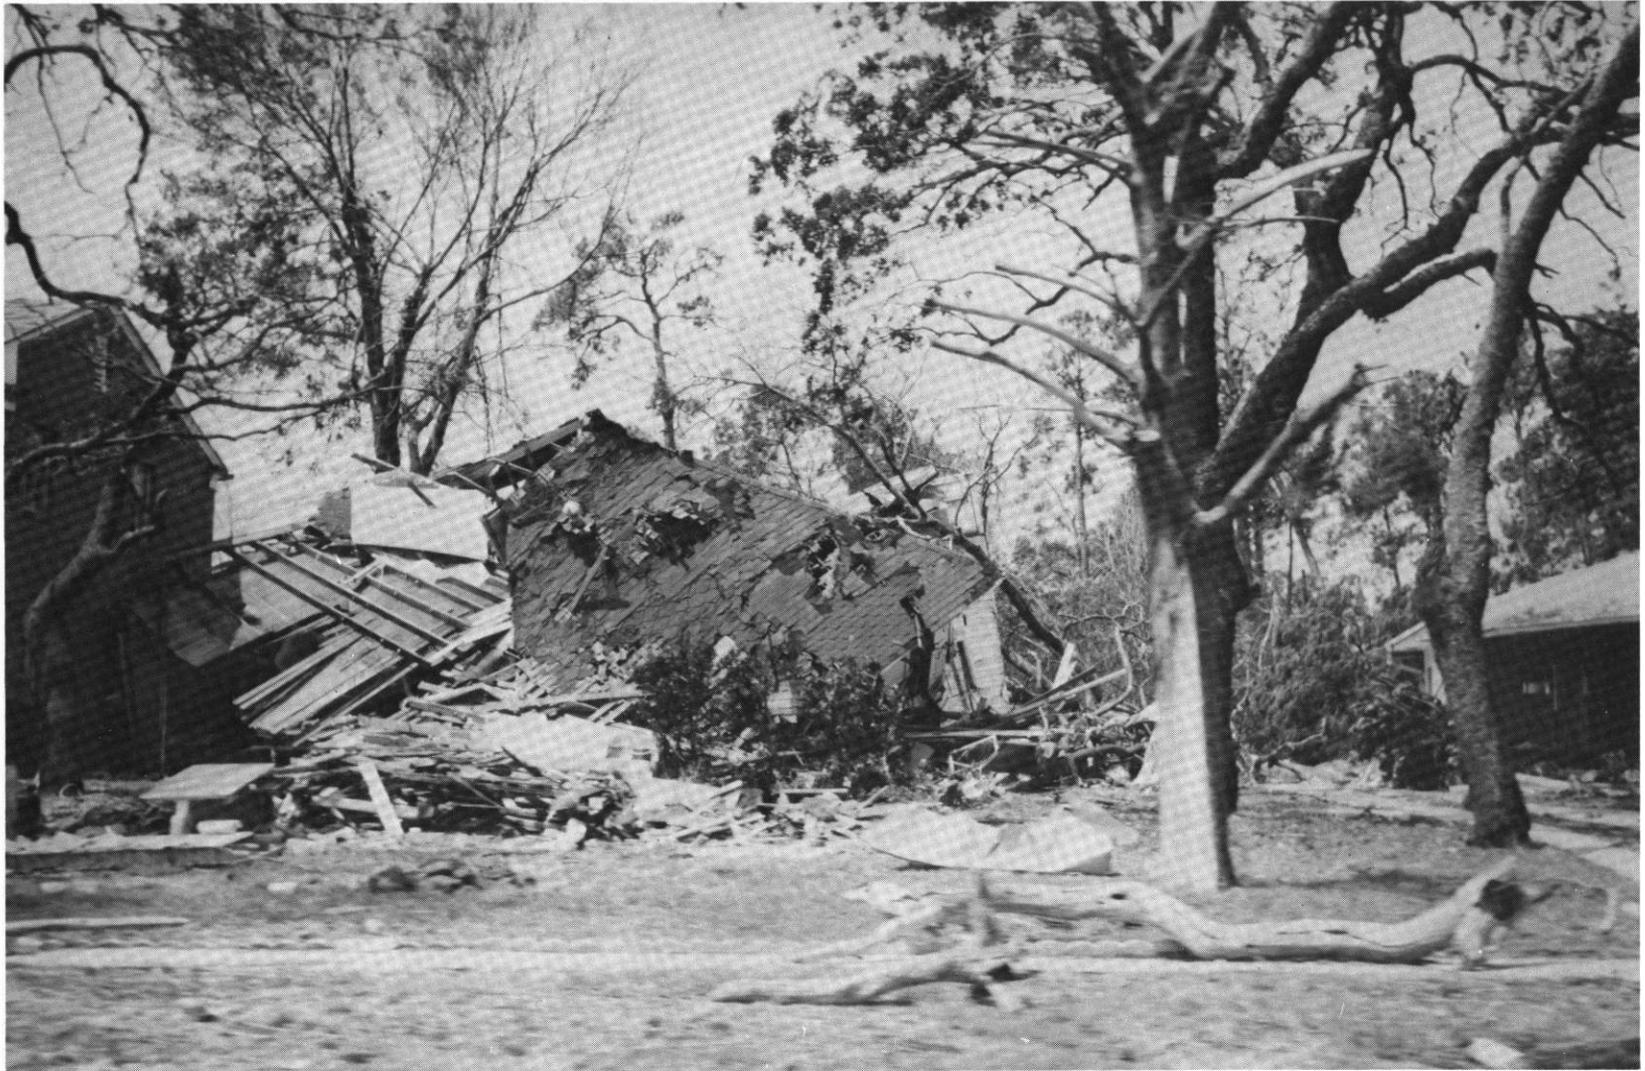
Figure 2.47 Collapsed frame house, between Biloxi and Gulfport, Mississippi.

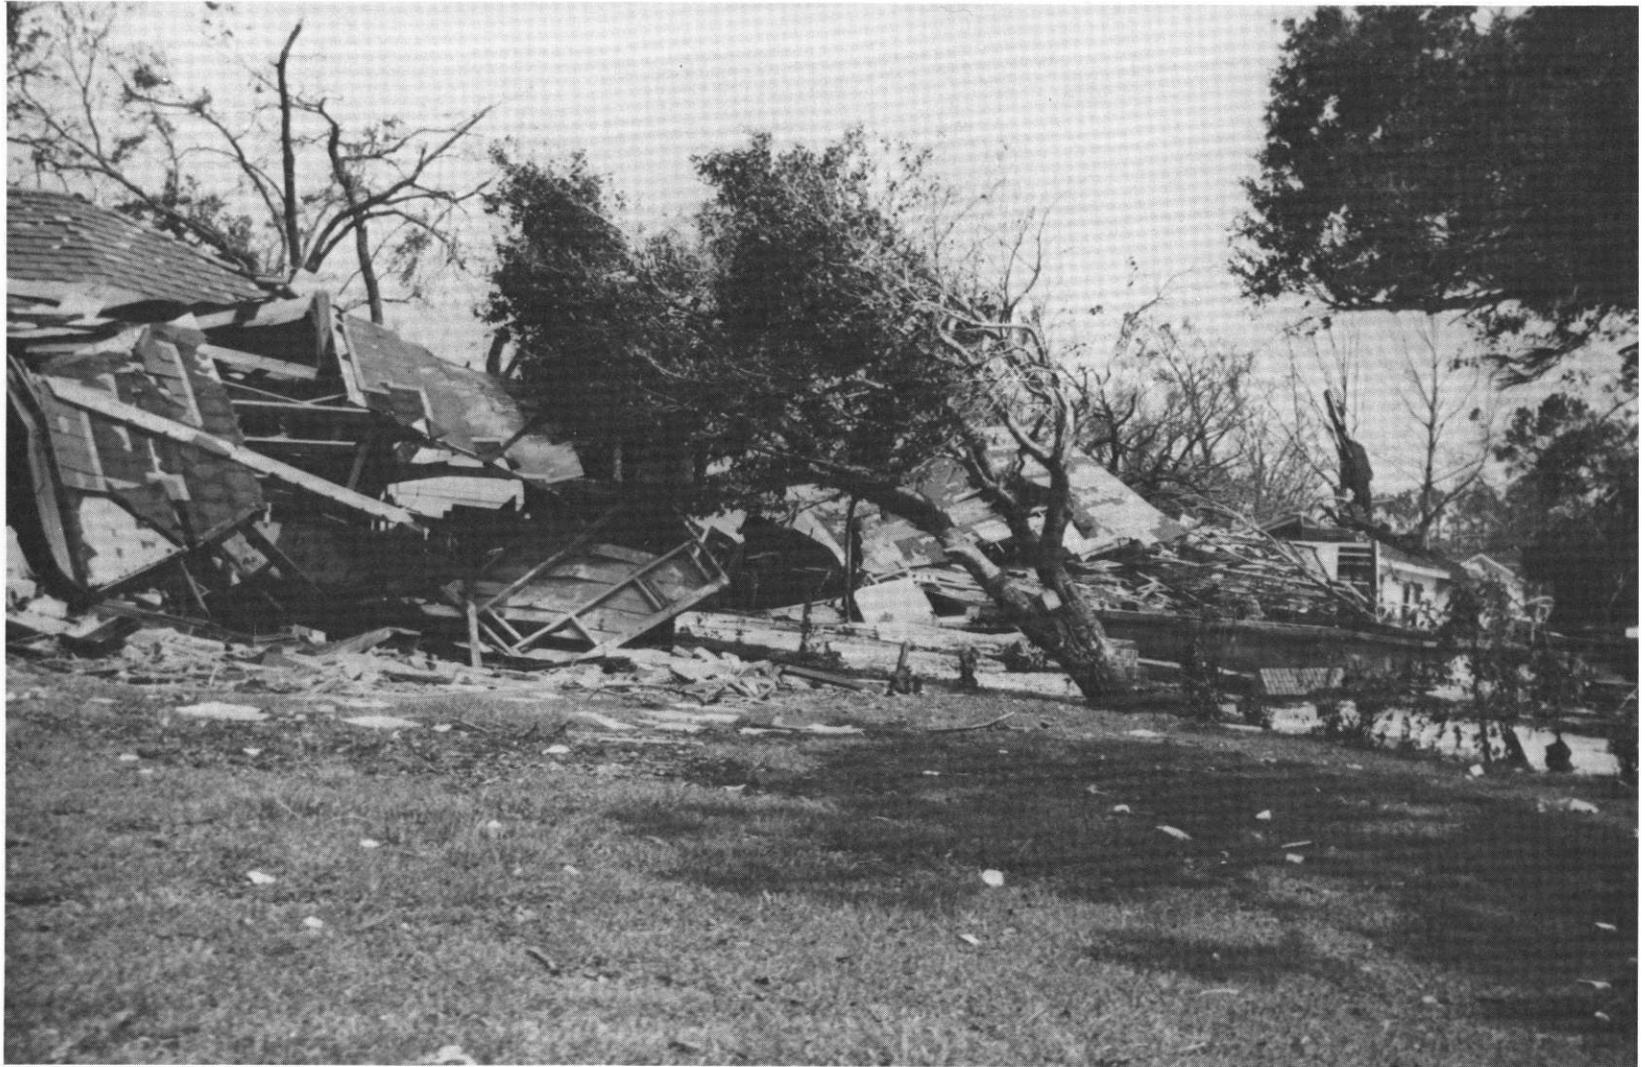
Figure 2.48 Collapsed frame house, Long Beach area.

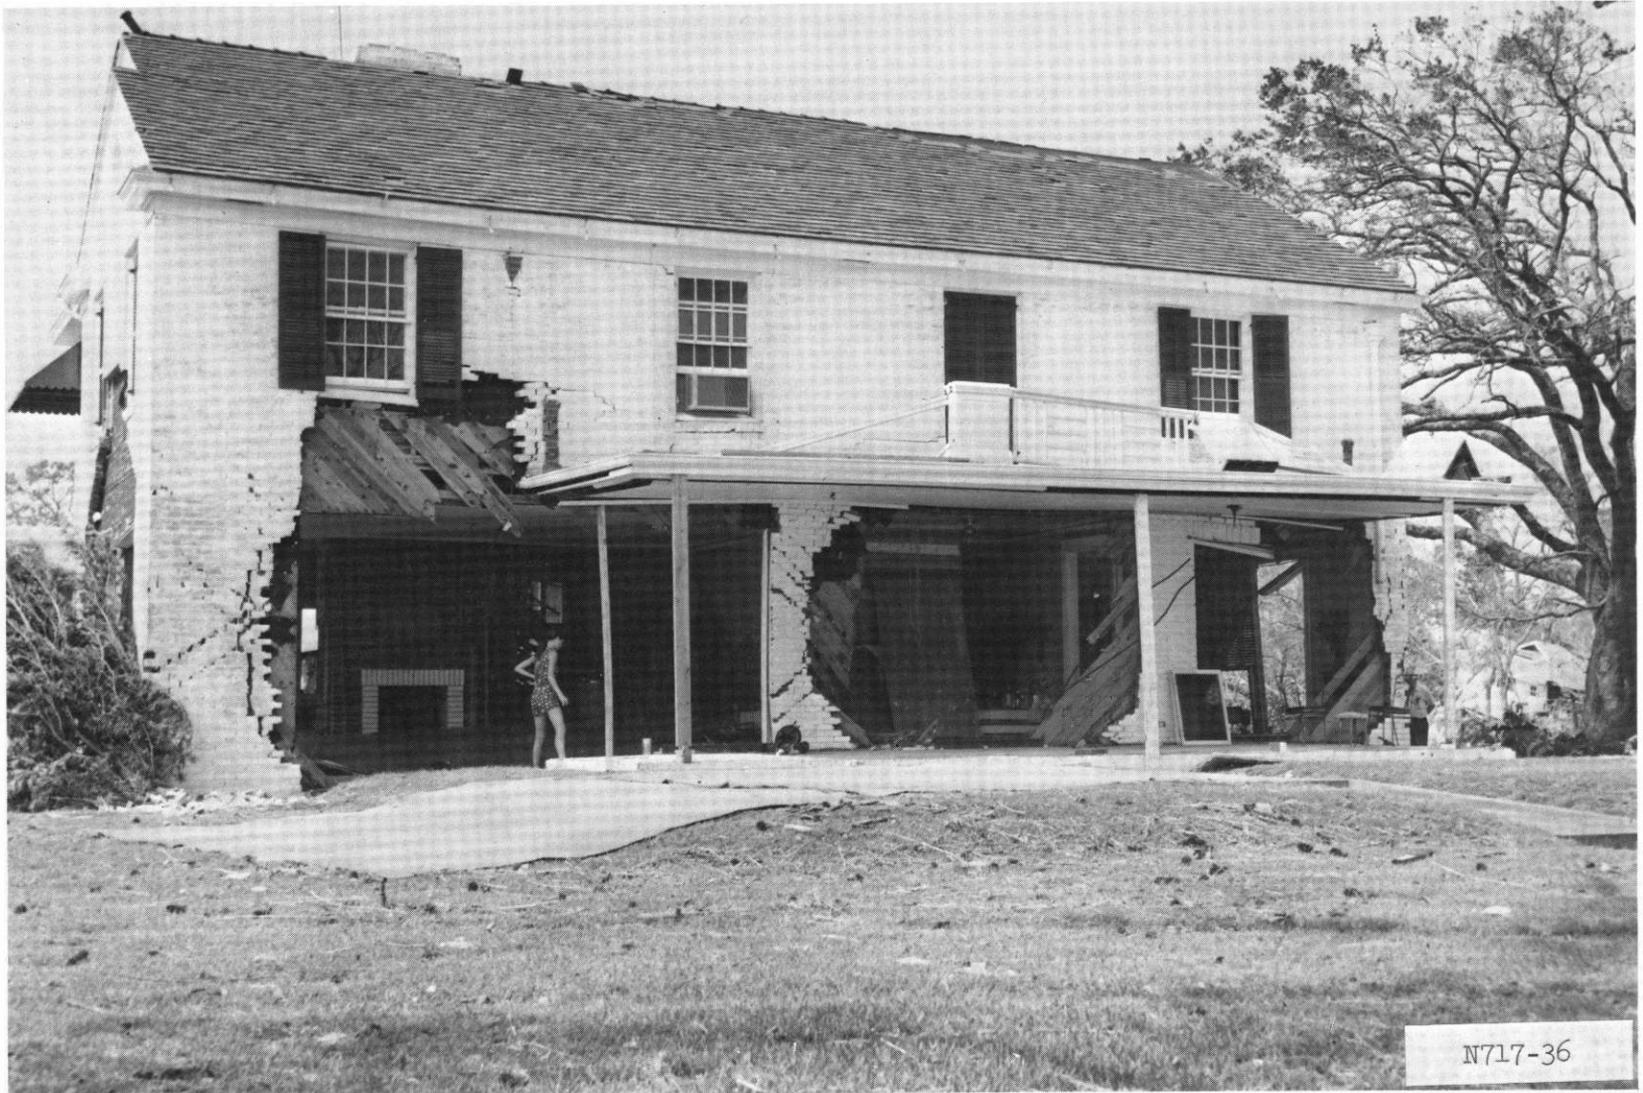
Figure 2.49 Residence, Long Beach, Mississippi.

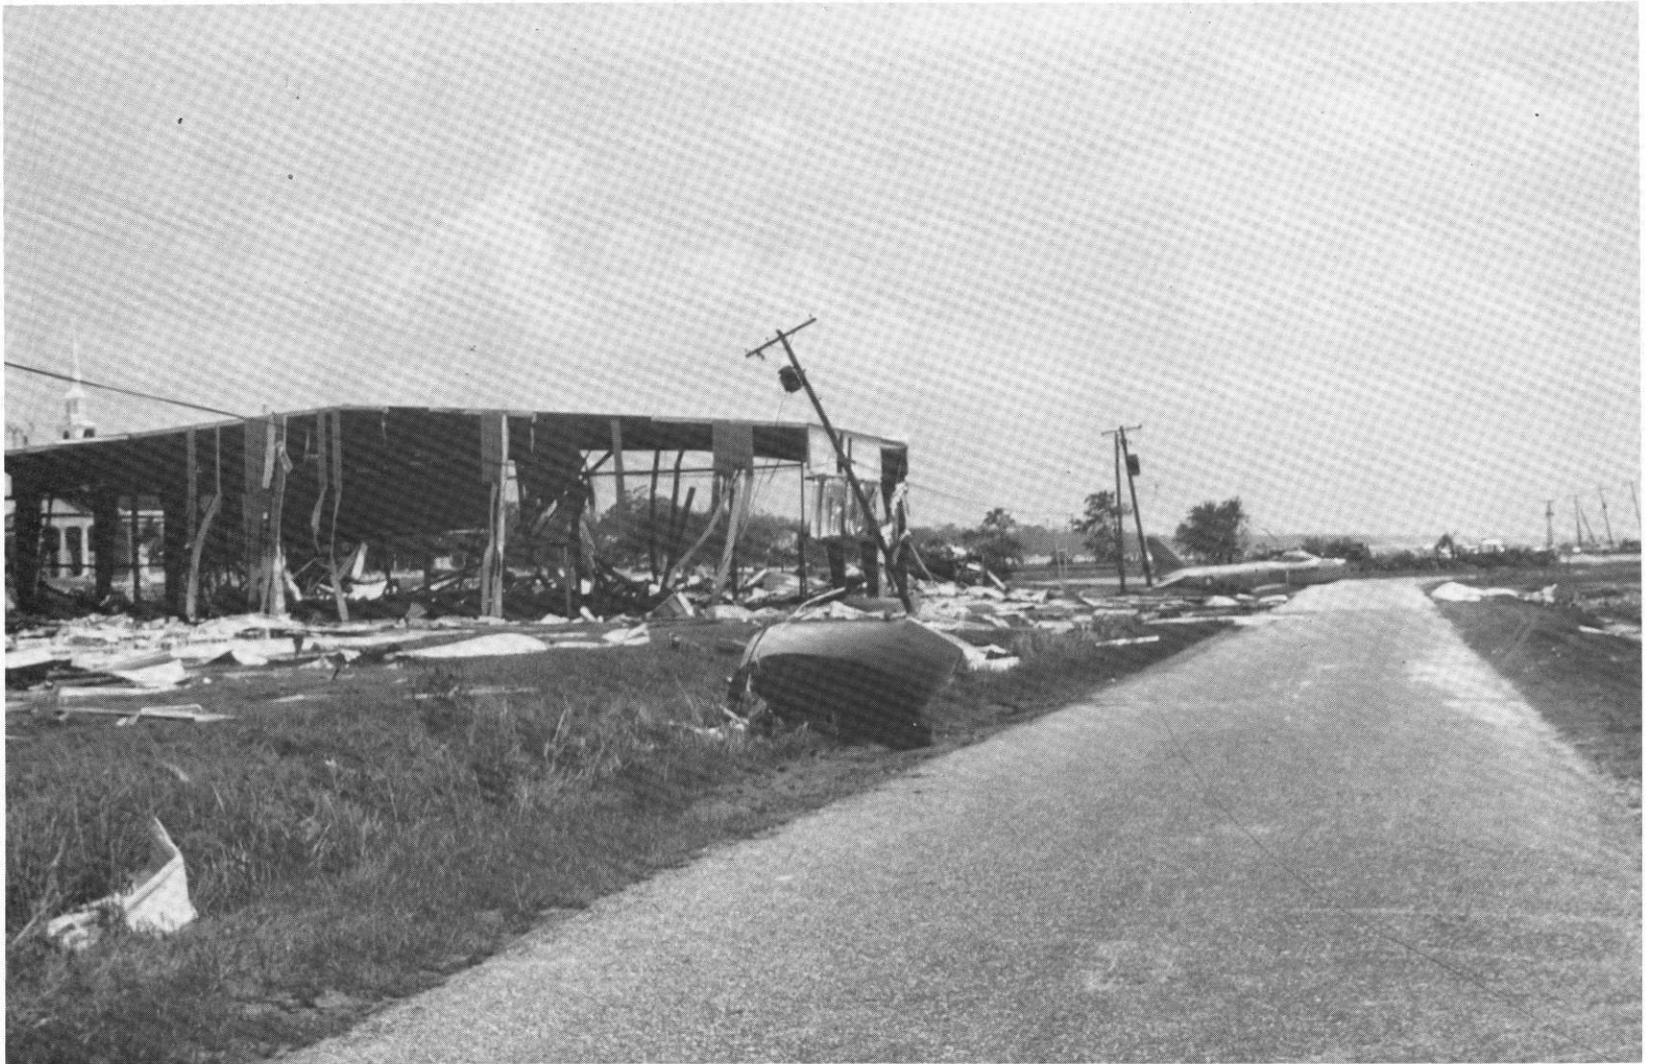
Figure 2.50 Steel frame recreation hall, Jones Memorial Park, Gulfport.

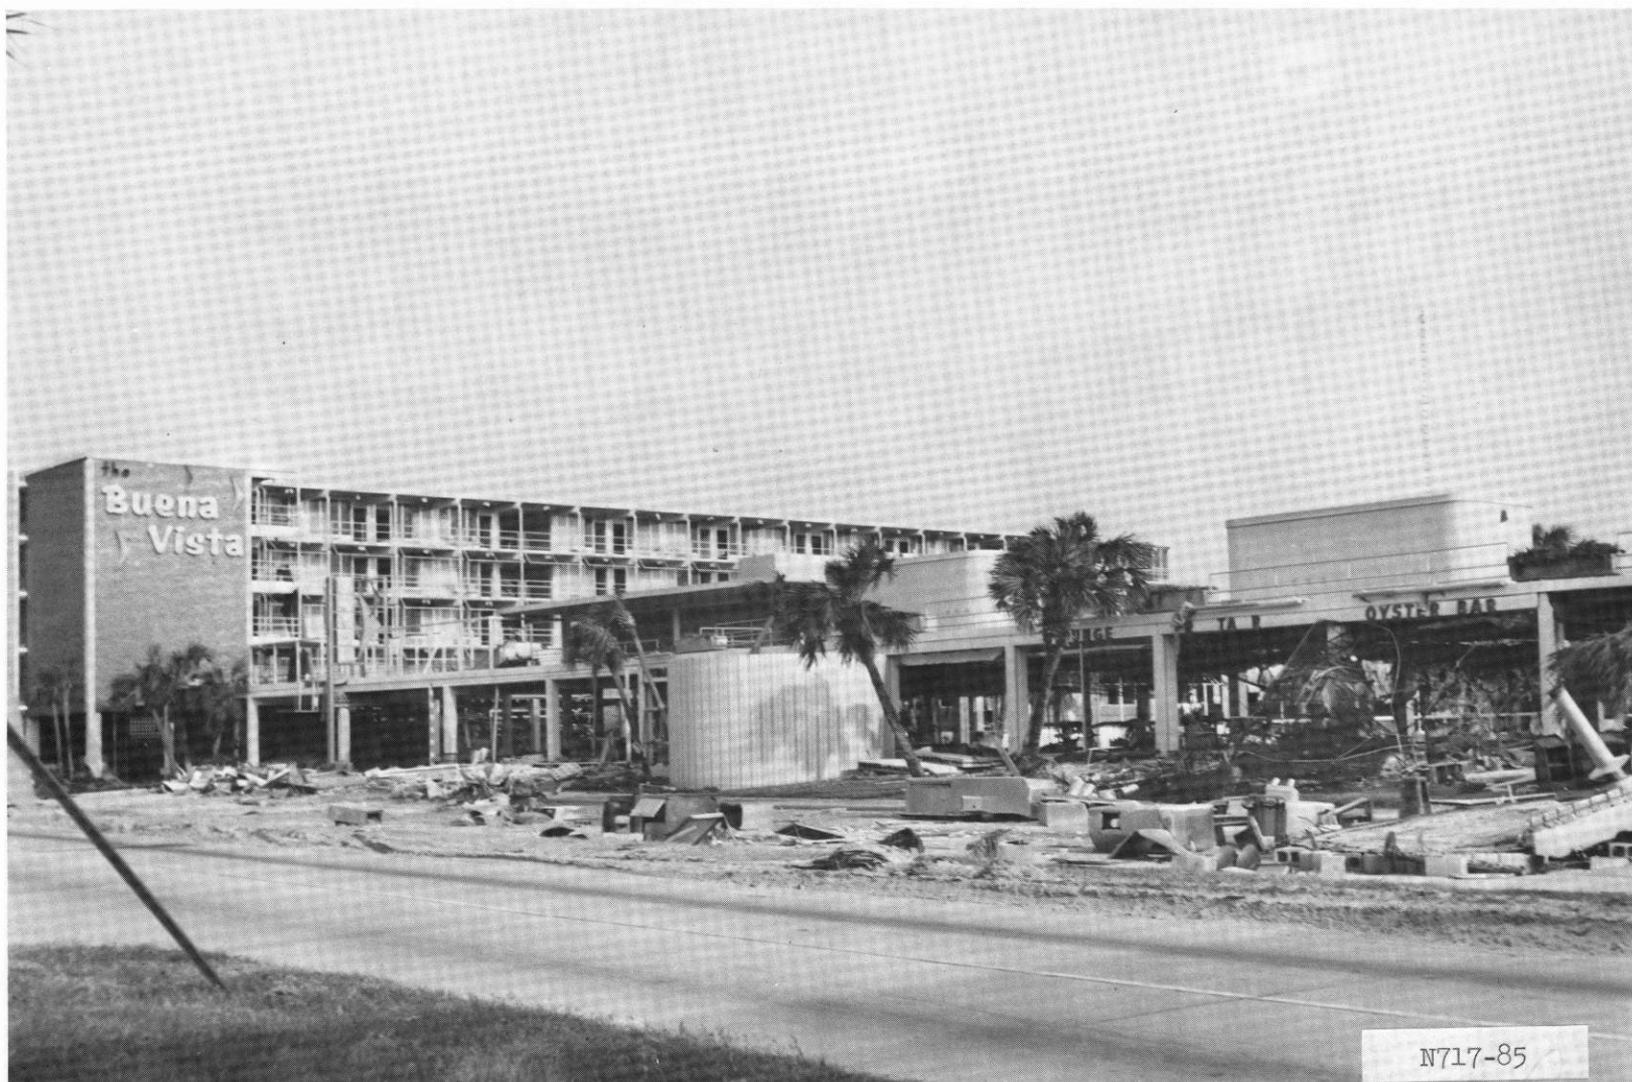
Figure 2.51 Frame restaurant structure, Biloxi, Mississippi.

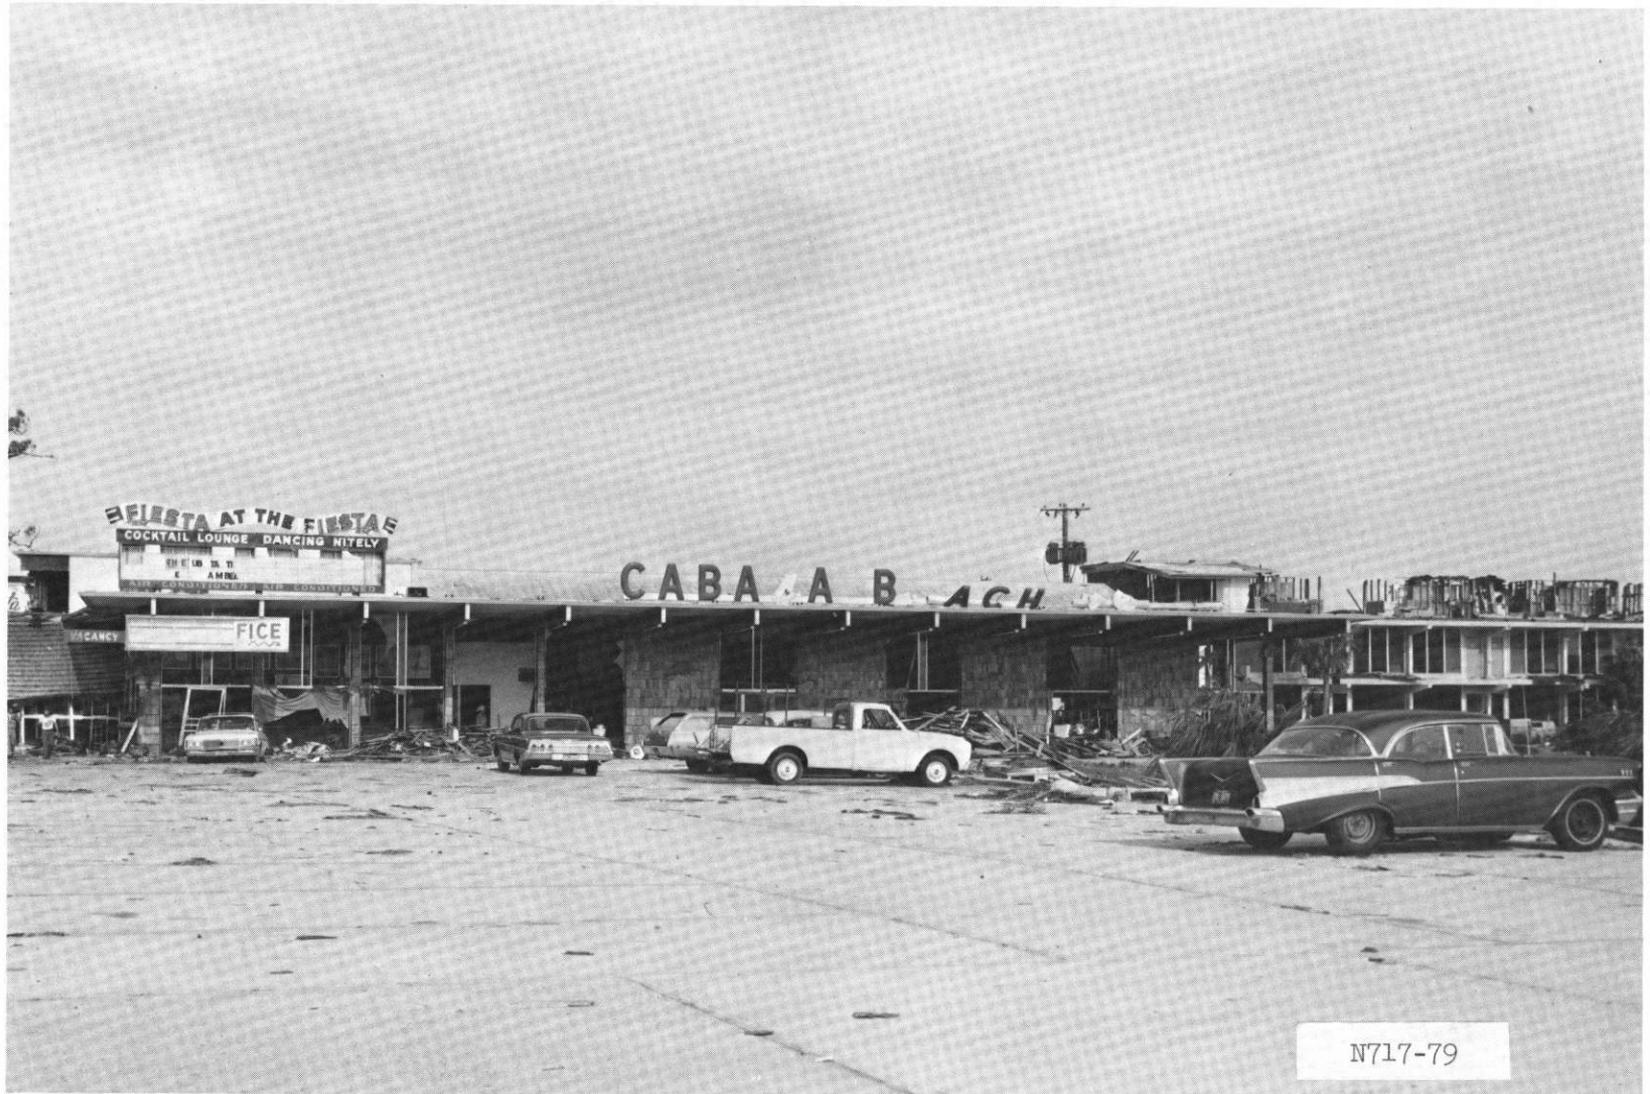
Figure 2.52 Frame motel structure, Biloxi, Mississippi. There had been fire damage before the storm to the building shown at the right.

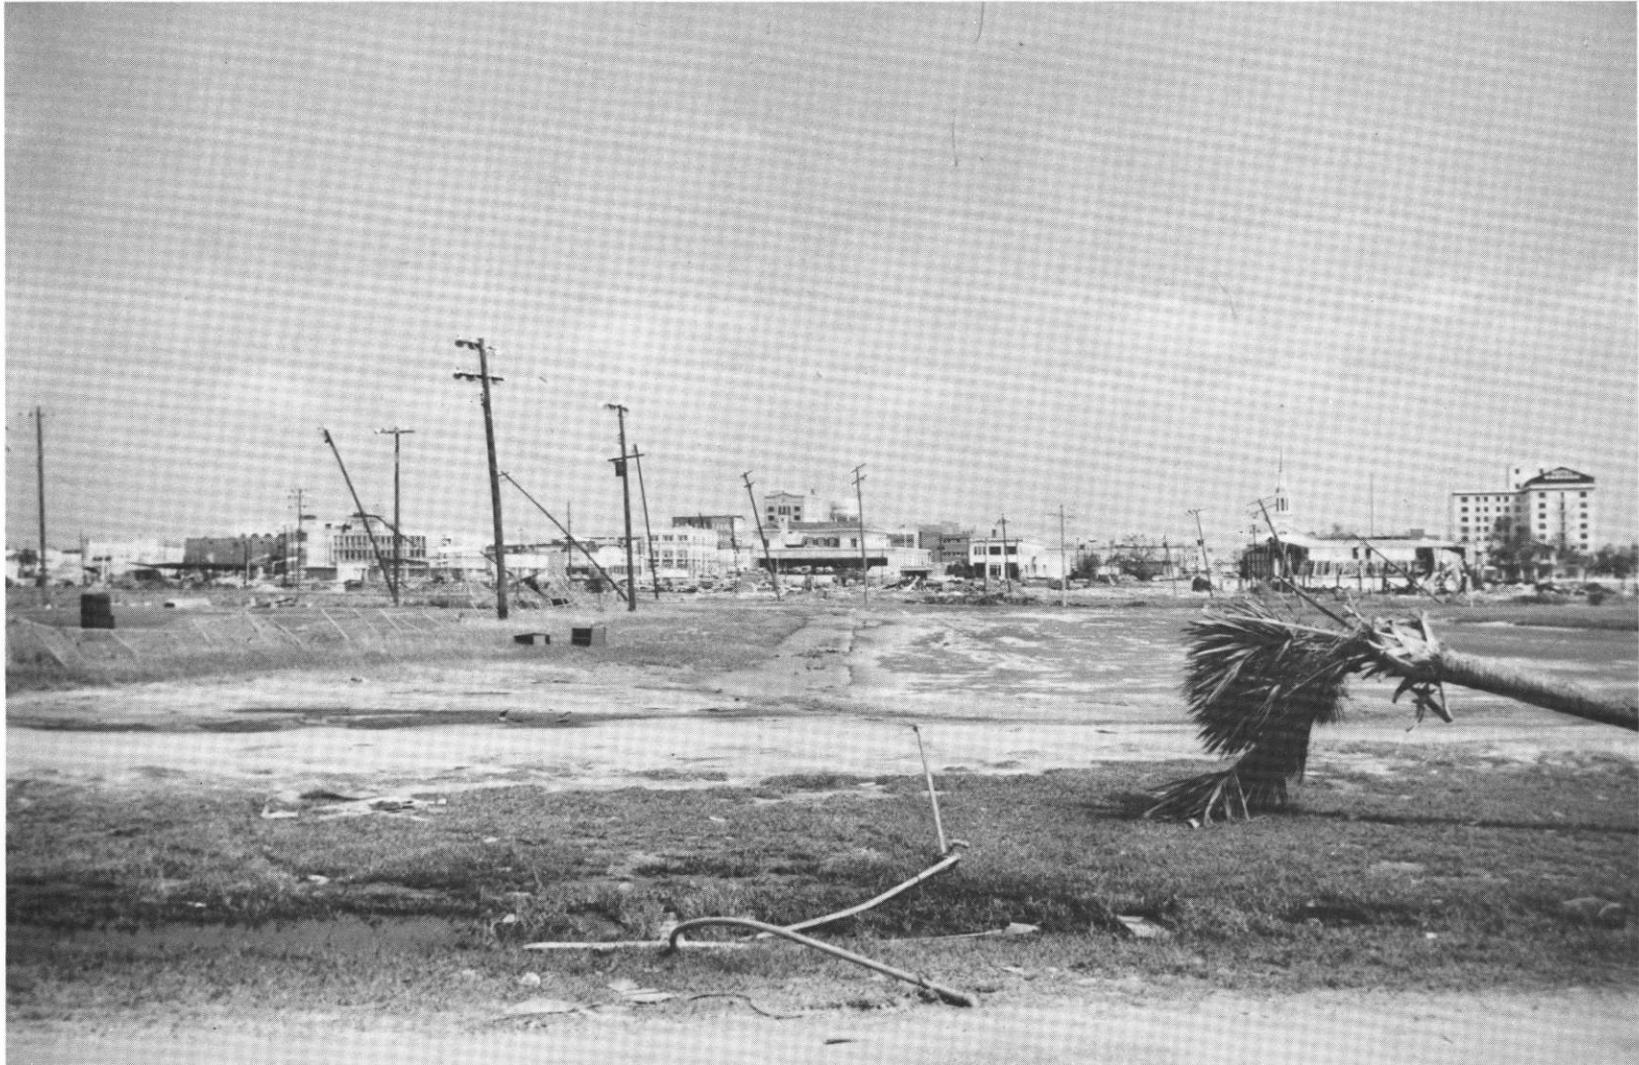
Figure 2.54 Gulfport business district from the south.

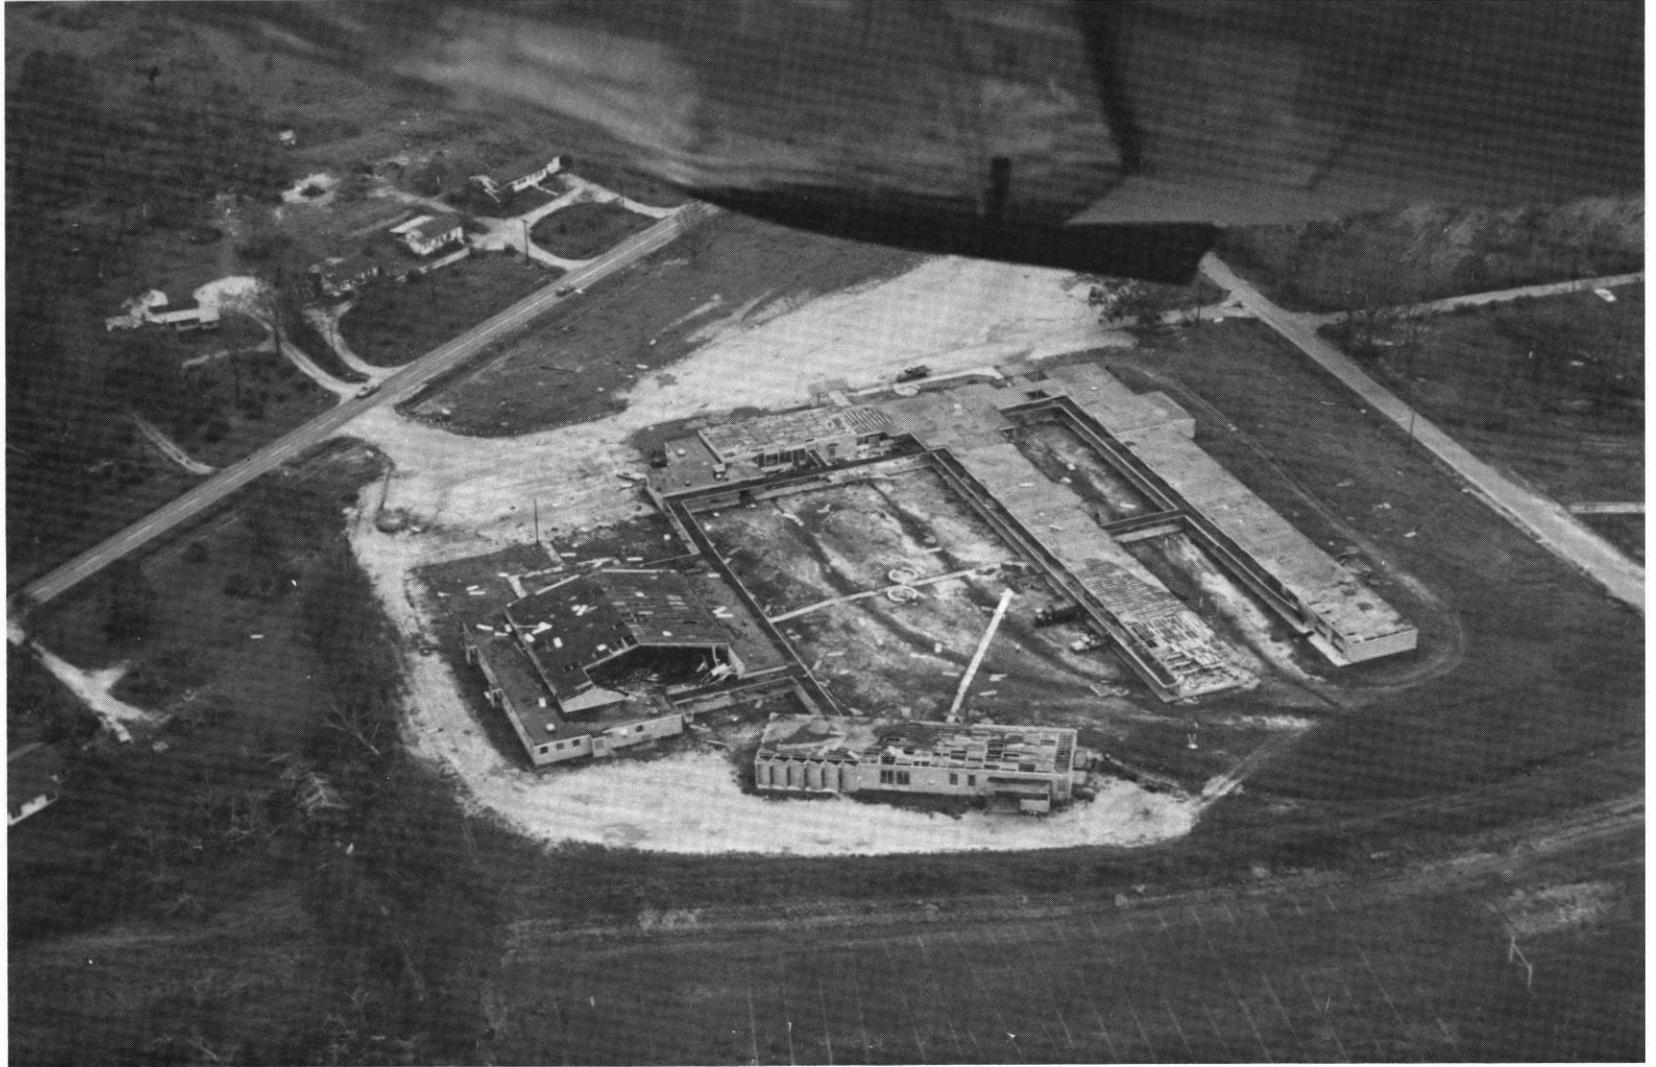
Figure 2.55 Poplarville High School, Poplarville, Mississippi.
