TECHNICAL REPORT N-70-10

SURVEY OF GULF COAST STRUCTURAL DAMAGE RESULTING FROM HURRICANE CAMILLE, AUGUST 1969

April 1970

By U. S. Army Engineer Waterways Experiment Station, Vicksburg, Mississippi

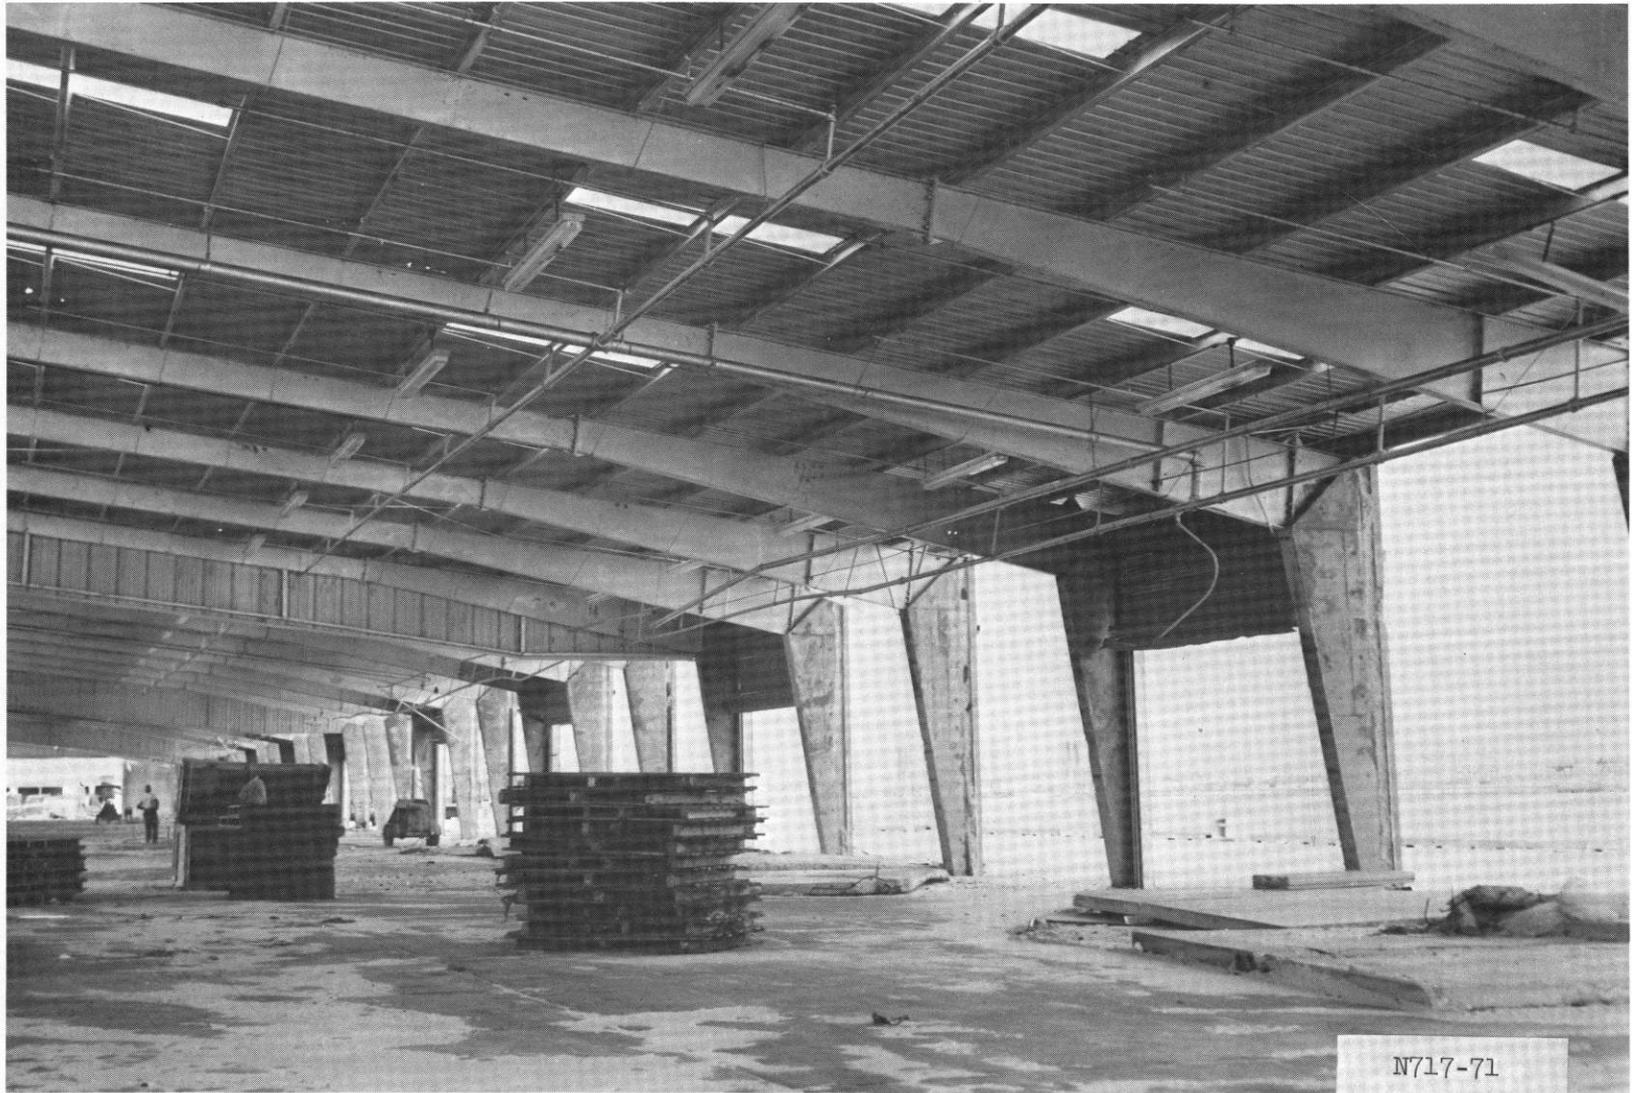
This building is a large clear span (span of about 125 feet) warehouse located at the southern tip of the Port of Gulfport. It is of rigid-frame construction with combination columns (steel sections encased in structural concrete) and with tilt-up concrete wall panels about 20 feet square by 6 inches thick and roll-up doors forming the walls. Light sheet metal purlins run along the length of the building and support a sheet metal roof. The columns appeared to have been cast in two steps, one to encase the steel section and the second to key in the tilt-up walls. The general construction is shown in Figures 3.1 and 3.2.

Figure 3.1 Close-up view of general construction of State Dock.

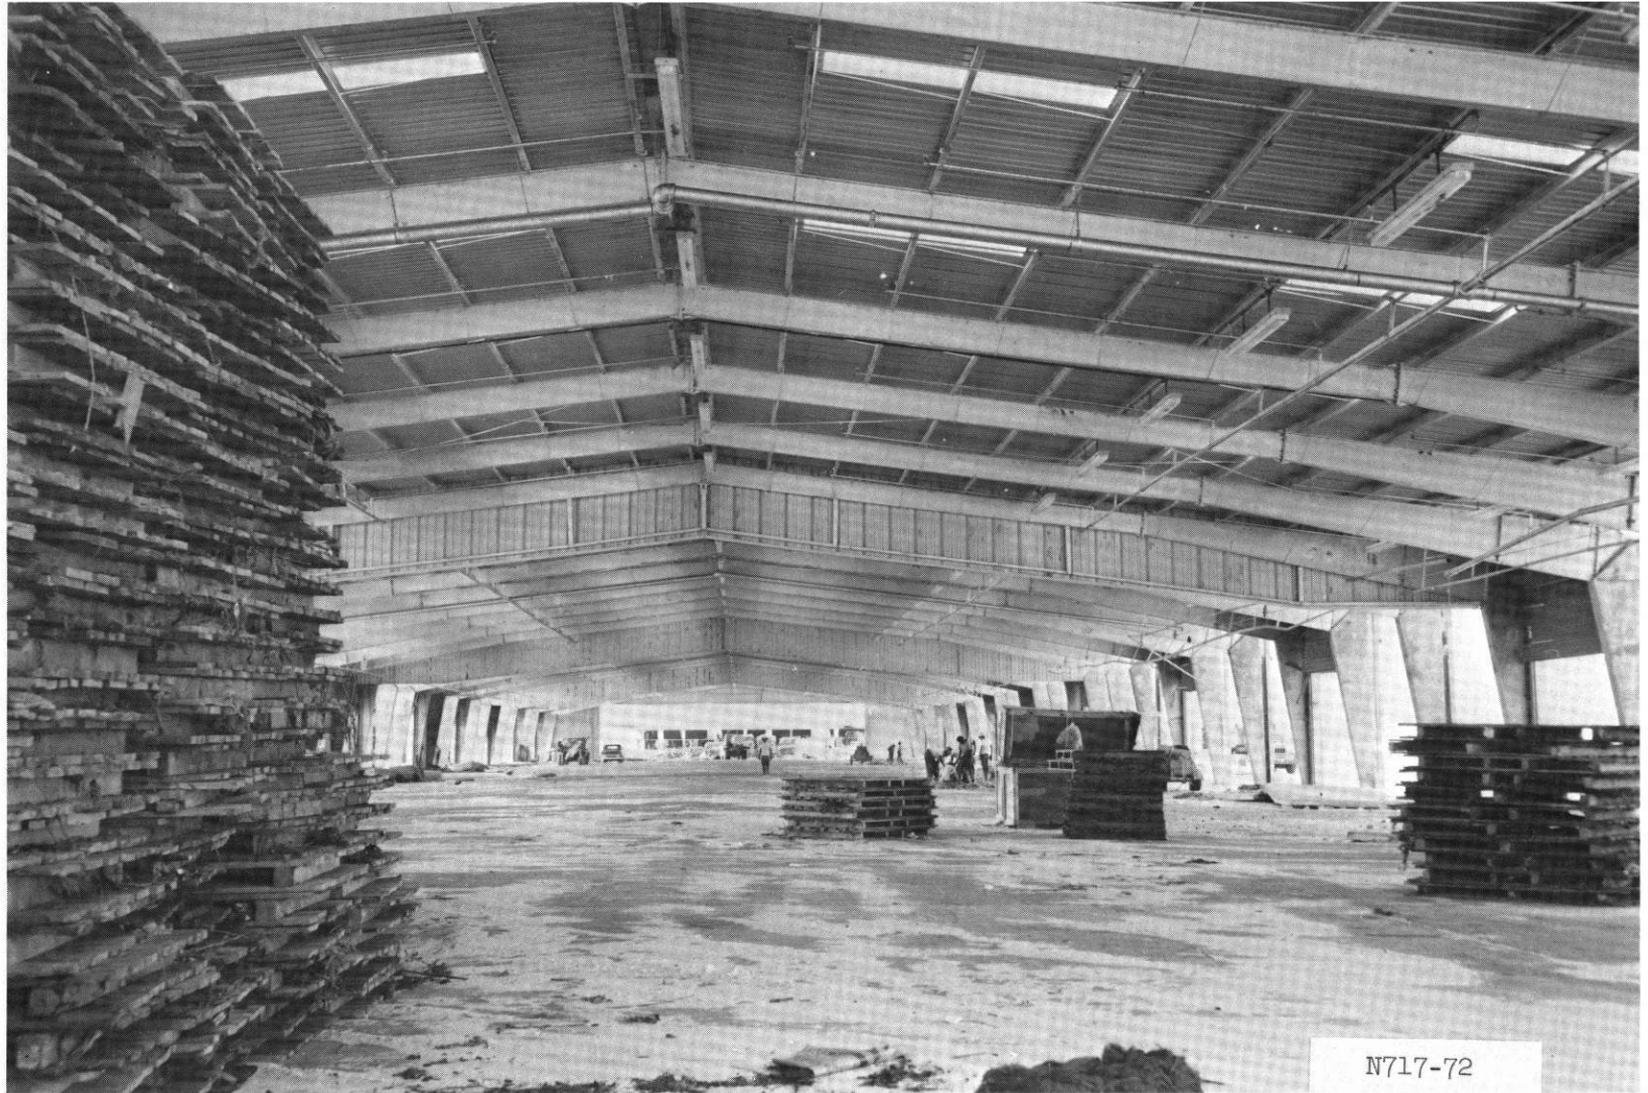
Figure 3.2 General view of State Dock.

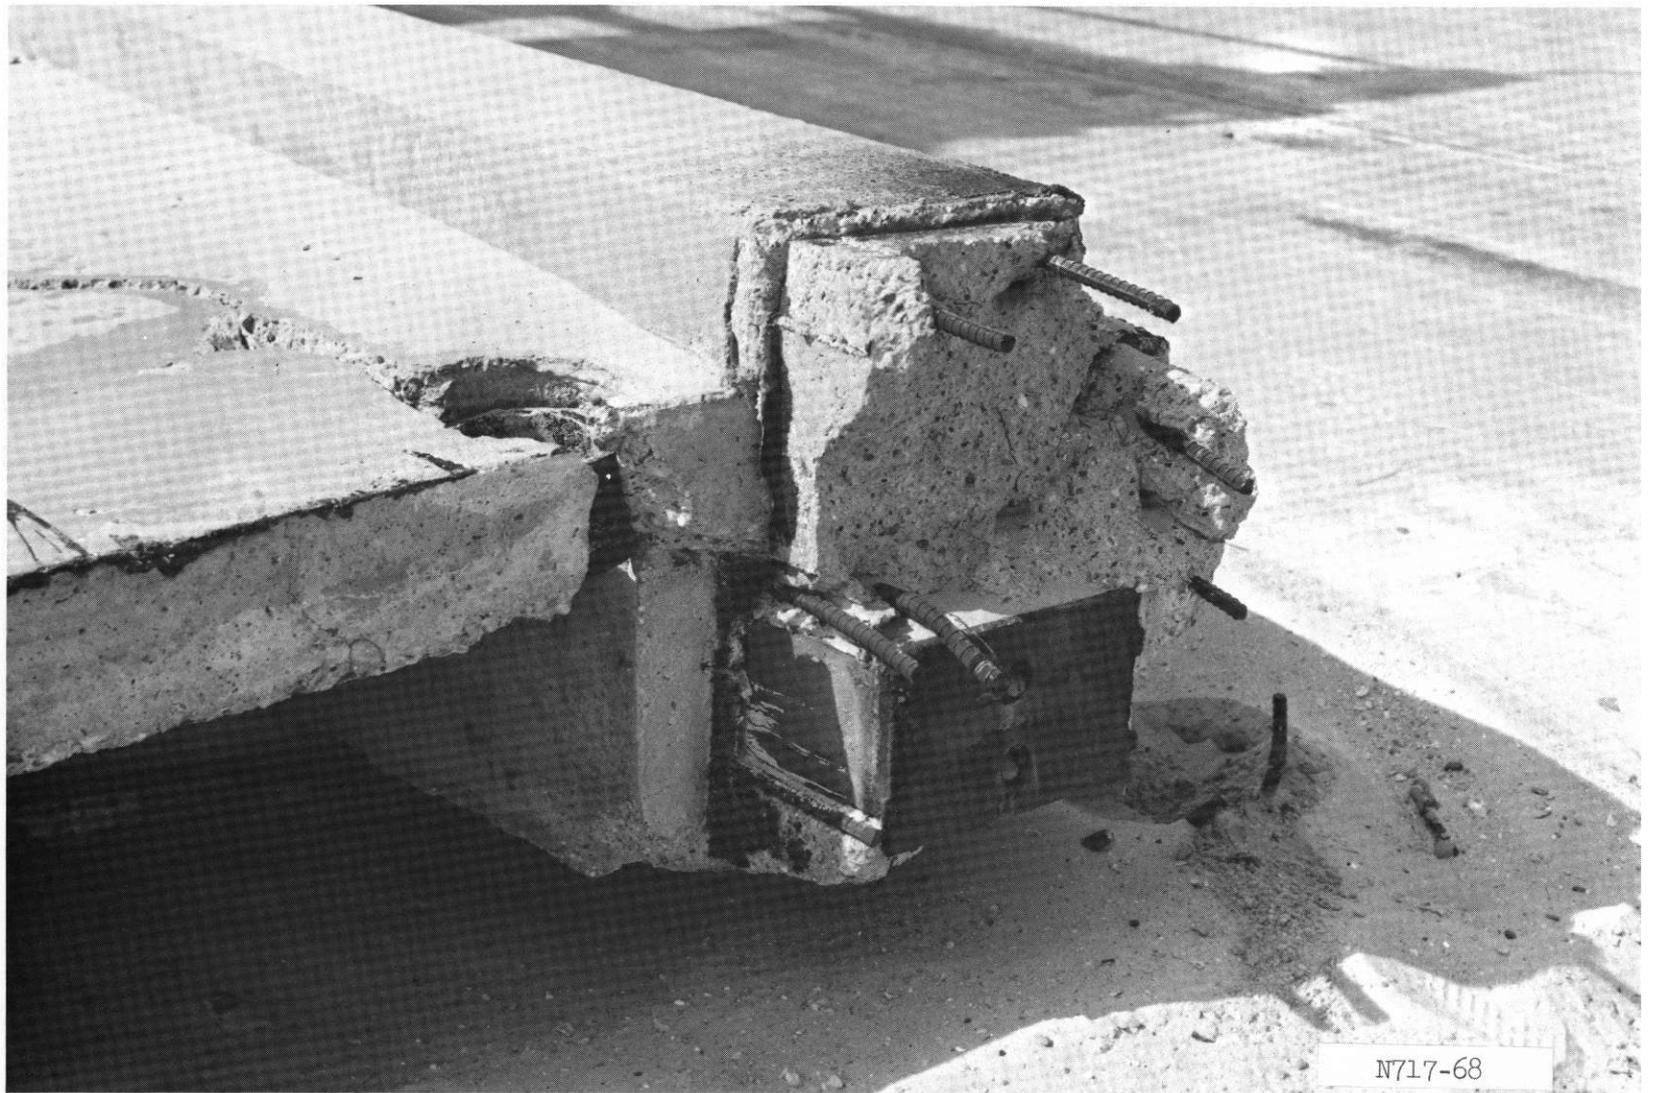
The connections at the base of the columns along the collapsed end wall failed. The dowels at the corner columns, shown in Figures 3.6 and 3.7, were very short, of small size, and had pulled out without breaking. The dowels in other columns along the end wall were larger and longer but still not adequate to develop the tensile strength of the dowel (Figure 3.8).

Figure 3.6 Southeast corner column, State Dock.

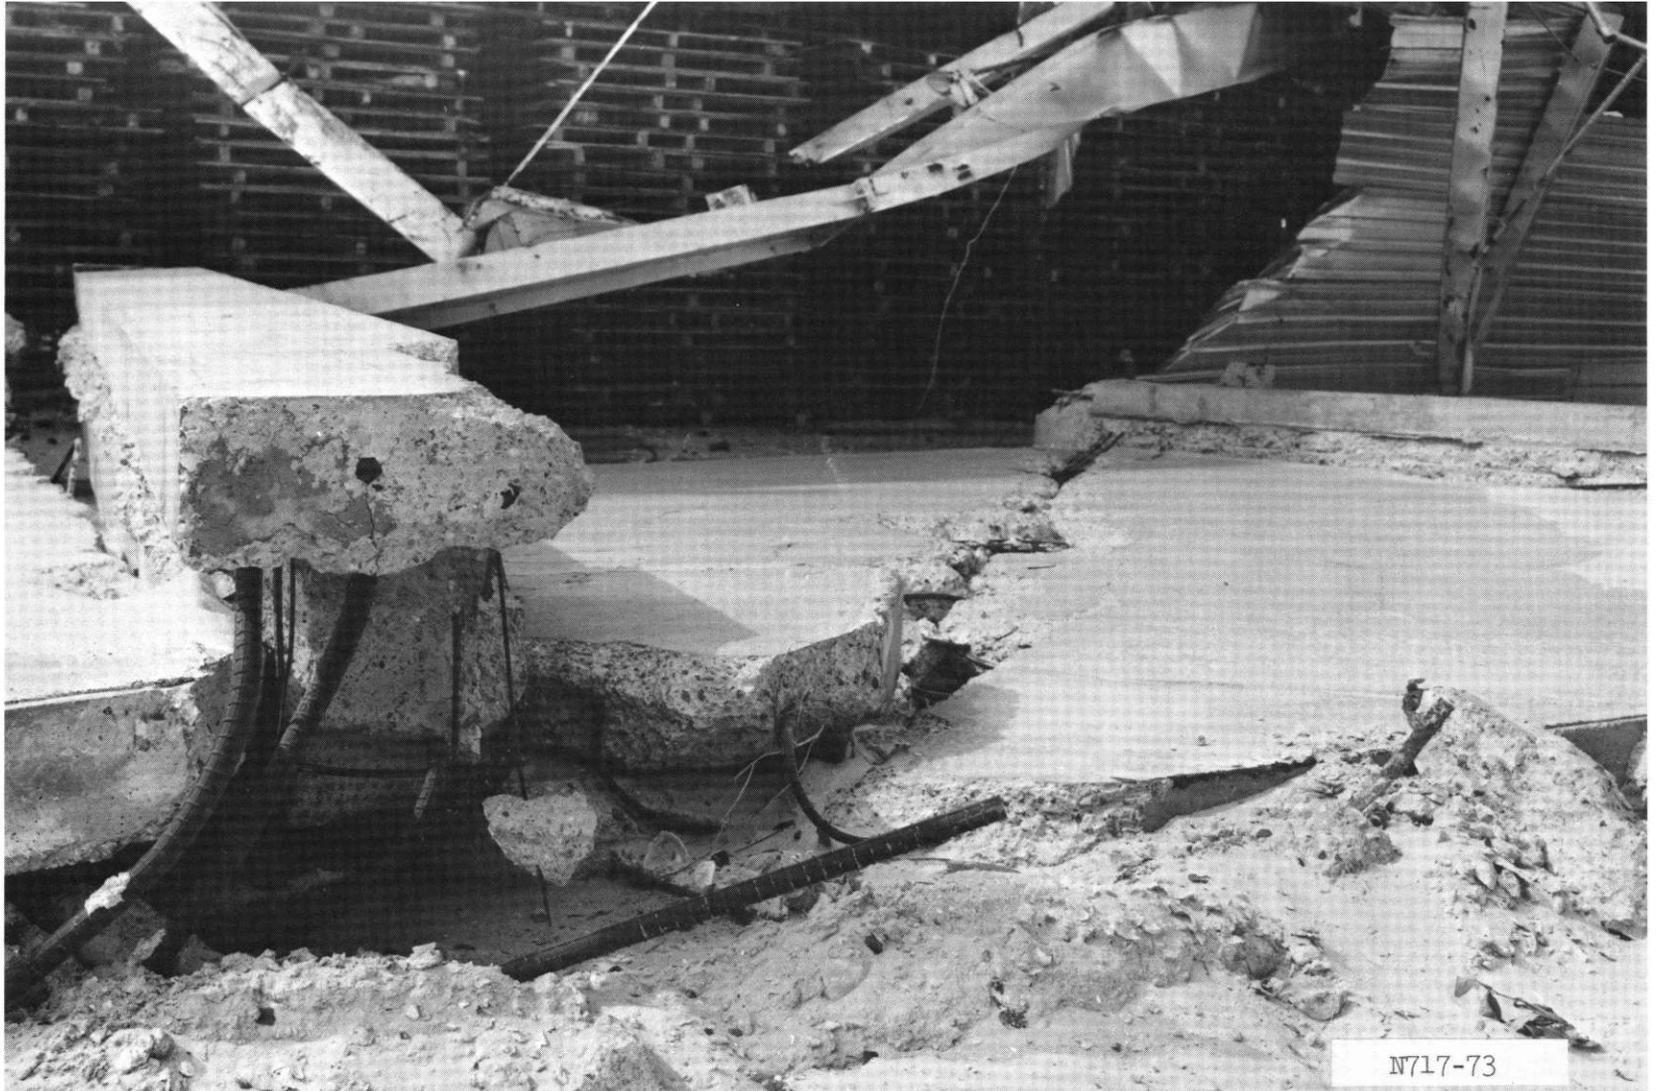
Figure 3.8 End-wall column and panel, State Dock.

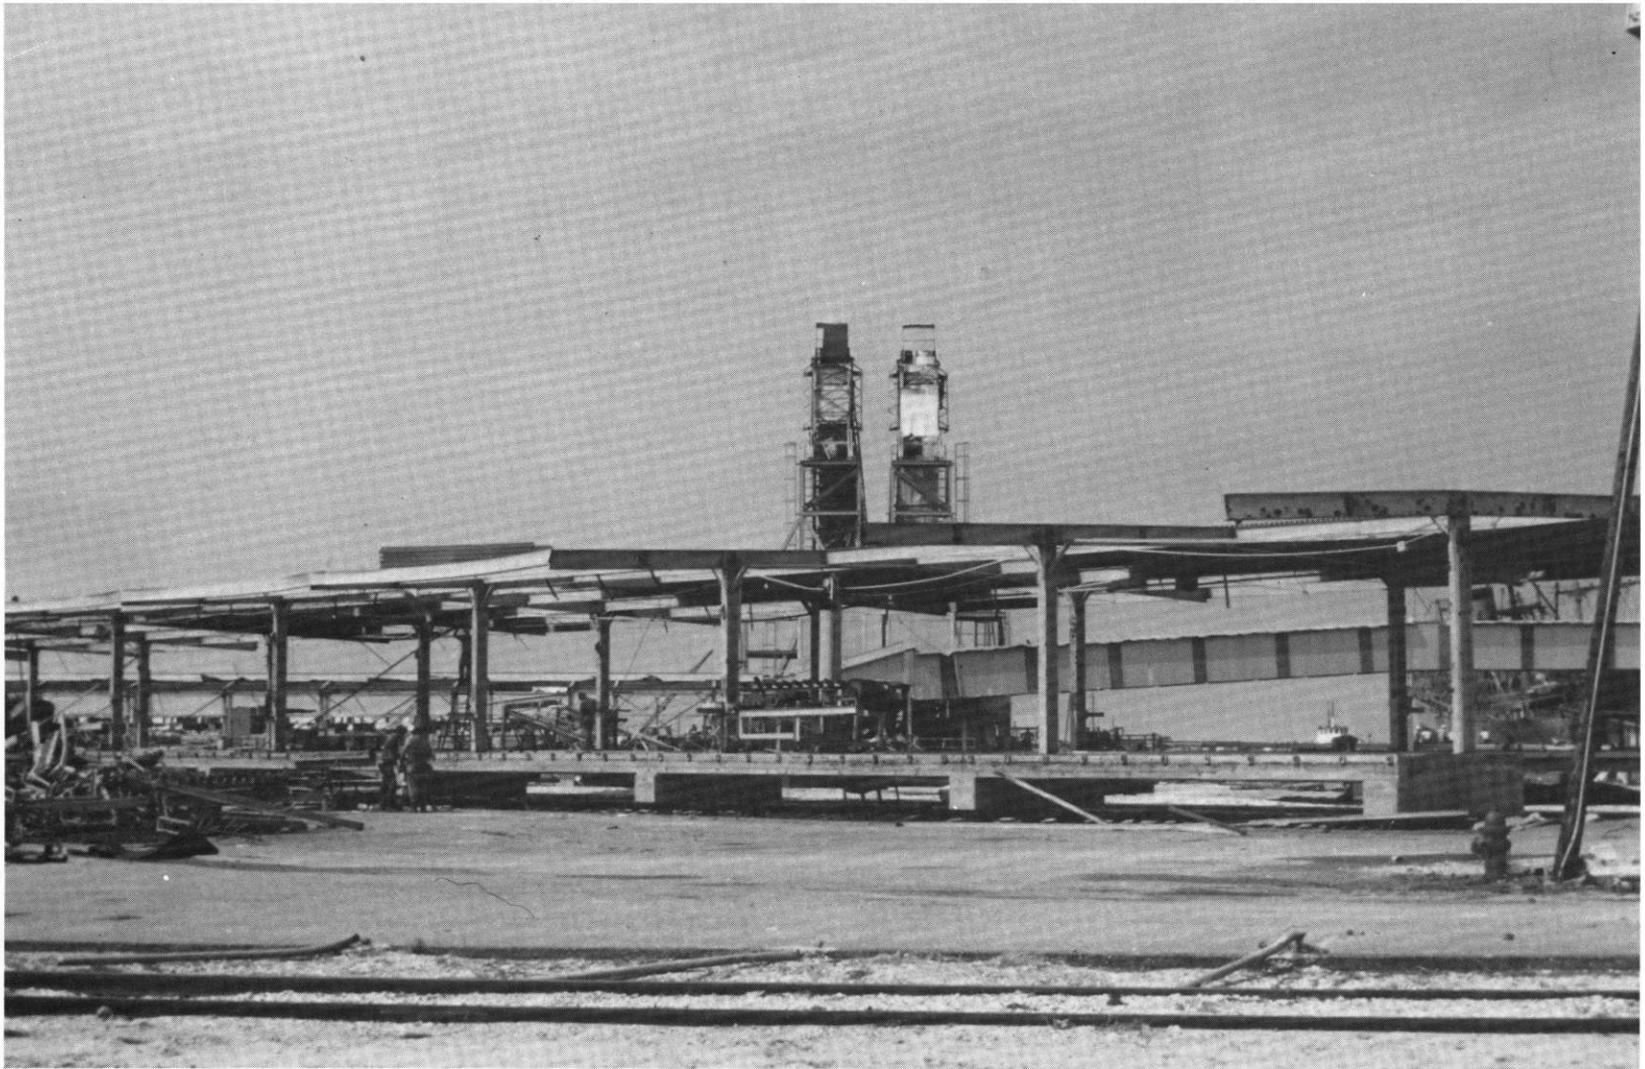
Other Port buildings were either metal-clad rigid-frame buildings, which lost almost all of the sheeting on the walls, or older reinforced concrete rigid-frame buildings located on the leeward side of the Port and which suffered only minor structural damage, even though much of their contents were washed out. Some of the metal-clad buildings are visible in Figure 3.11 and in the background of Figures 3.13 and 3.17.

Figure 3.11 Buildings on east side of Port of Gulfport, Gulfport, Mississippi.

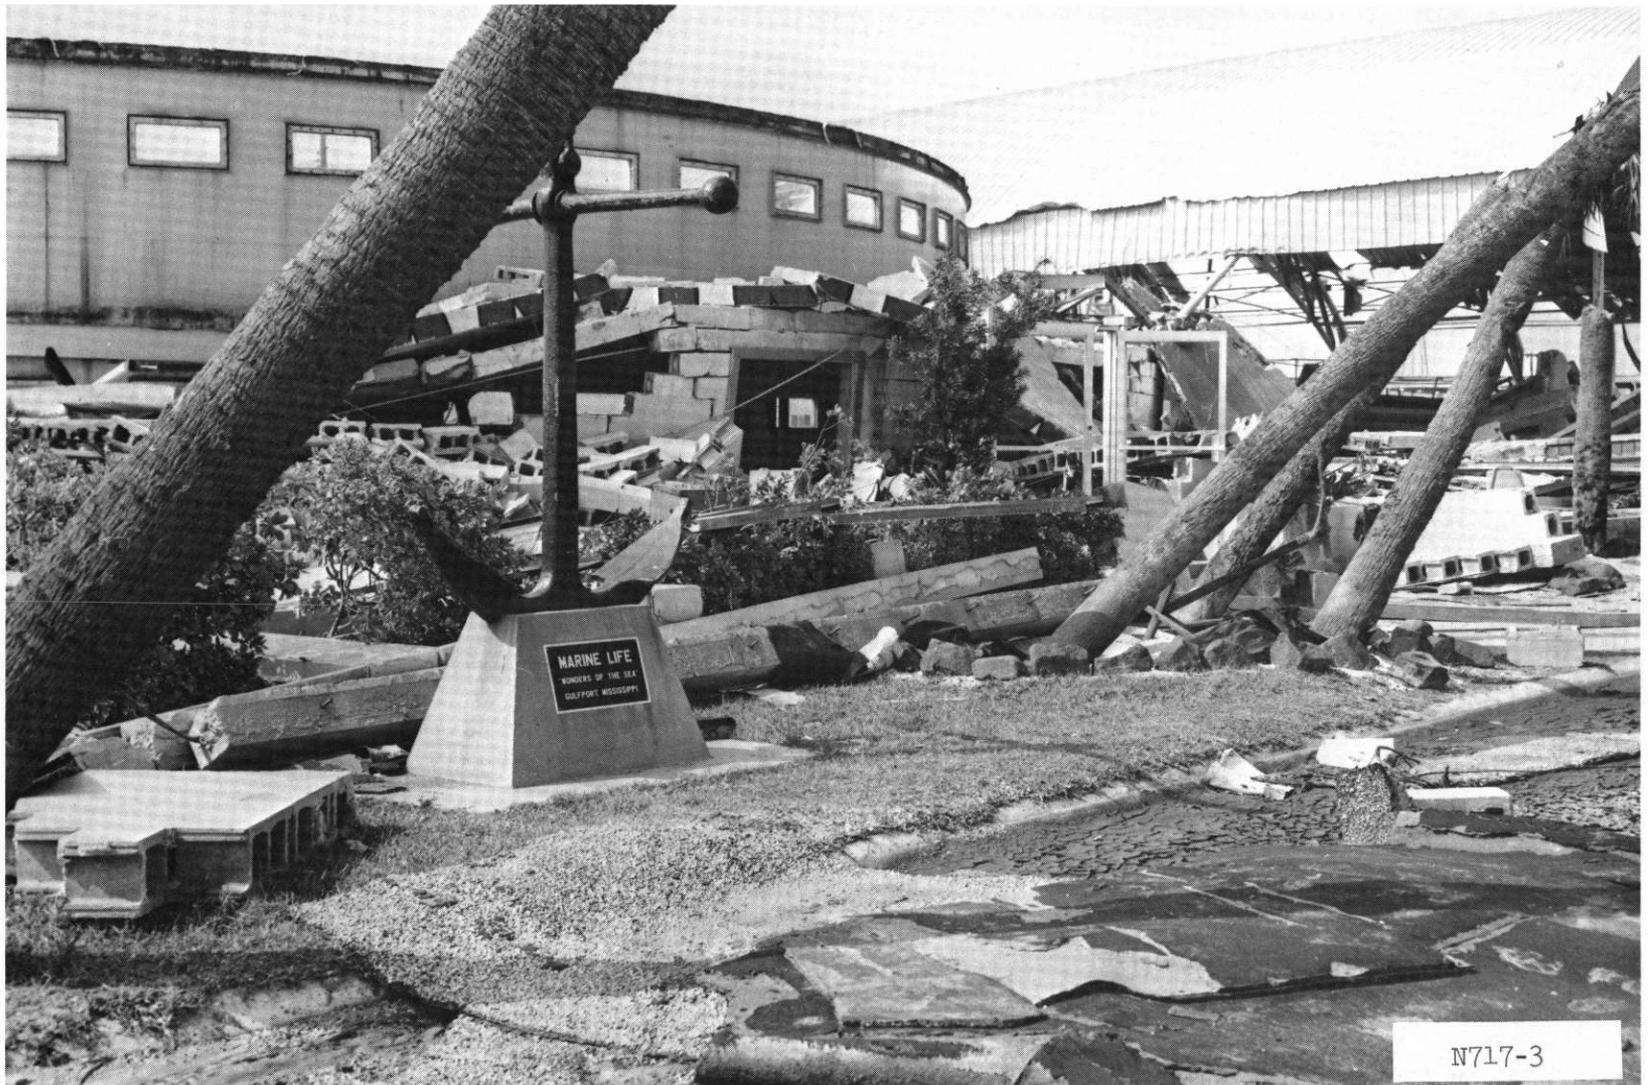
Marine Life consisted of a group of various structures (Figure 3.12). A large steel arch which this team was told was designed for 120-mph winds sheltered a display tank and a concrete seating area. A small (30 to 50 spaces) NFSS shelter was located under this seating area. A concrete floor and block wall structure surrounded the large display tank to the east of the arch.

Figure 3.12 Marine Life Aquarium.

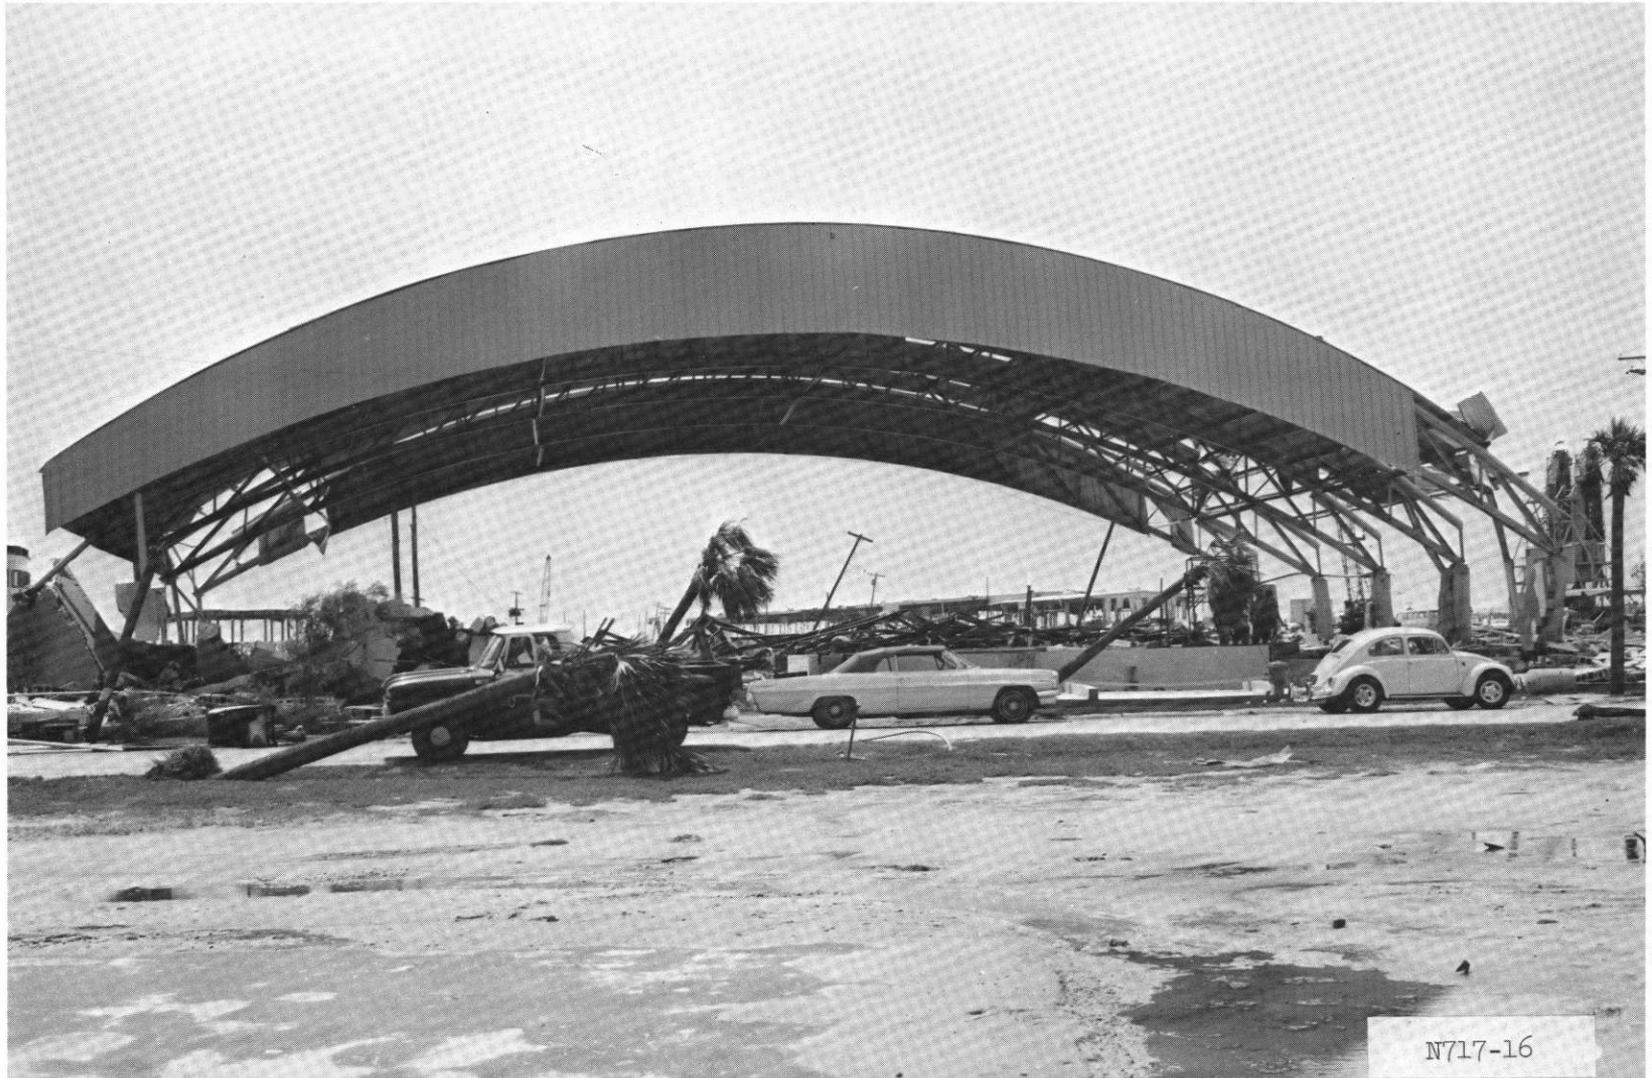
N717-16

The steel arch remained standing despite the loss of two pipe column supports at the northeast corner (corner nearest the camera and to the left in Figure 3.13) and the dropping of the other three columns on the east side. Some roofing was torn off the west side of the arch (Figure 3.14). The middle pier supporting the west end of the arch was badly damaged

Figure 3.13 Marine Life steel arch.

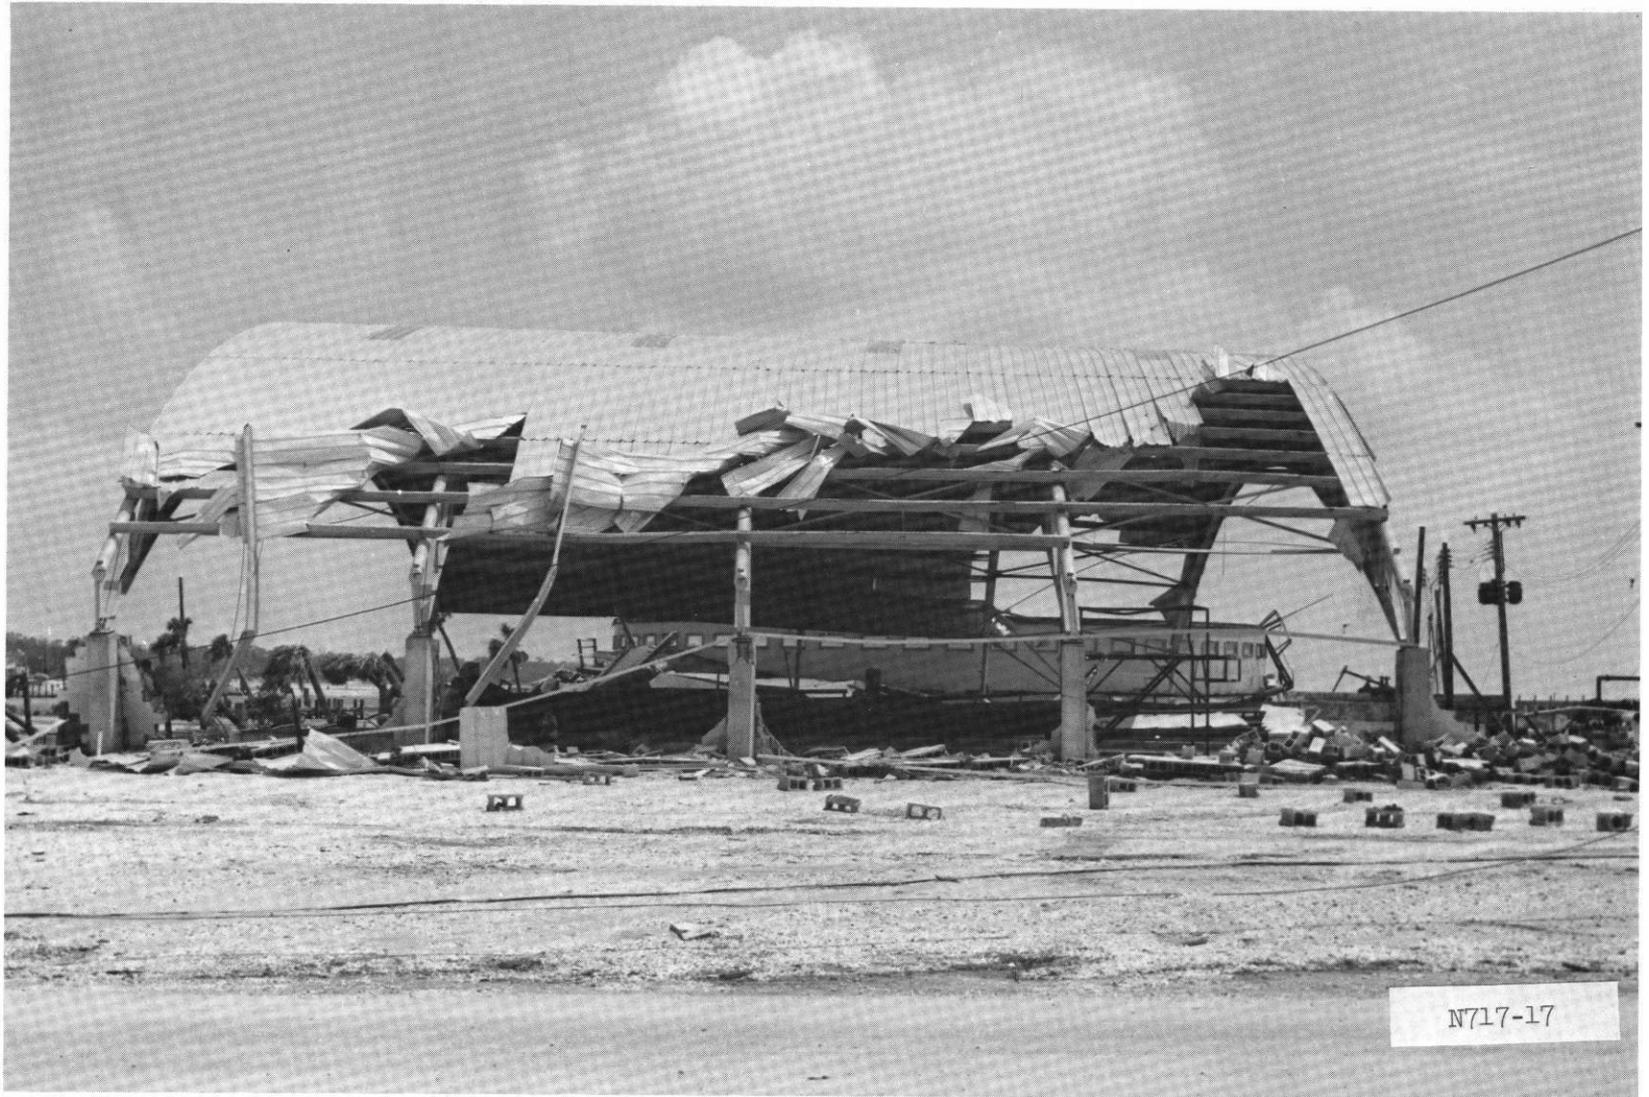
Figure 3.14 Marine Life arch.

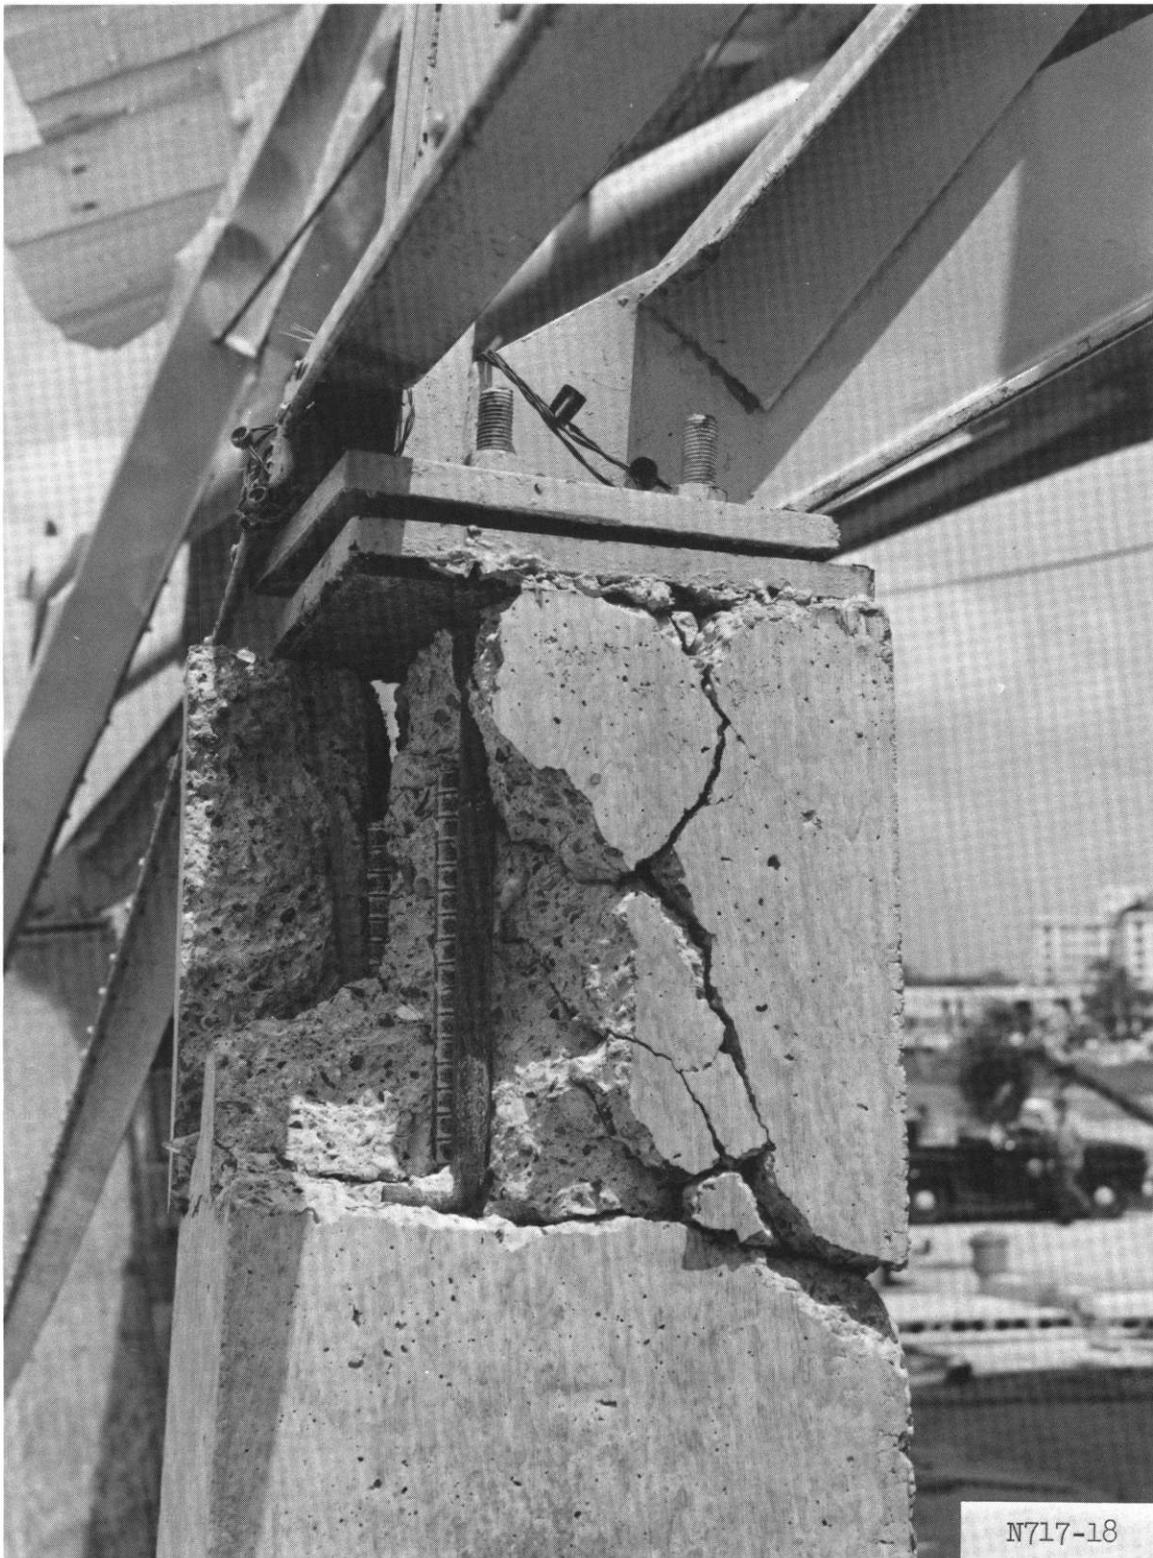
(Figure 3.15) and no doubt would have functioned better had more column ties been included near the top of the pier.

Figure 3.15 Center pier supporting west end of arch, Marine Life.

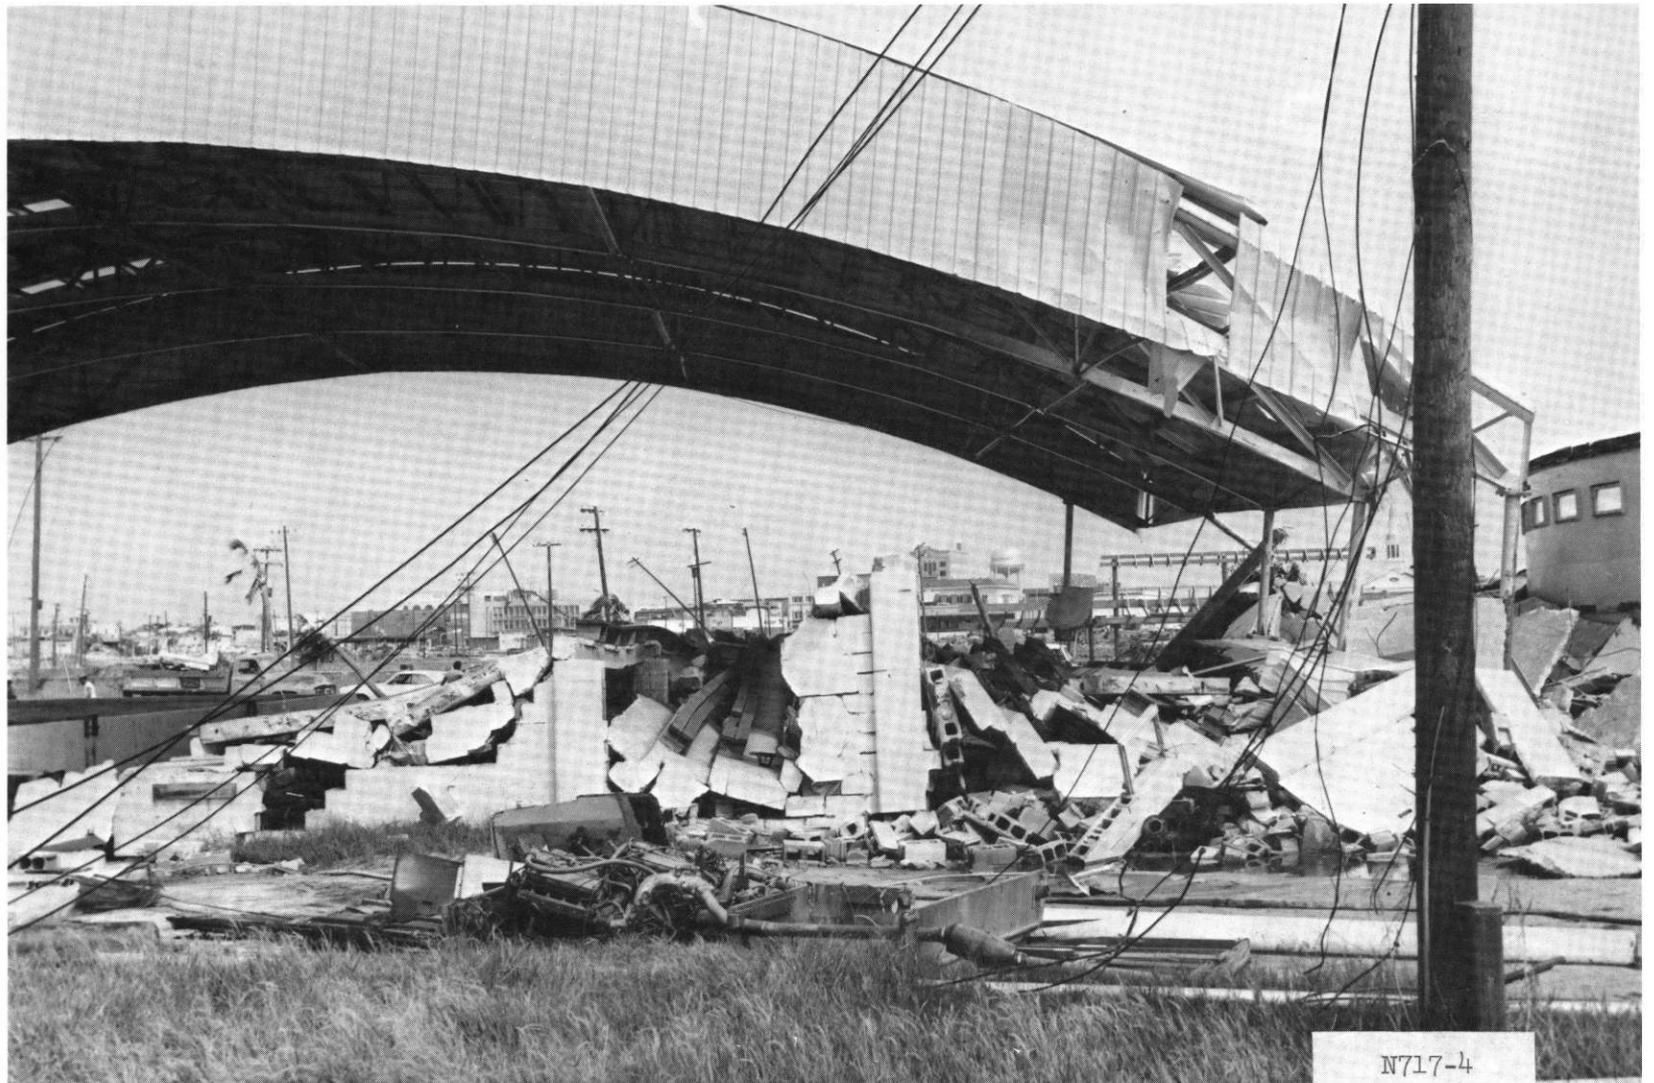
N717-4

The approximate maximum water wave level during Hurricane Camille is the top of the bent cladding on the arch (see Figure 3.16).

Figure 3.16 Southeast corner of Marine Life arch.

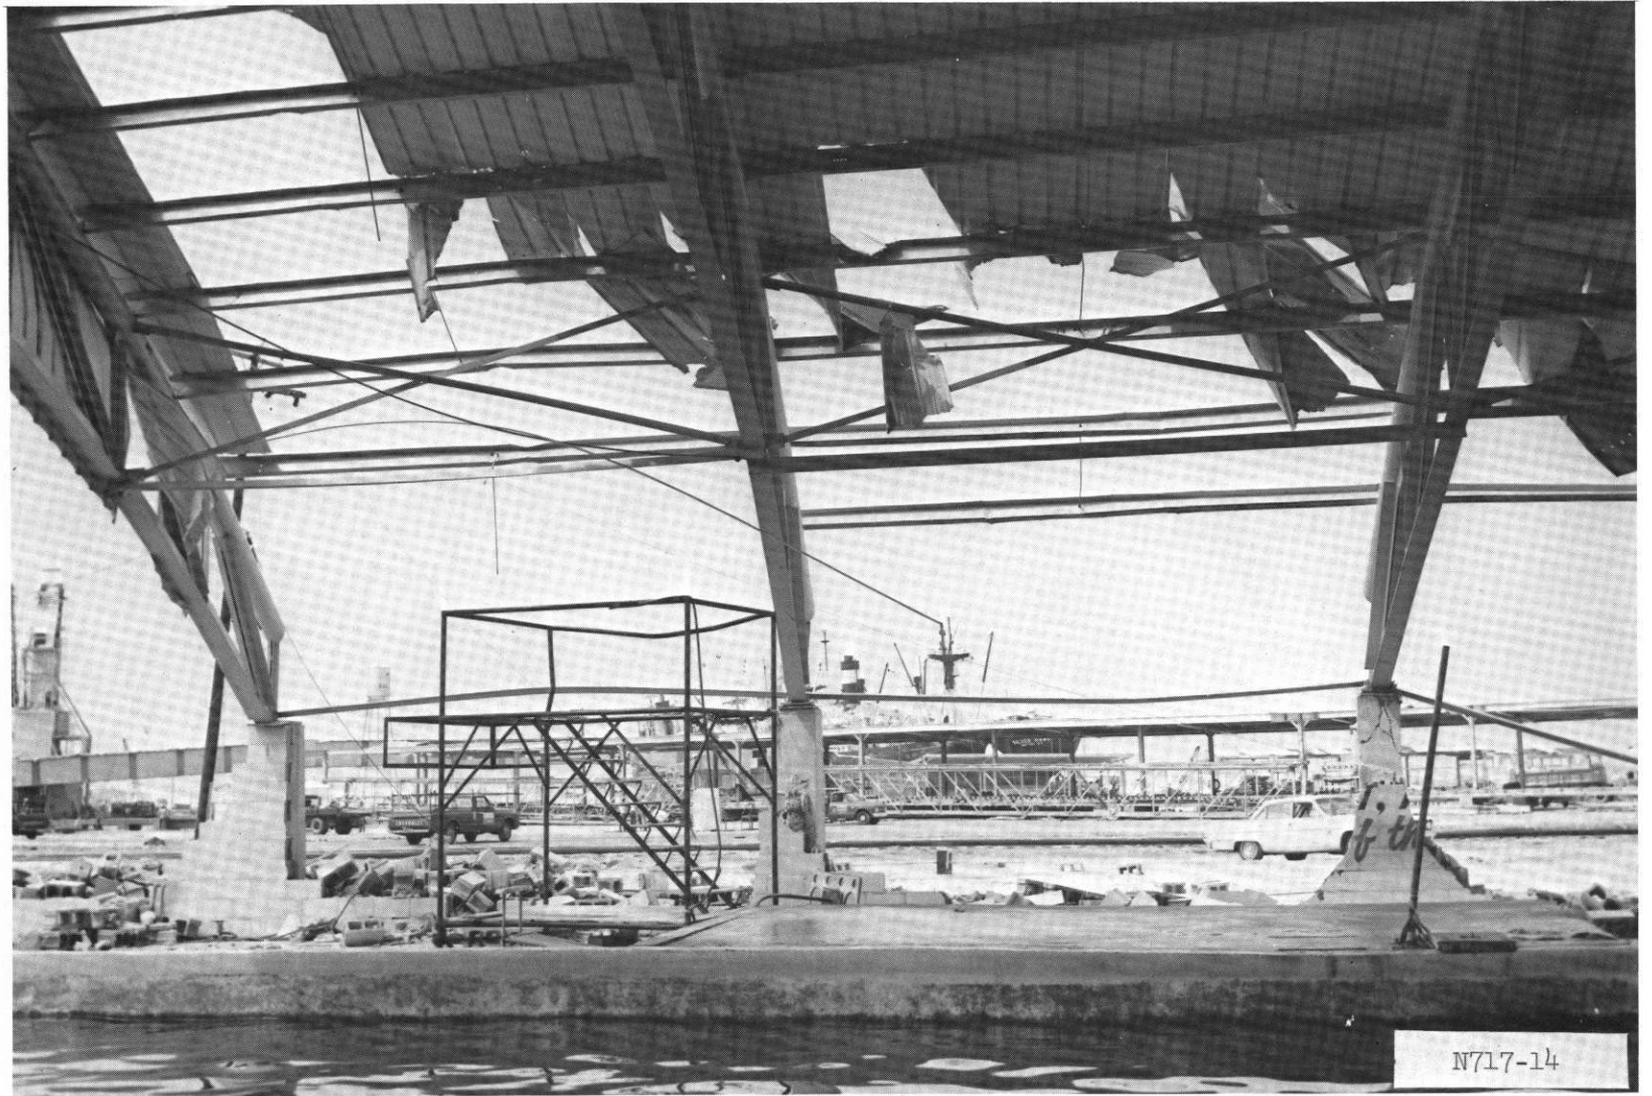
The block wall along the west side of the arch was almost completely destroyed (Figure 3.17).

Figure 3.17 West end of Marine Life arch.

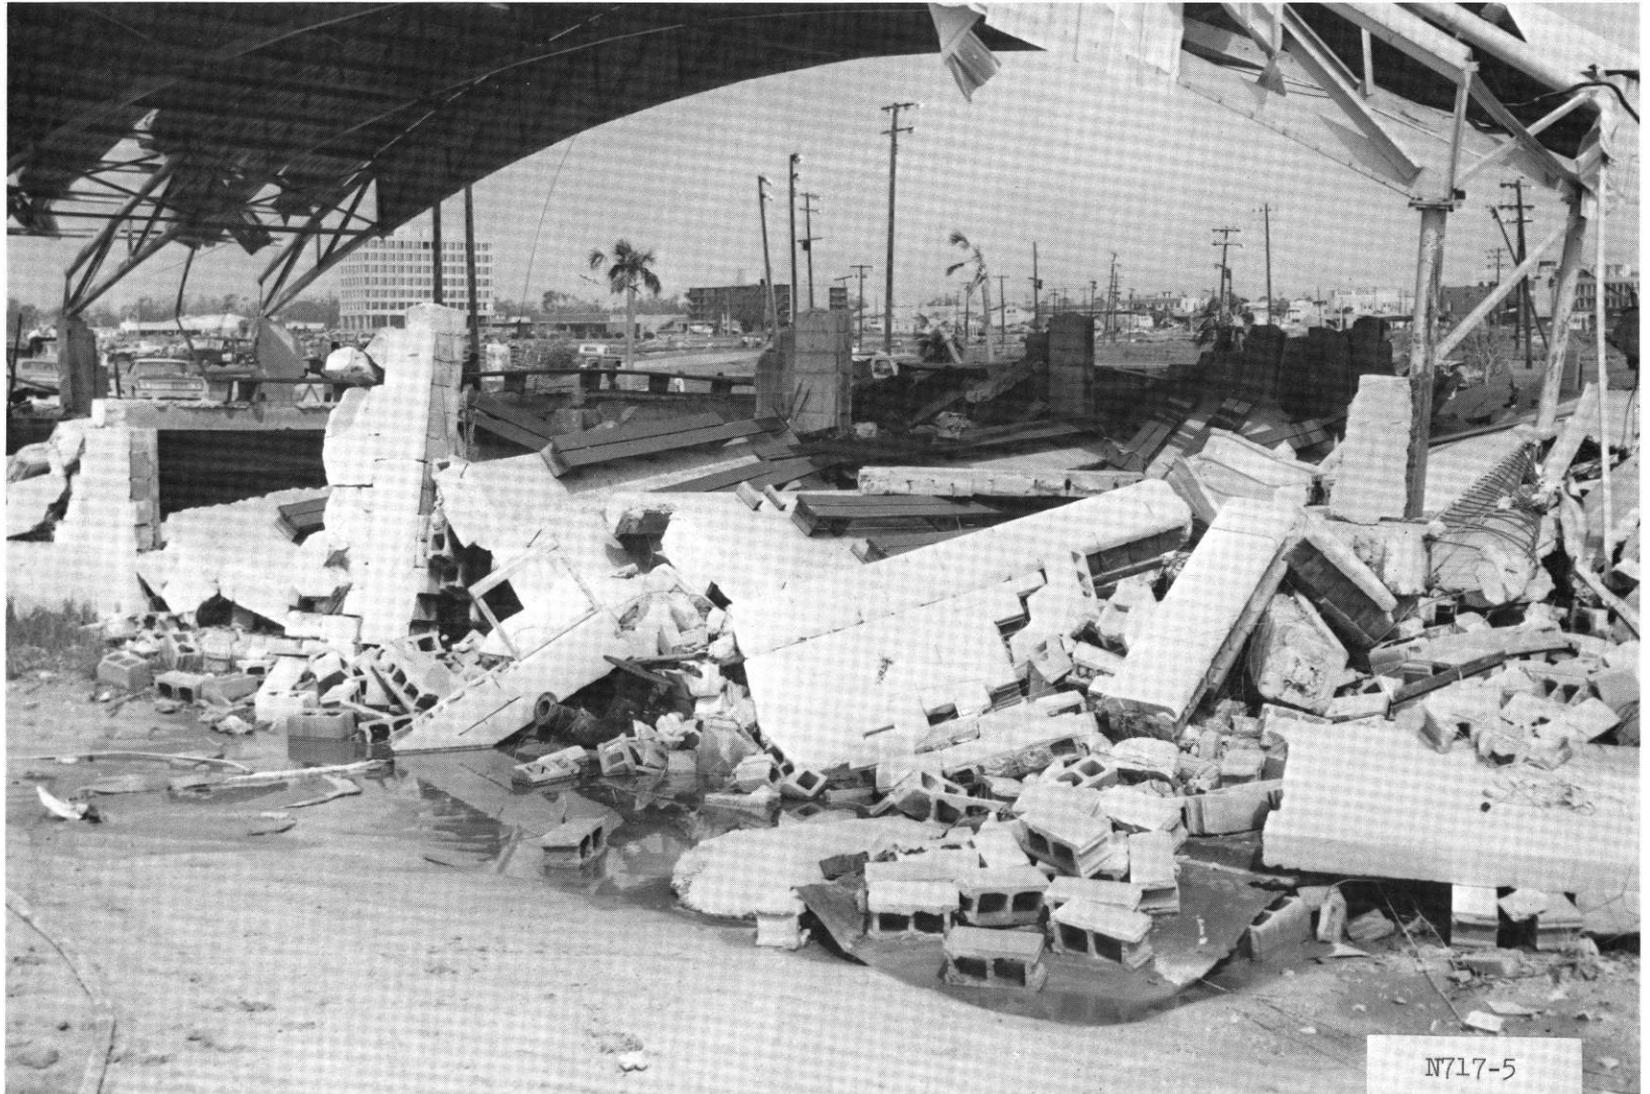
This seating area under the east side of the arch was completely collapsed (Figures 3.18 and 3.19). The seating area appeared to have failed when the water lifted the seating and dropped it onto the walls crushing some block and failing the beams of the seating portion at the supporting walls, thus transforming the beams into essentially simply supported spans which then fell (Figures 3.20 through 3.22). It was not clear whether these beams had been designed for continuity; the steel arrangement, but not the splice length, suggests that they were.

Figure 3.18 Seating area under Marine Life arch.
