TECHNICAL REPORT N-70-10

SURVEY OF GULF COAST STRUCTURAL DAMAGE RESULTING FROM HURRICANE CAMILLE, AUGUST 1969

April 1970

By U. S. Army Engineer Waterways Experiment Station, Vicksburg, Mississippi

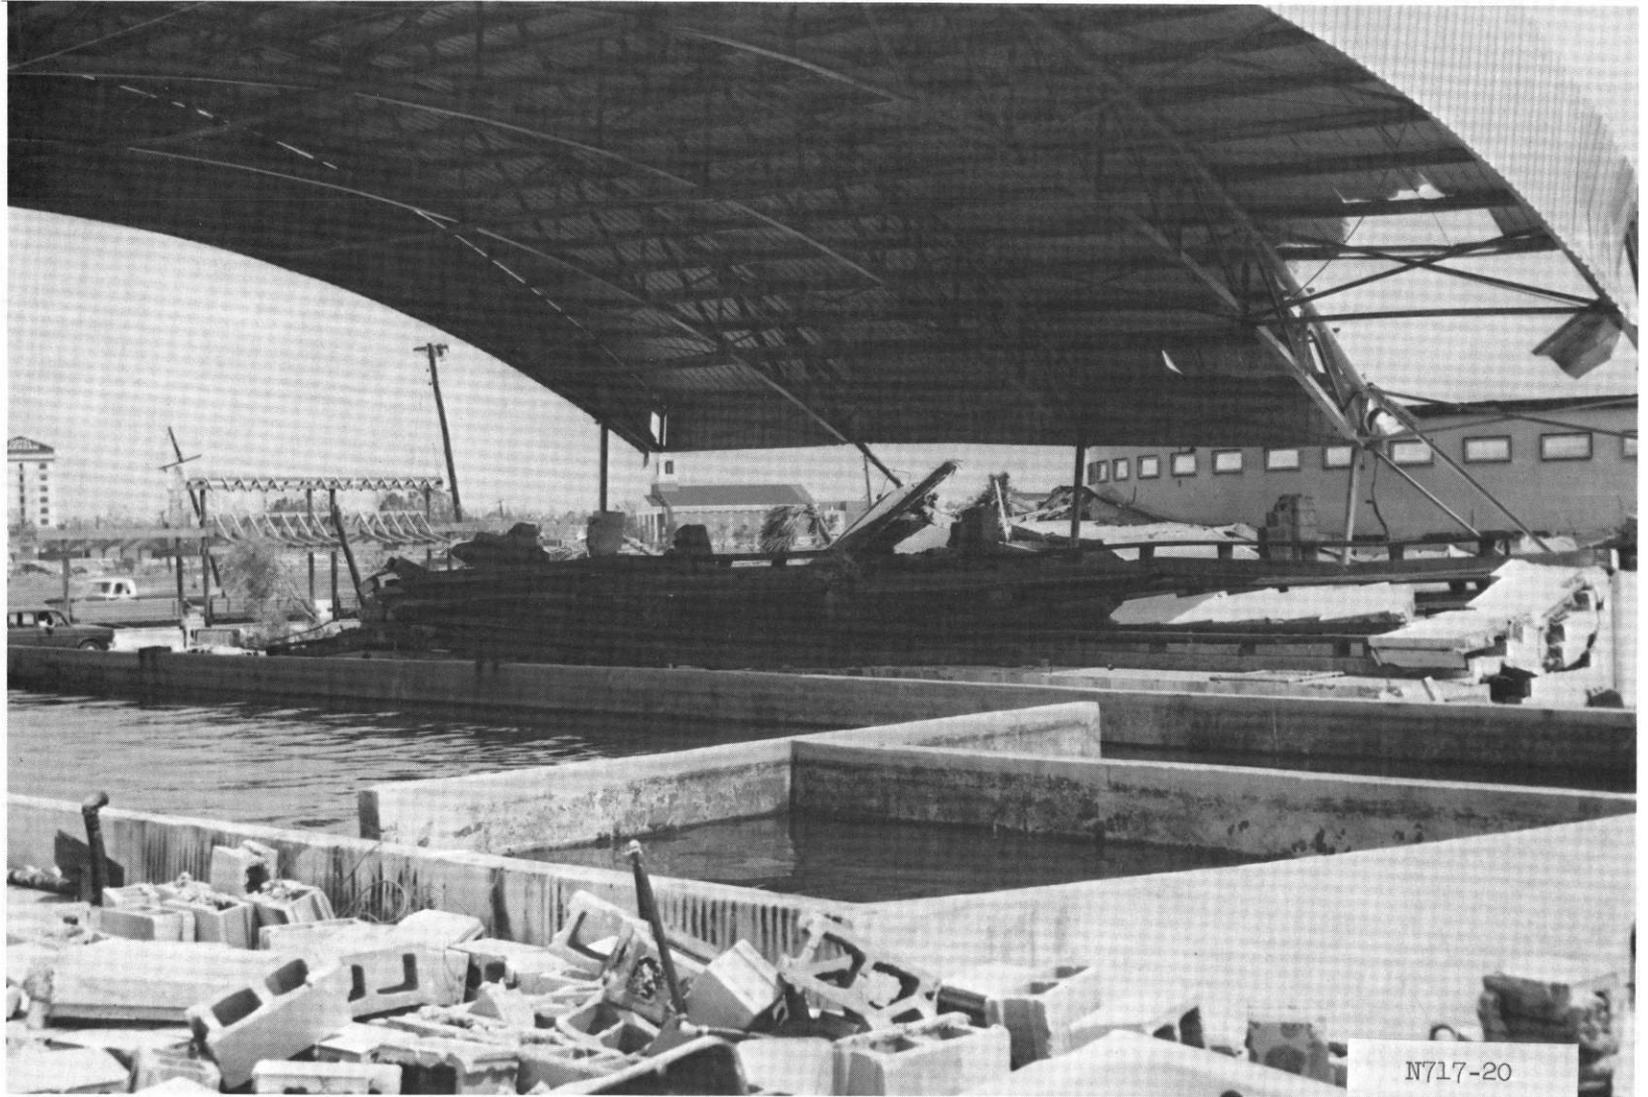
N717-20

This seating area under the east side of the arch was completely collapsed (Figures 3.18 and 3.19). The seating area appeared to have failed when the water lifted the seating and dropped it onto the walls crushing some block and failing the beams of the seating portion at the supporting walls, thus transforming the beams into essentially simply supported spans which then fell (Figures 3.20 through 3.22). It was not clear whether these beams had been designed for continuity; the steel arrangement, but not the splice length, suggests that they were.

Figure 3.19 Seating area and arch at Marine Life.

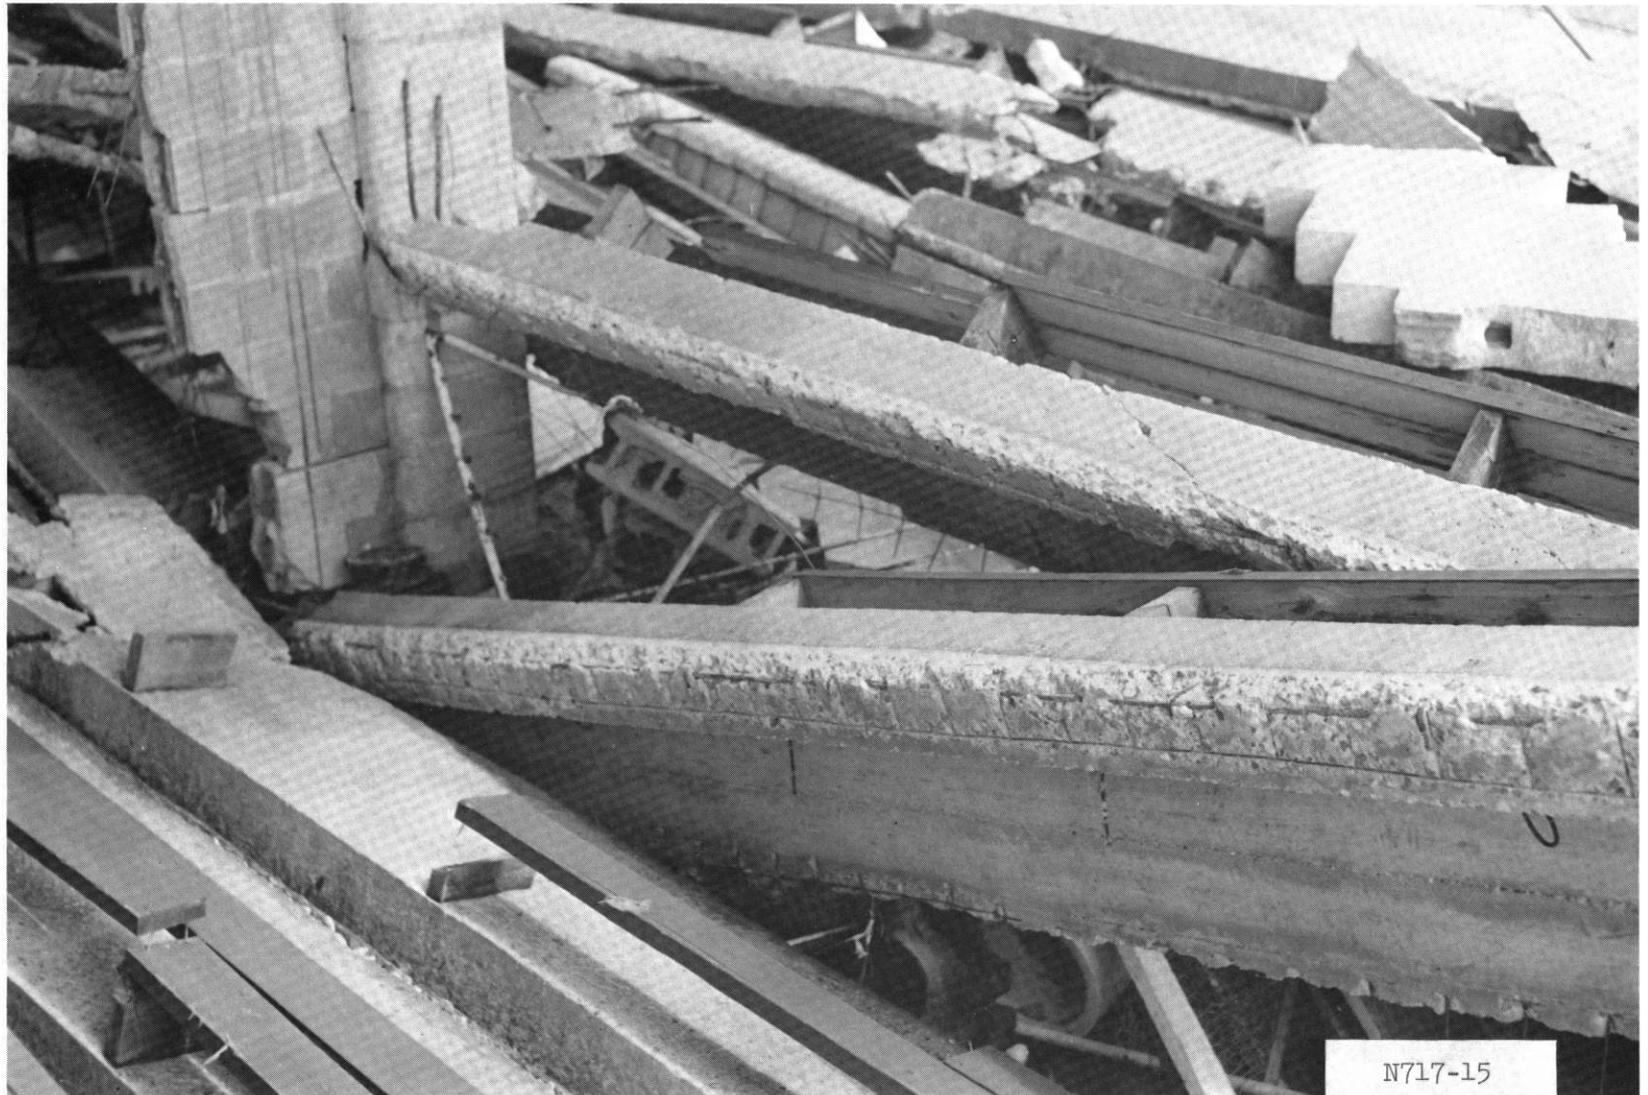
The welded-wire fabric of the seating slab tore out of the beams easily and had little or no cover, as can be seen in the beam shown in the foreground of Figure 3.20 and in Figure 3.23, which shows a beam that ultimately failed in torsion.

Figure 3.20 Close-up of seating area, Marine Life.

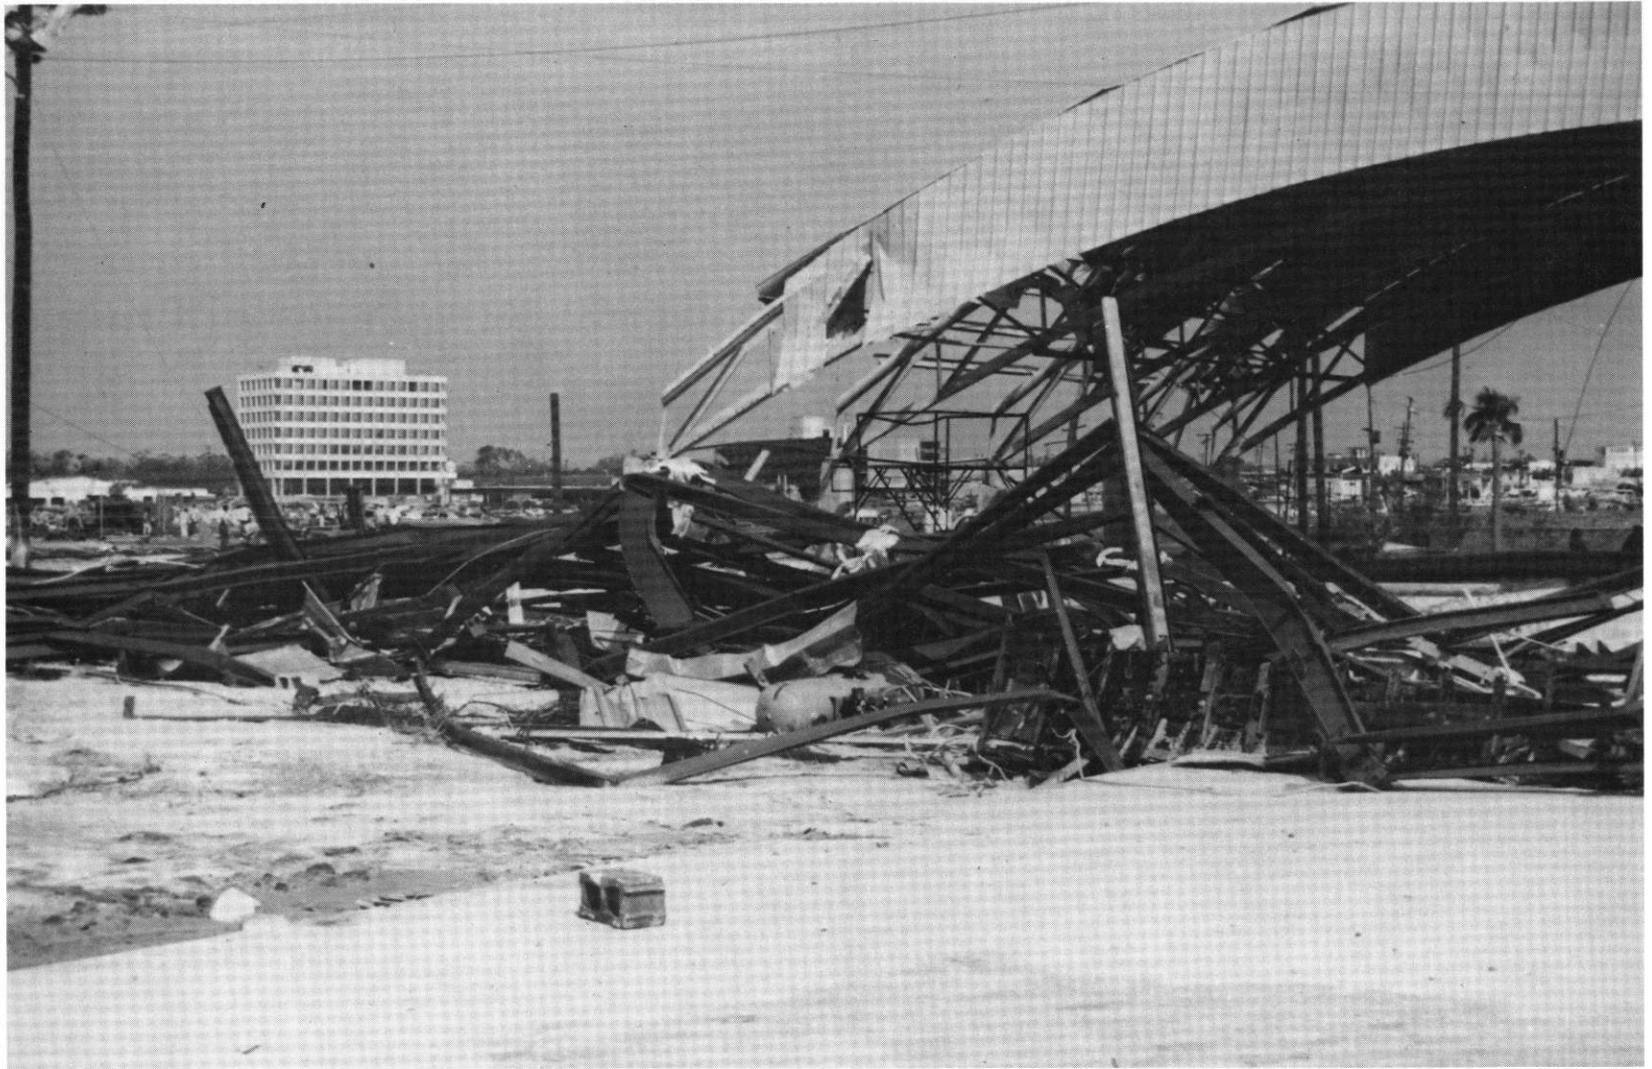
The steel frame ended up in a pile west-northwest of the building slab (Figure 3.28) with one column still tied to the slab (Figure 3.29). The welds at the base plate of another column failed (Figure 3.30).

Figure 3.28 Steel frame of Marine Shop south of Marine Life.

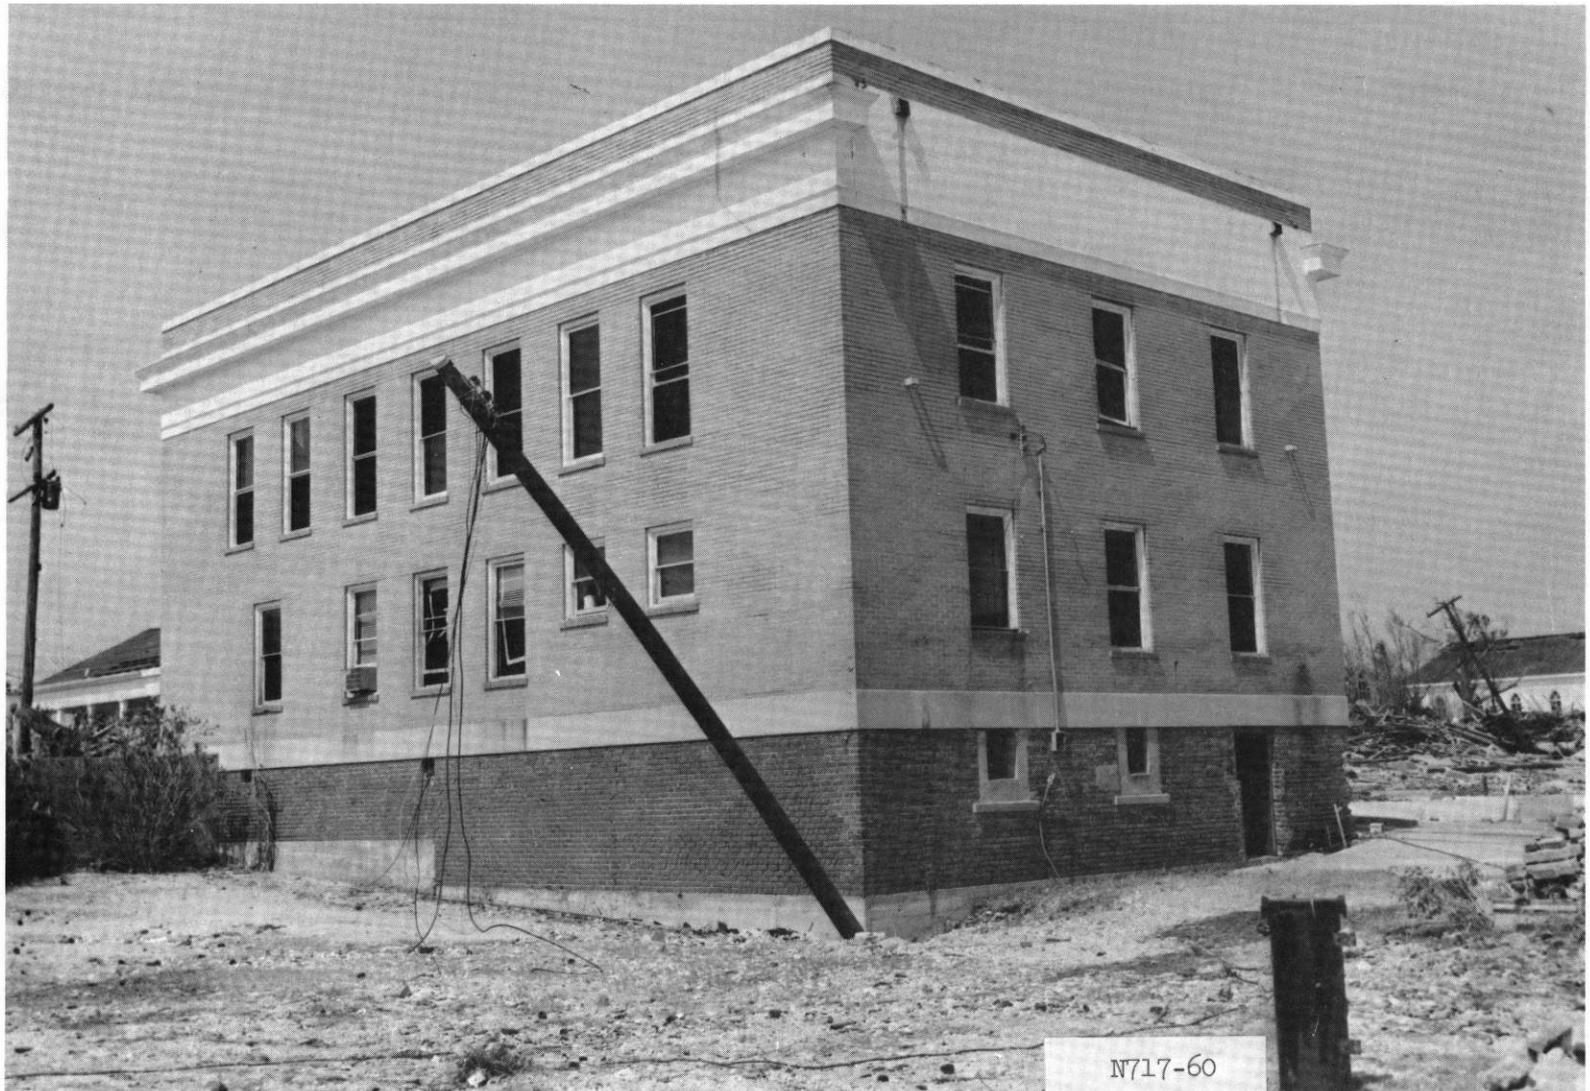
Figure 3.32 Pass Christian City Hall.

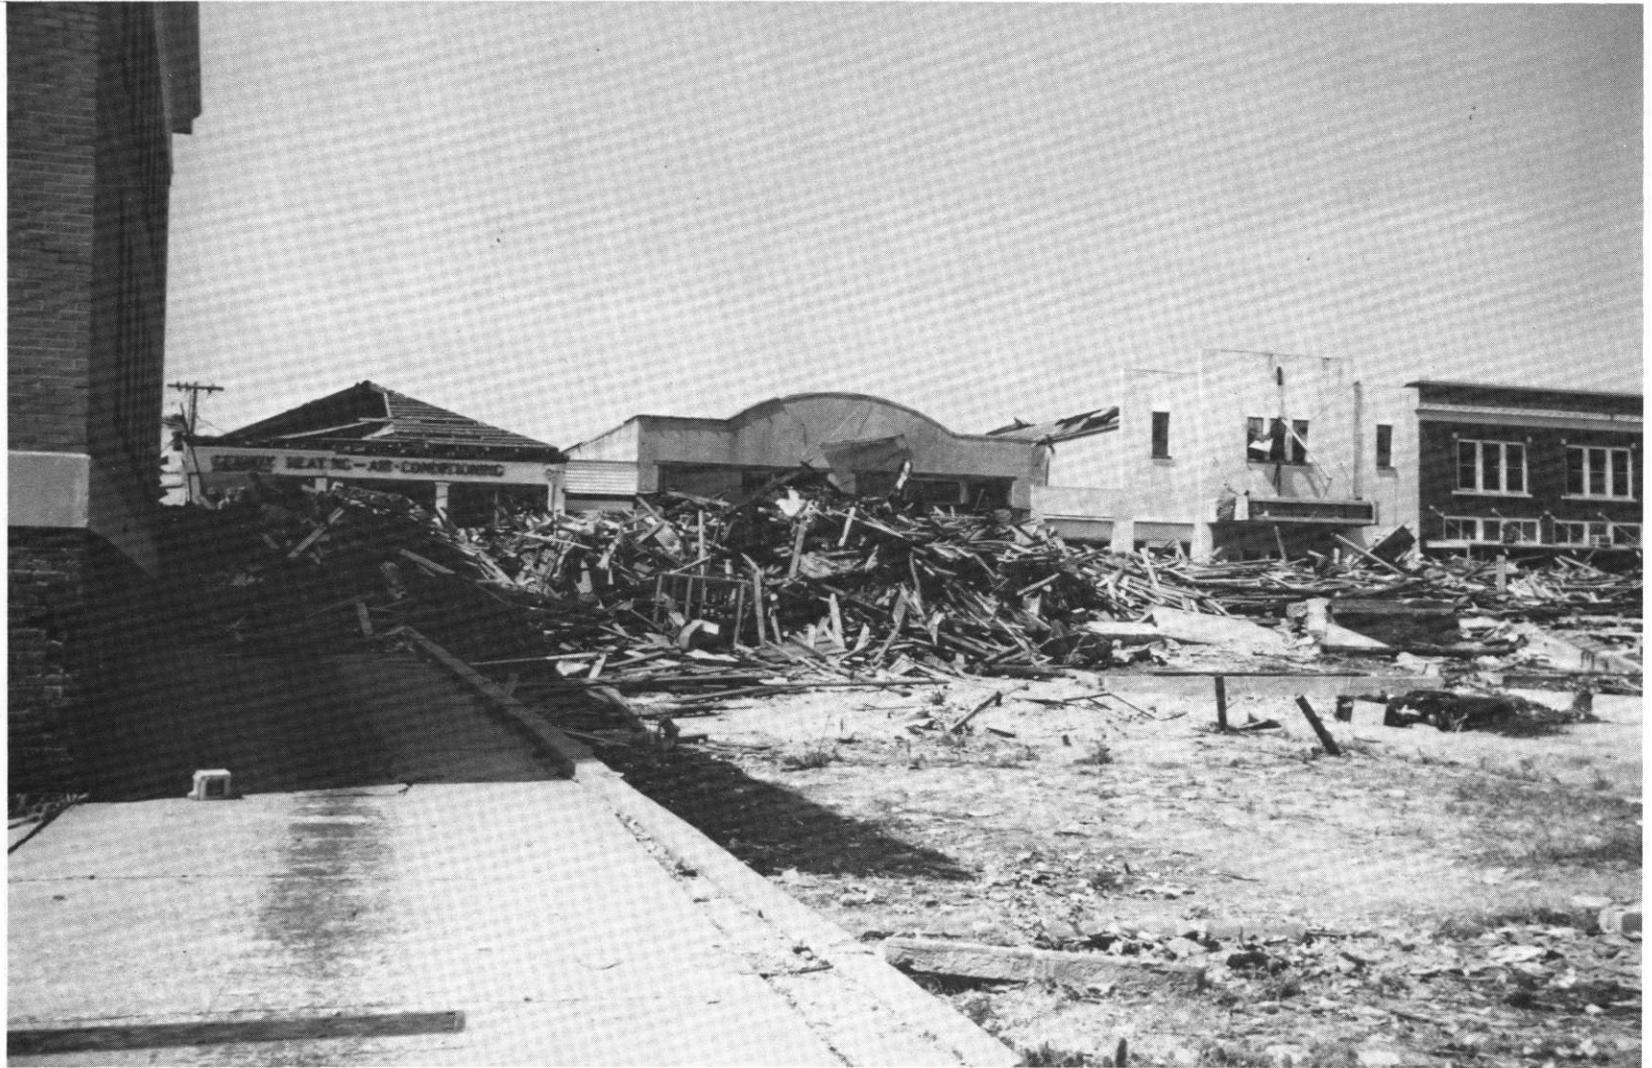
Figure 3.33 Businesses behind and east of Pass Christian City Hall.

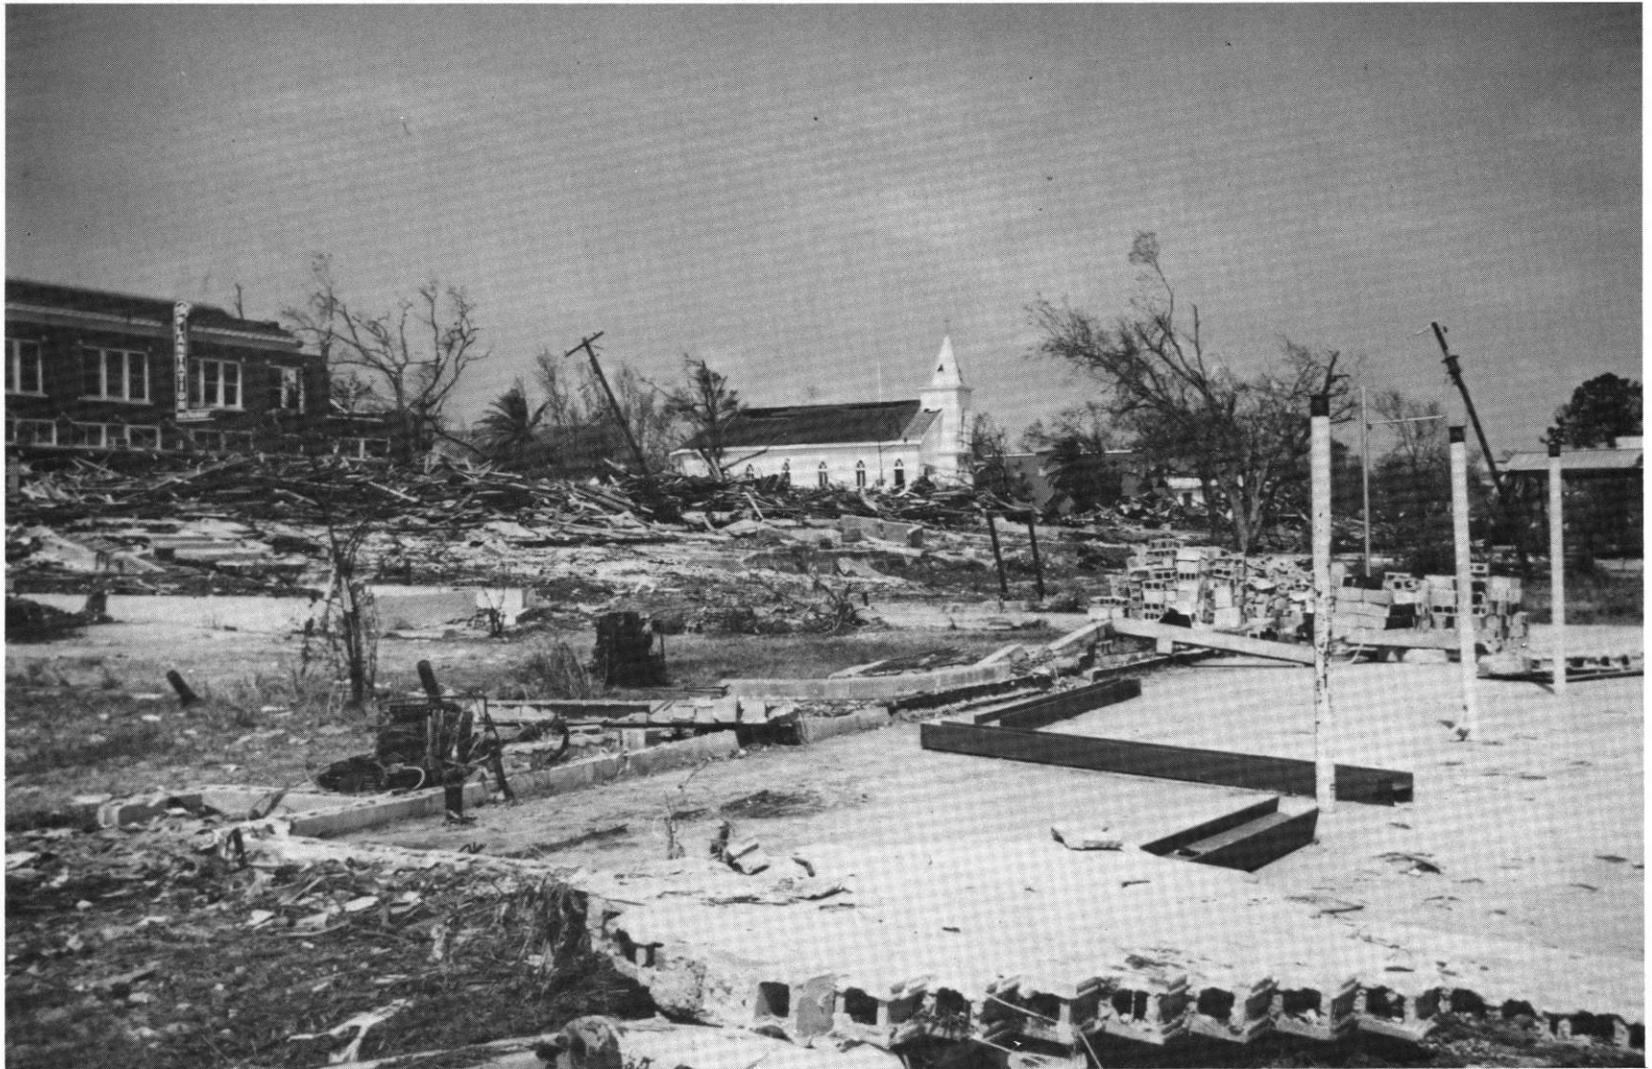
Figure 3.34 Area east of Pass Christian City Hall.

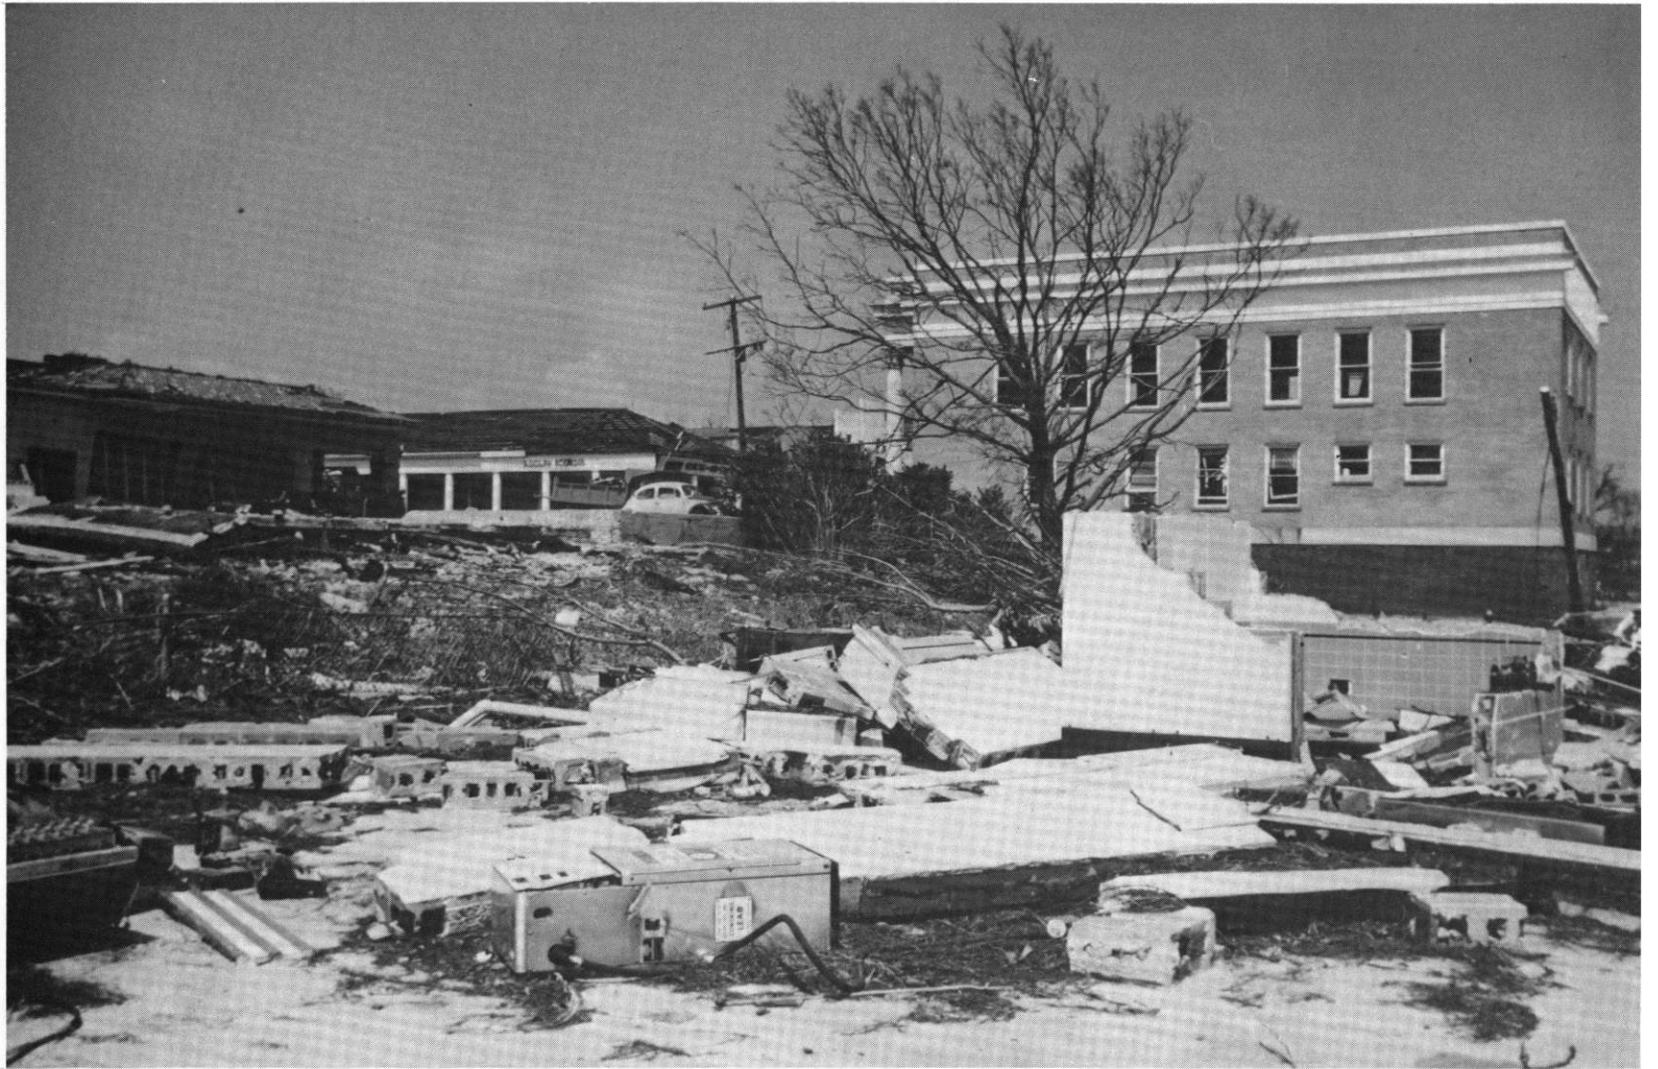
Figure 3.35 Area west of Pass Christian City Hall.

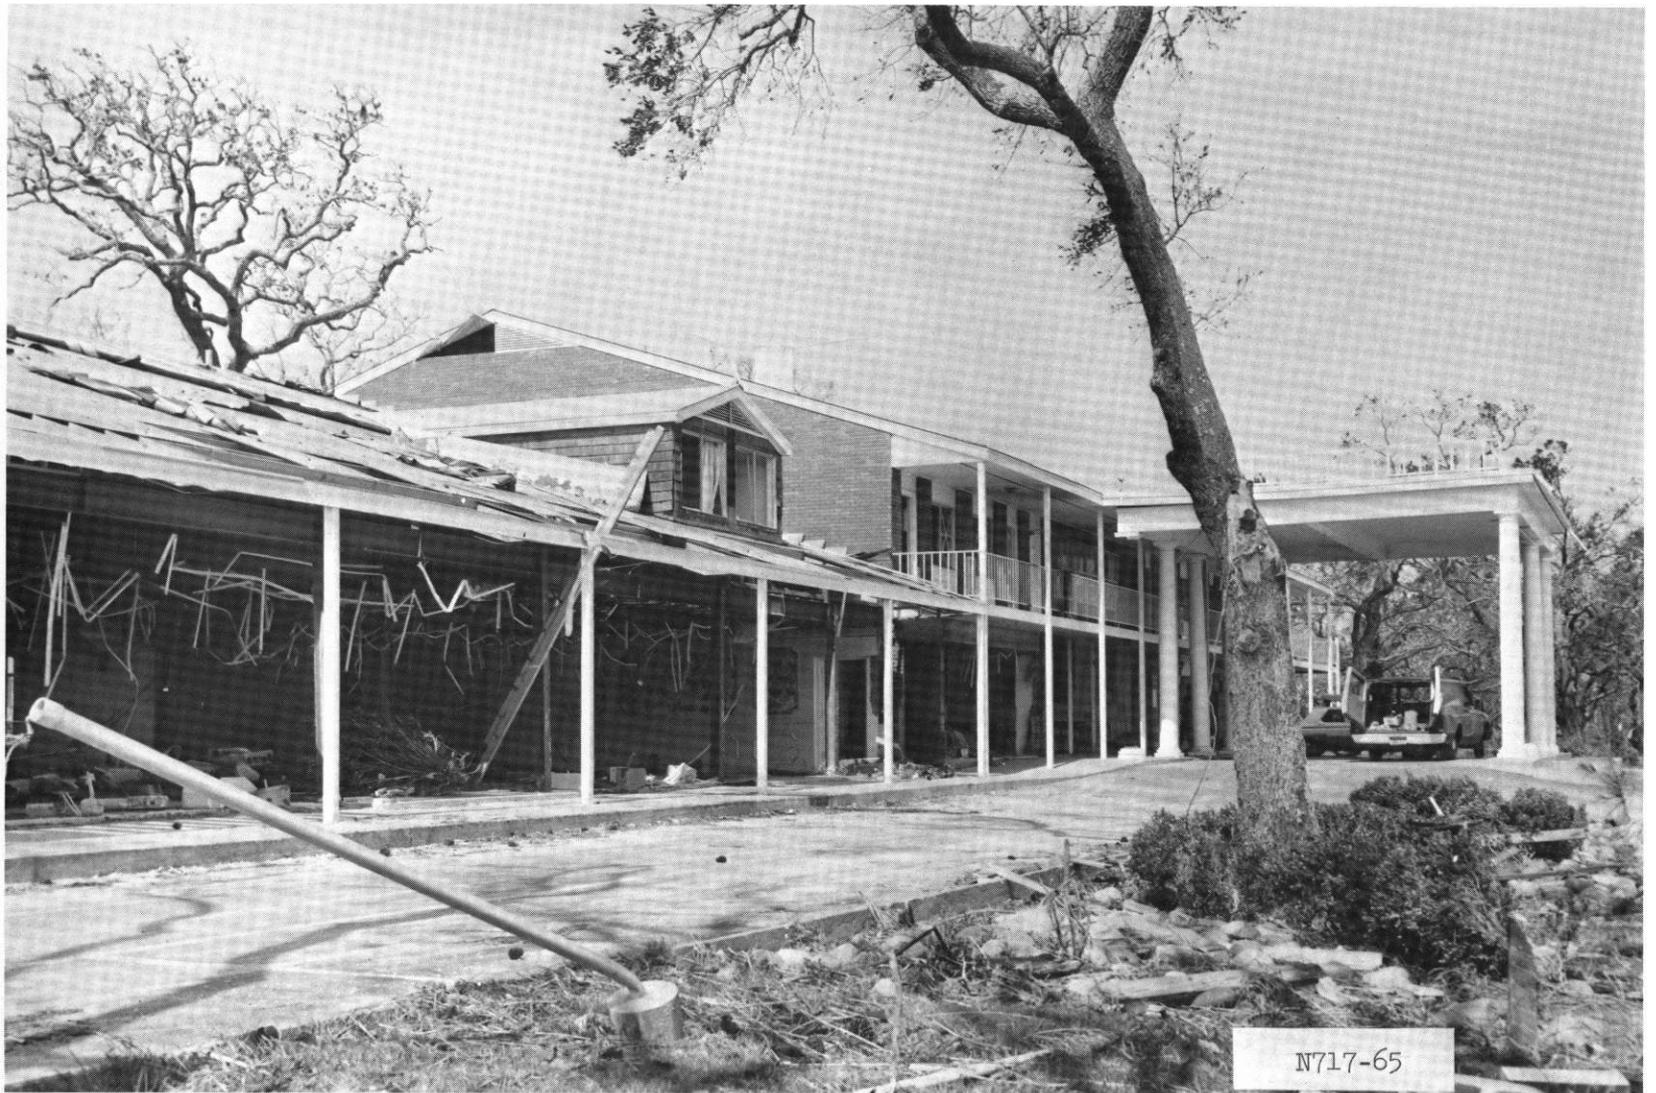
N717-65

Figure 3.38 Ramada Inn, Long Beach.

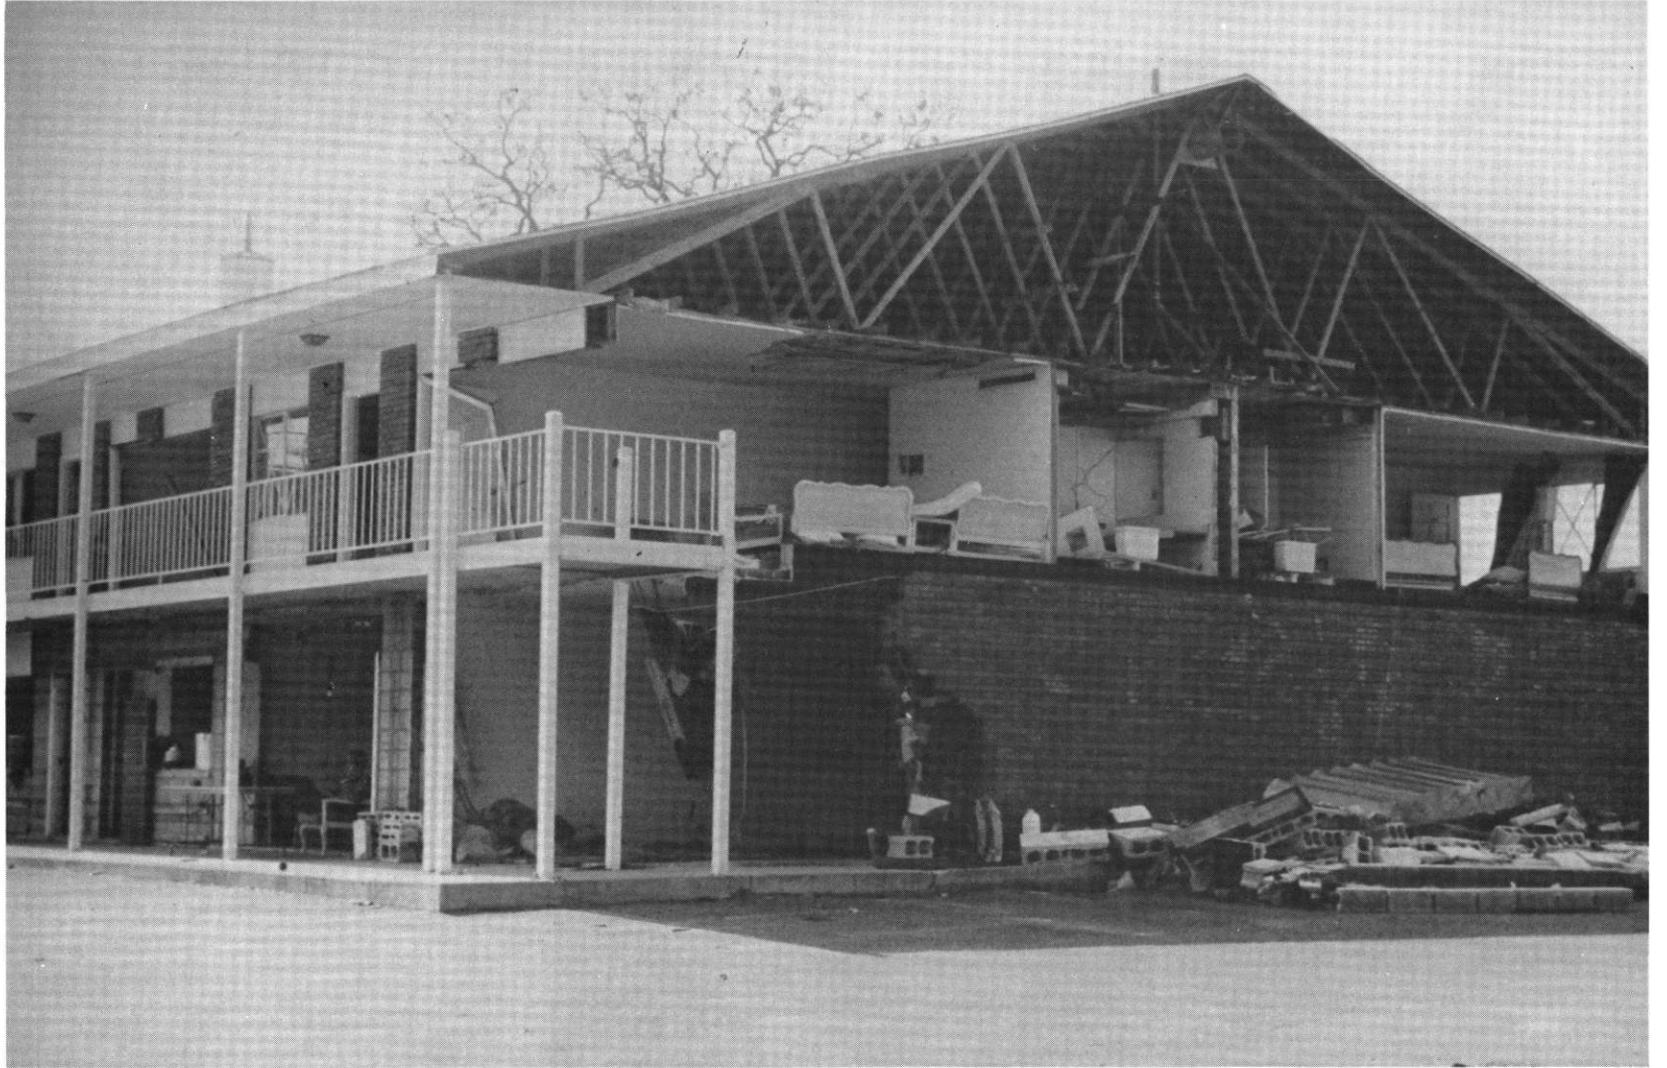
Figure 3.39 East wall of Ramada Inn main building.

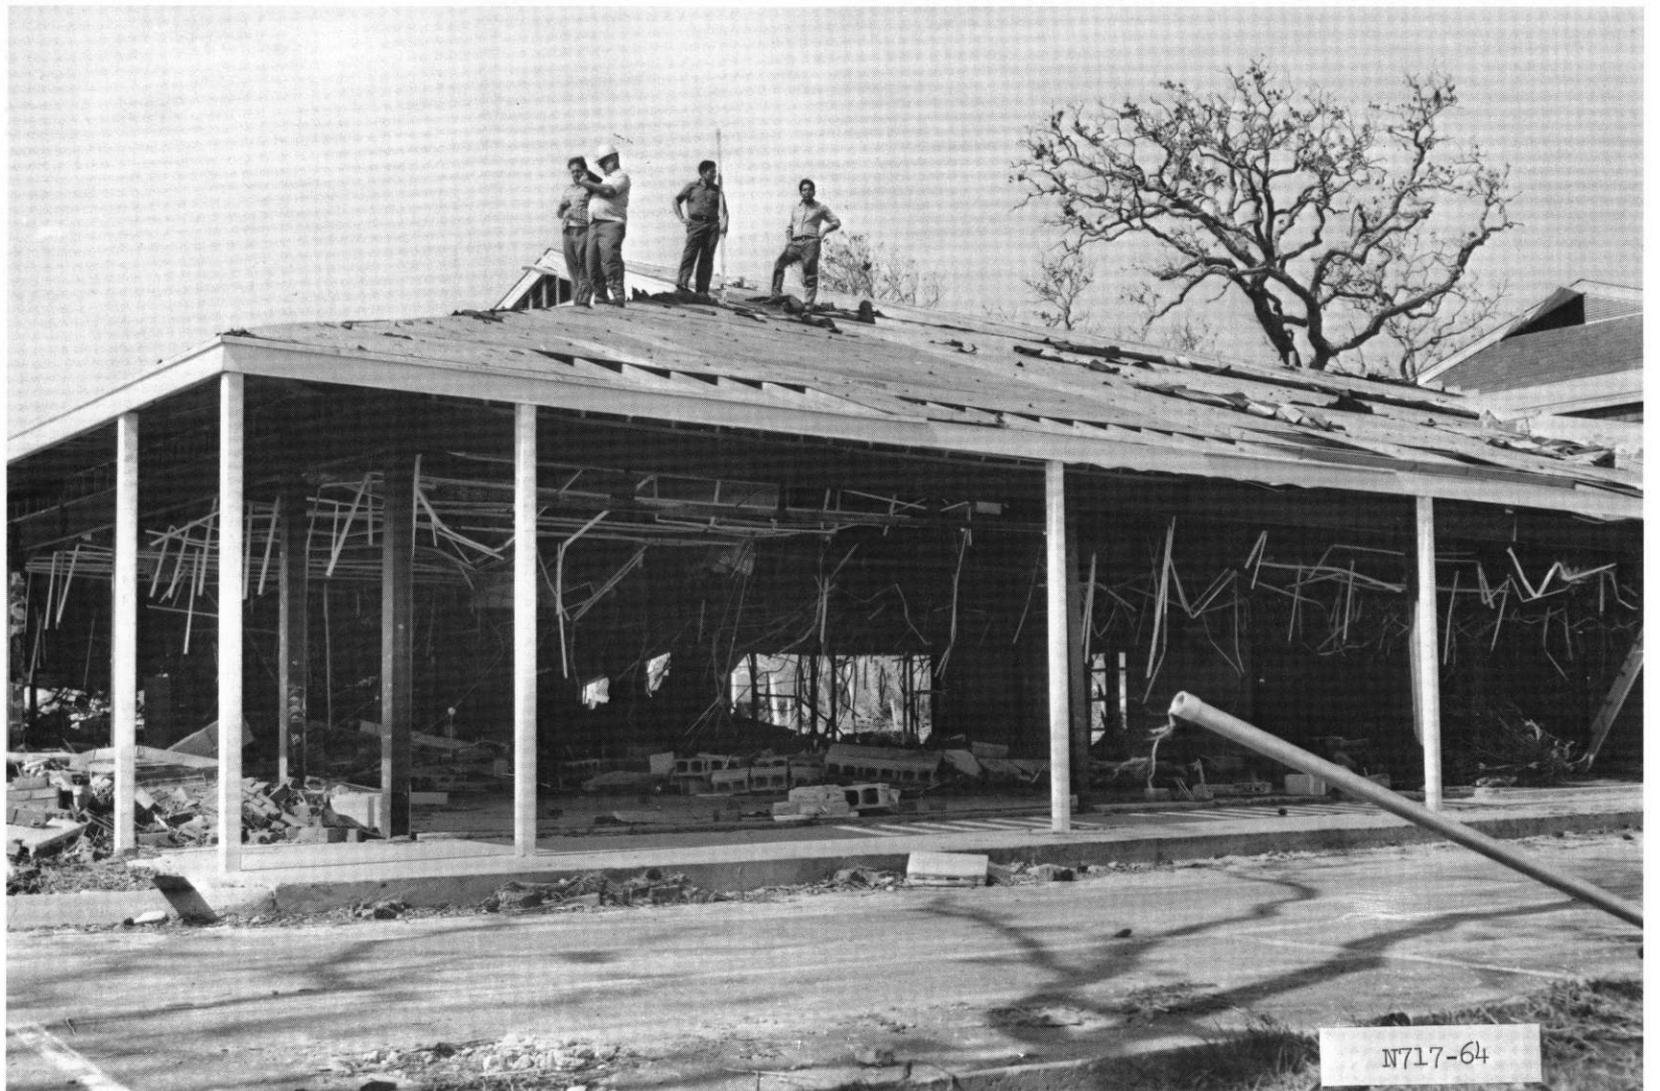
Figure 3.40 Ramada Inn dining area.

The main building (Figure 3.38) was parallel to the highway. There appeared to be two wings perpendicular to and behind the main building. The east wing was completely leveled and the west wing was relatively undamaged. The east wall of the main building was out (Figure 3.39), and the entire first floor suffered extensive water damage, especially in the dining area (Figure 3.40).

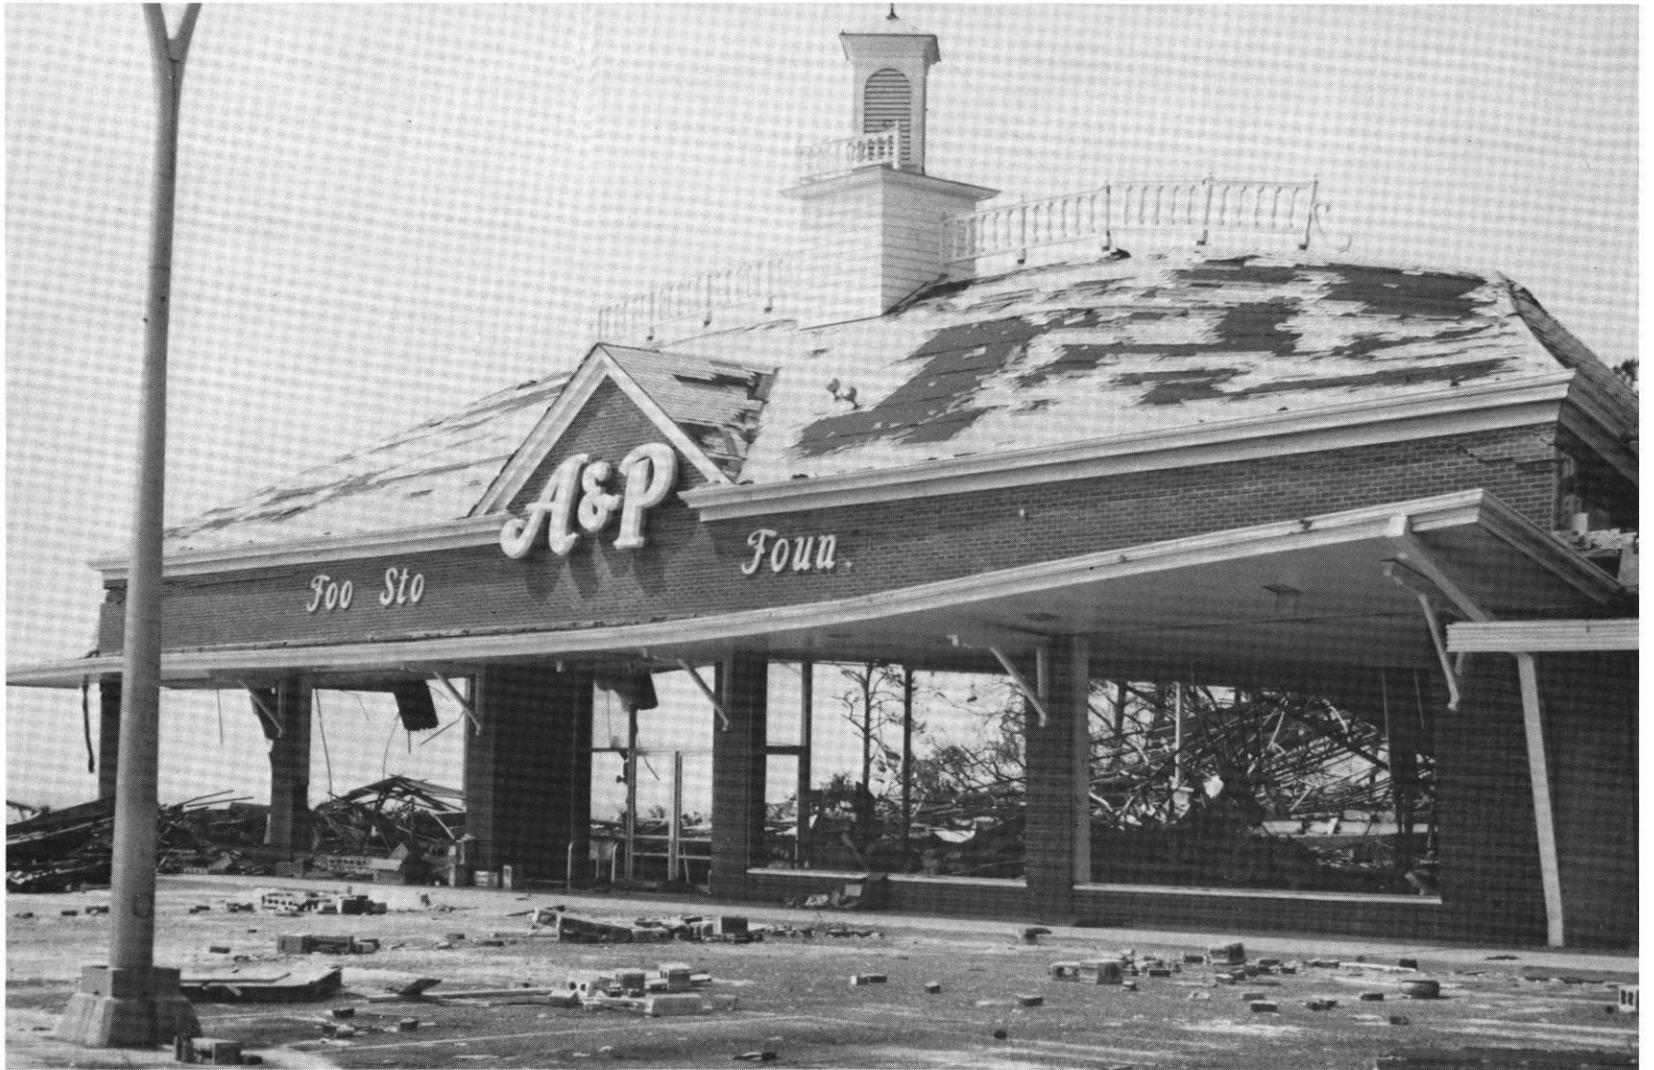
Figure 3.41 Front of A&P store, Long Beach.

This complex, located several blocks east of the Ramada Inn in Long Beach, was constructed mainly of block walls, steel pipe columns and main beams, and with small angle trusses or bar joists supporting the roof. The front of the A&P store is shown in Figure 3.41.

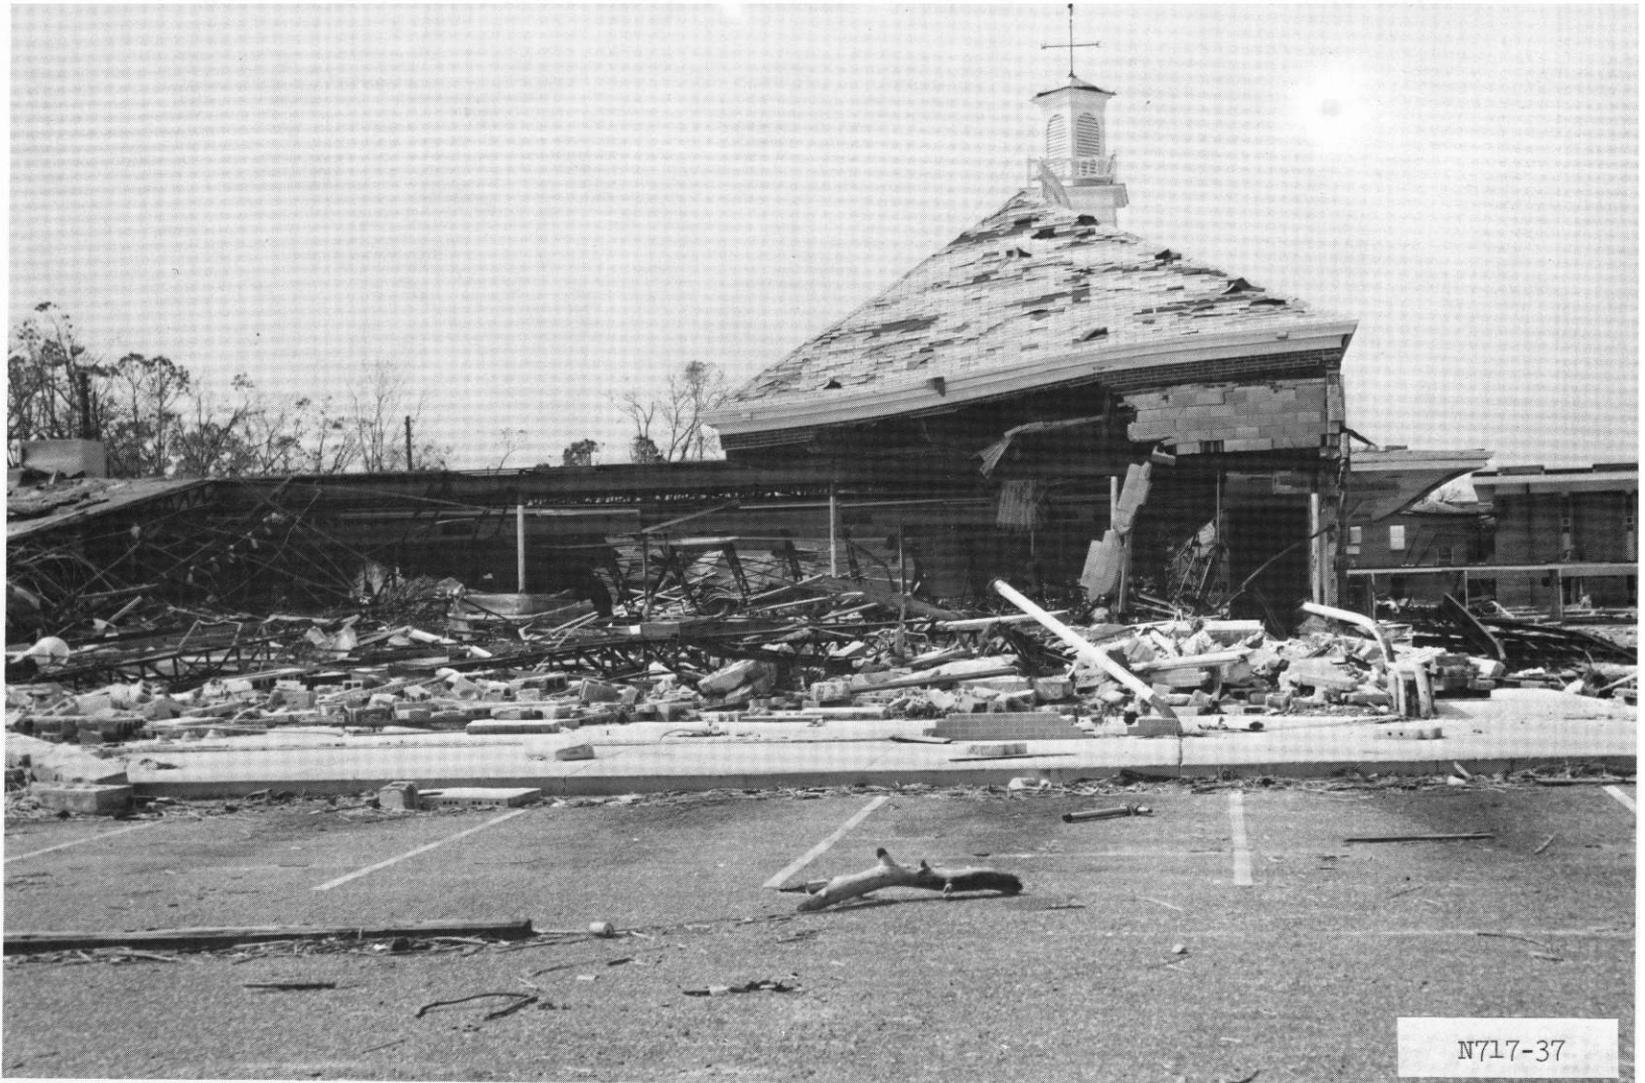
A Walgreen's store located on the seaward side of the A&P collapsed completely with much debris ending up in or behind the A&P (Figure 3.42). The angle trusses appeared to have been set into the block and brick exterior walls and fell with the wall. Small bulb angles placed atop the trusses and supporting the roofing panels spaced the trusses laterally.

Figure 3.42 Side view of A&P with remains of Walgreen's in foreground, Long Beach.
