TECHNICAL REPORT N-70-10

SURVEY OF GULF COAST STRUCTURAL DAMAGE RESULTING FROM HURRICANE CAMILLE, AUGUST 1969

April 1970

By U. S. Army Engineer Waterways Experiment Station, Vicksburg, Mississippi

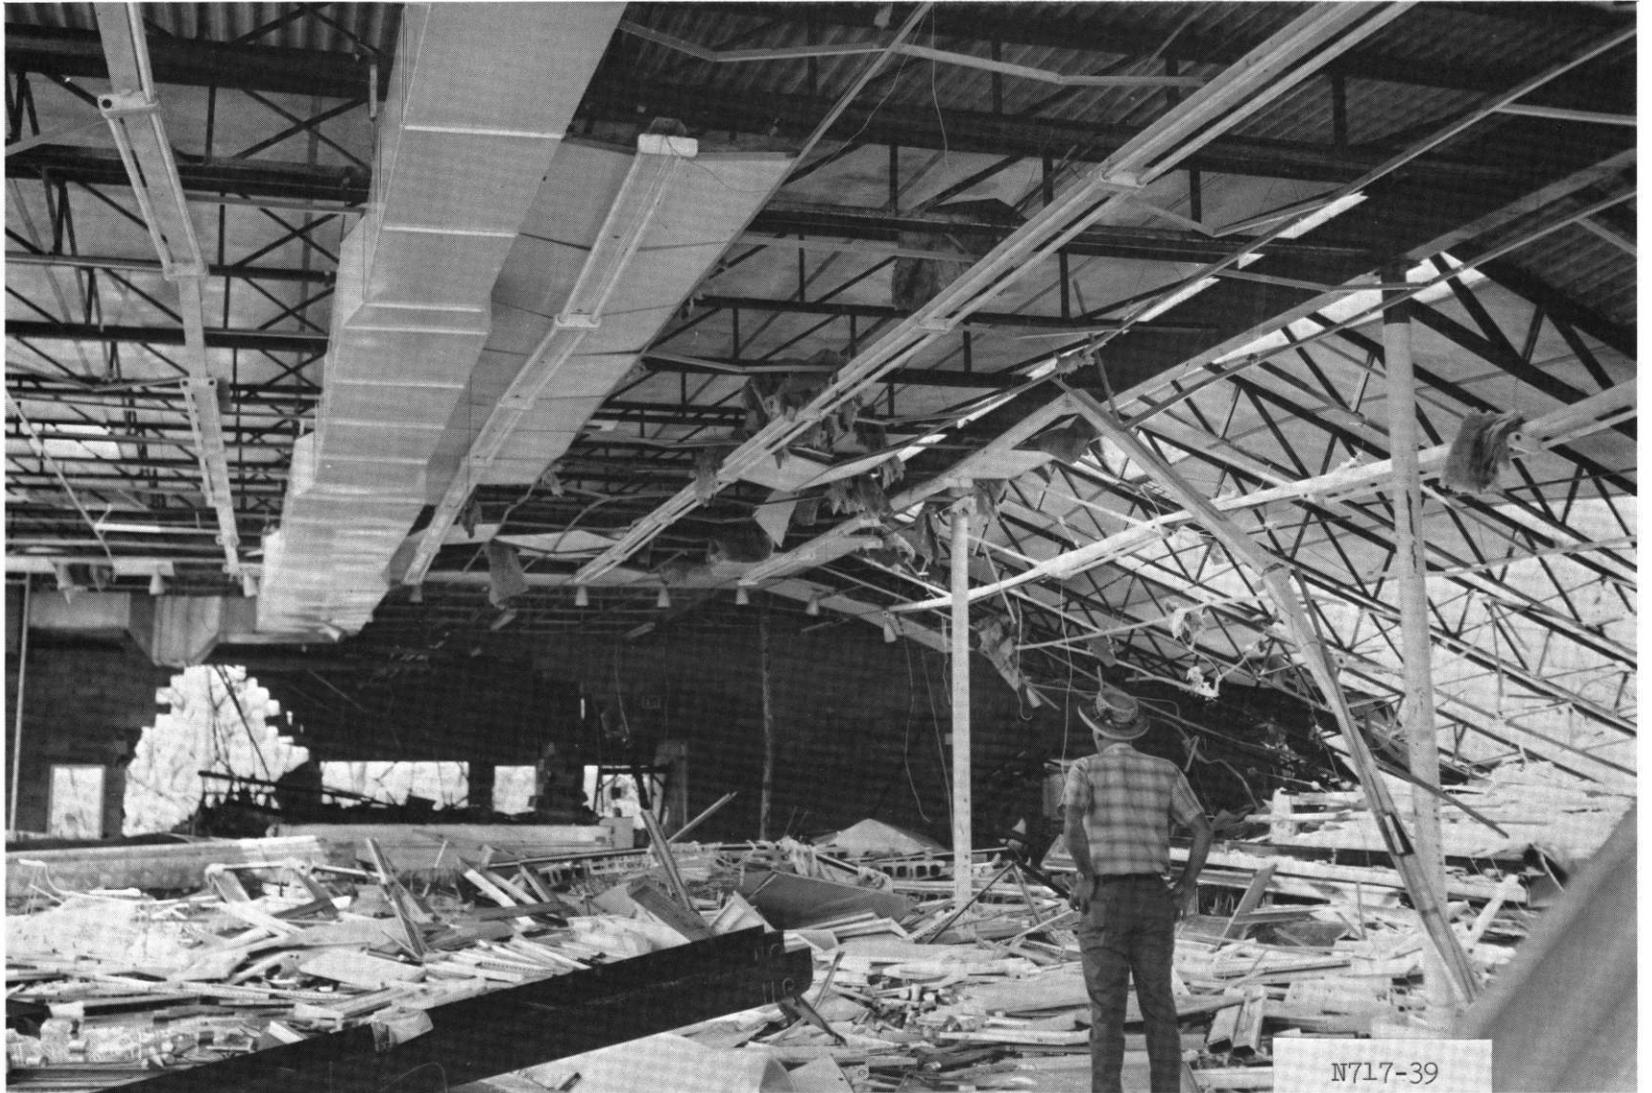
The two side bays of the A&P store collapsed, probably when the walls between this building and the adjoining stores were destroyed. One corner of the wooden truss hip roof at the front of the A&P was left cantilevered over the debris (Figure 3.43). The center bay, supported on steel beams at both ends, did not suffer extensive structural damage (Figure 3.44). The presence of lamps in the fixtures shows that the water did not reach the ceiling level.

Figure 3.44 Central bay of A&P, Long Beach.

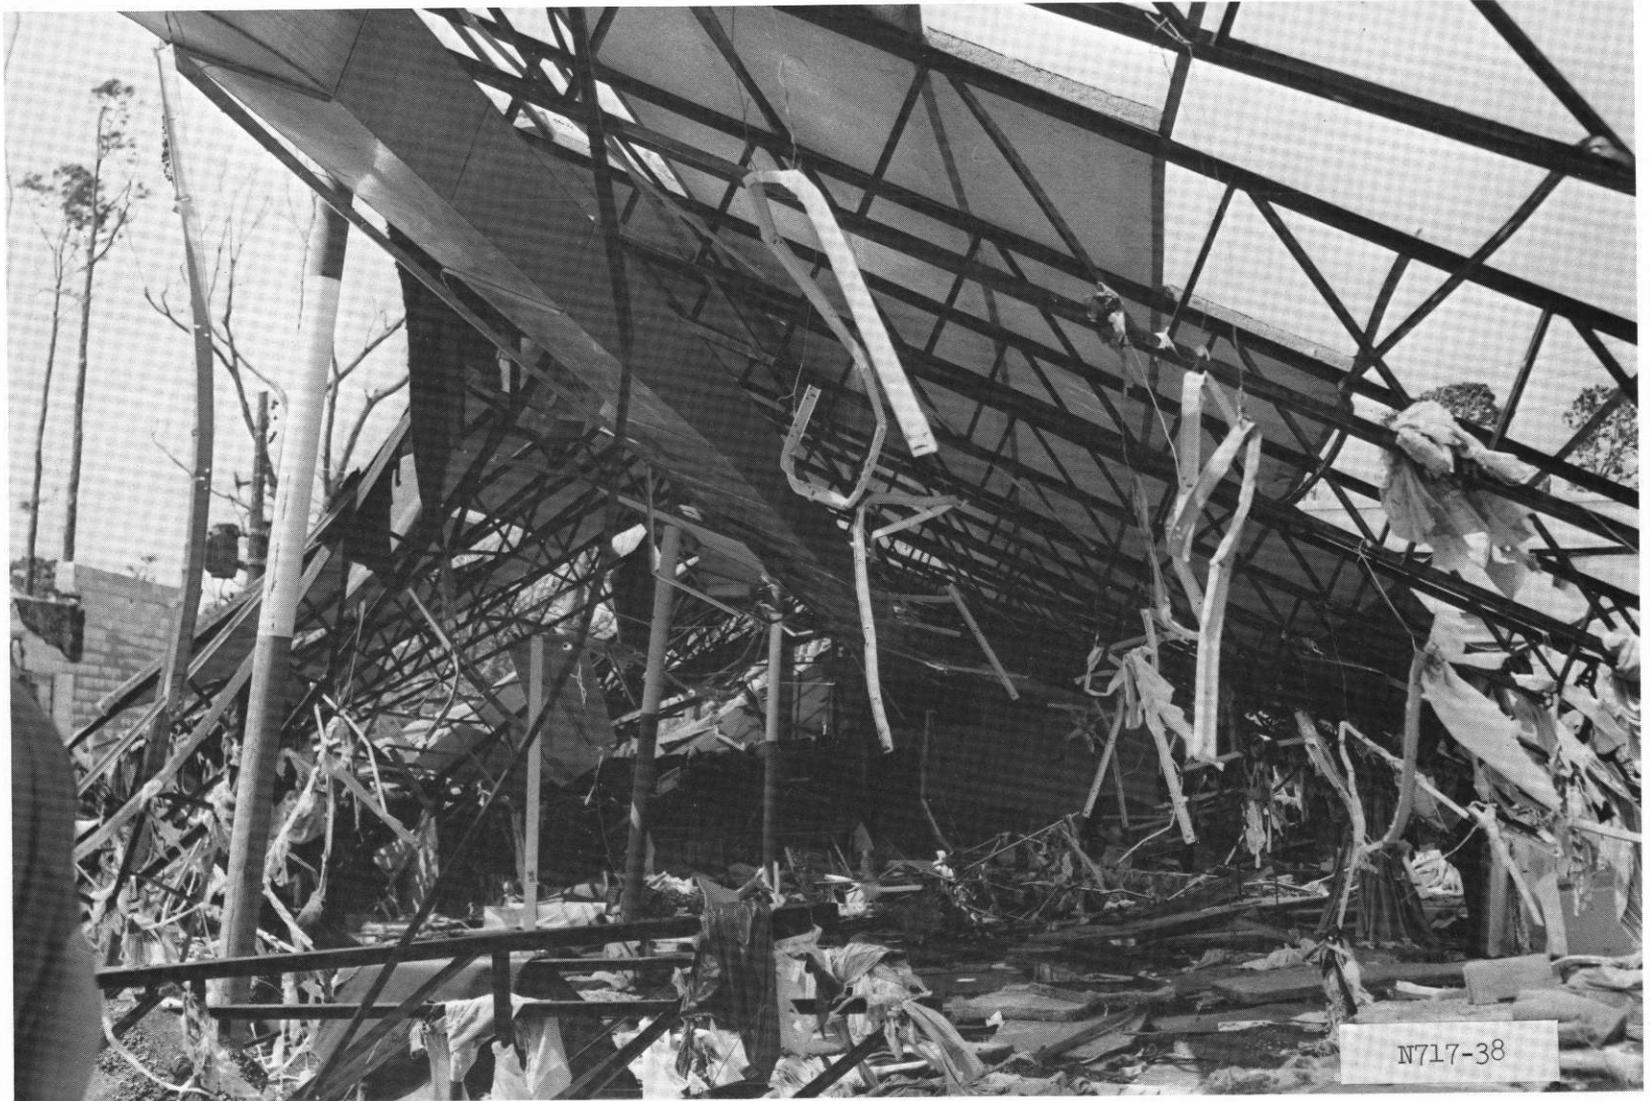
The center row of beams and columns of the Morgan and Lindsey variety store directly north of the A&P survived with most of the roof trusses remaining connected to the beams (Figure 3.45). The other ends sat on masonry walls which collapsed.

Figure 3.45 Morgan & Lindsey store, Long Beach.

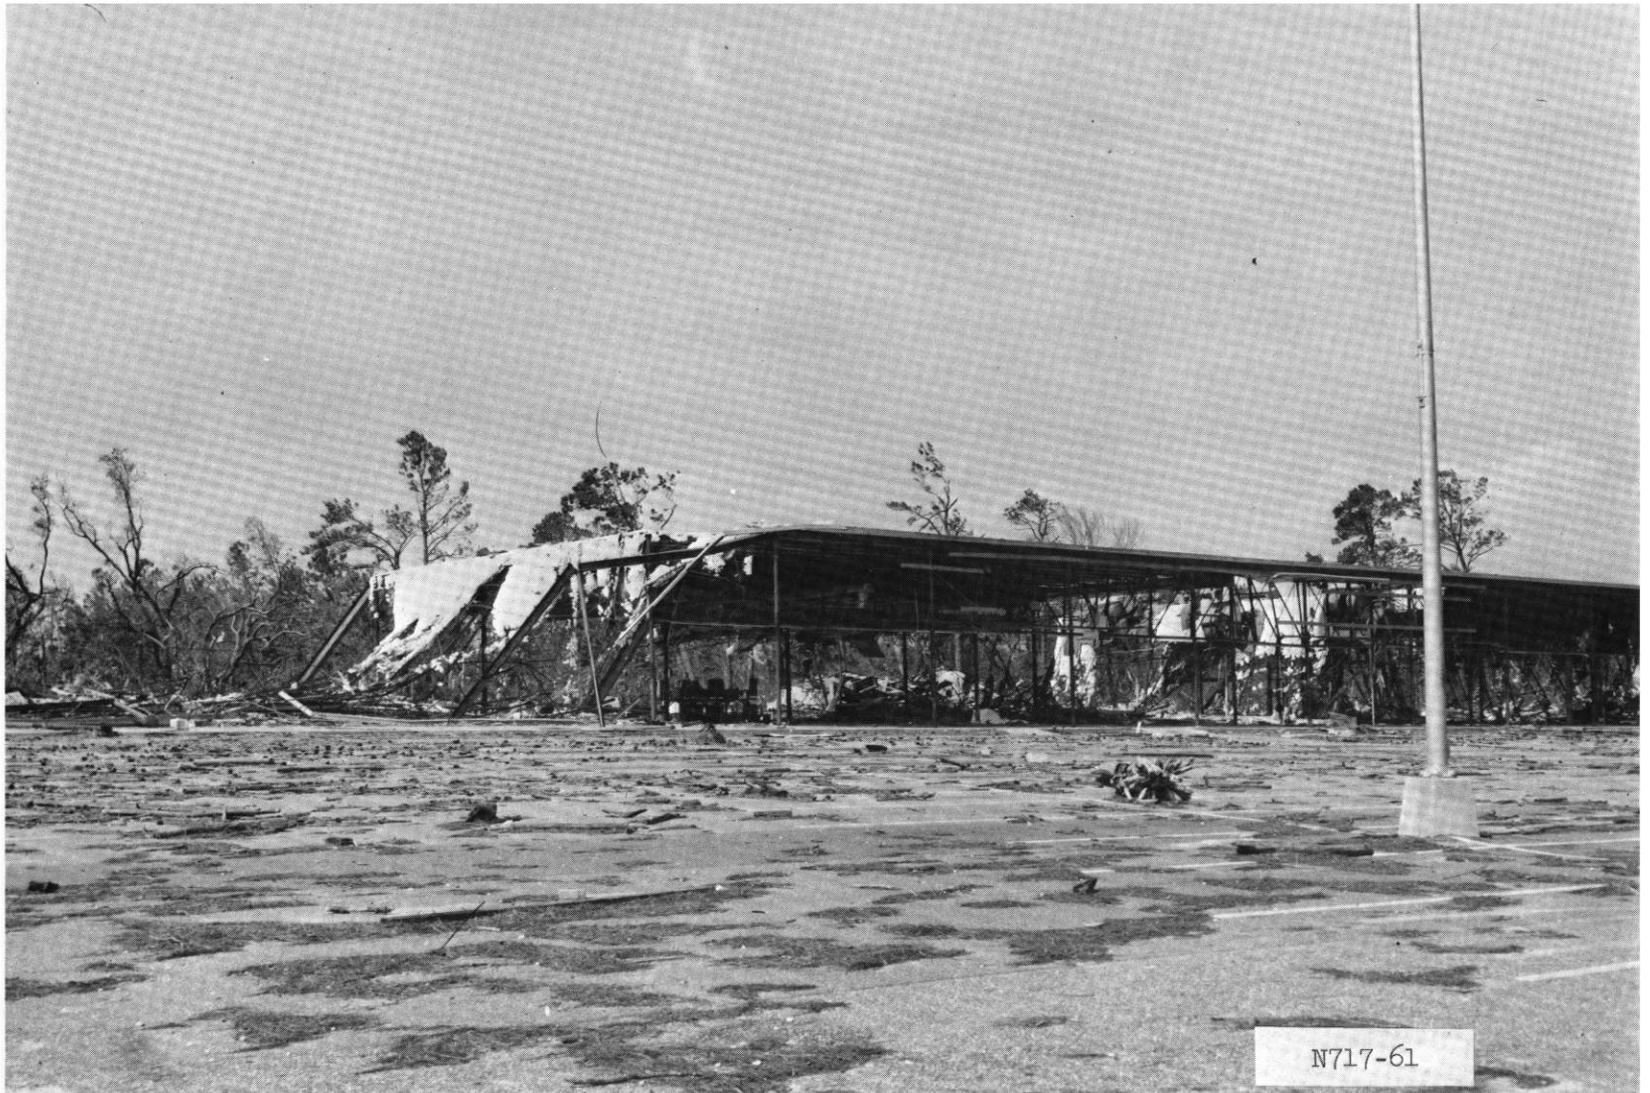
Figure 3.46 Gulf Plaza shopping center.

Several stores, including a large discount-type store, were located in Gulf Plaza near the Long Beach-Pass Christian boundary and contained in a large pipe column, beam, and bar joist structure with glass and block walls. As can be seen in Figures 3.46 and 3.47, the exterior walls and store contents were completely washed away, leaving only portions of the building frame. It appeared that only a minimum amount of welding had been used to attach the bar joists to the supporting beams.

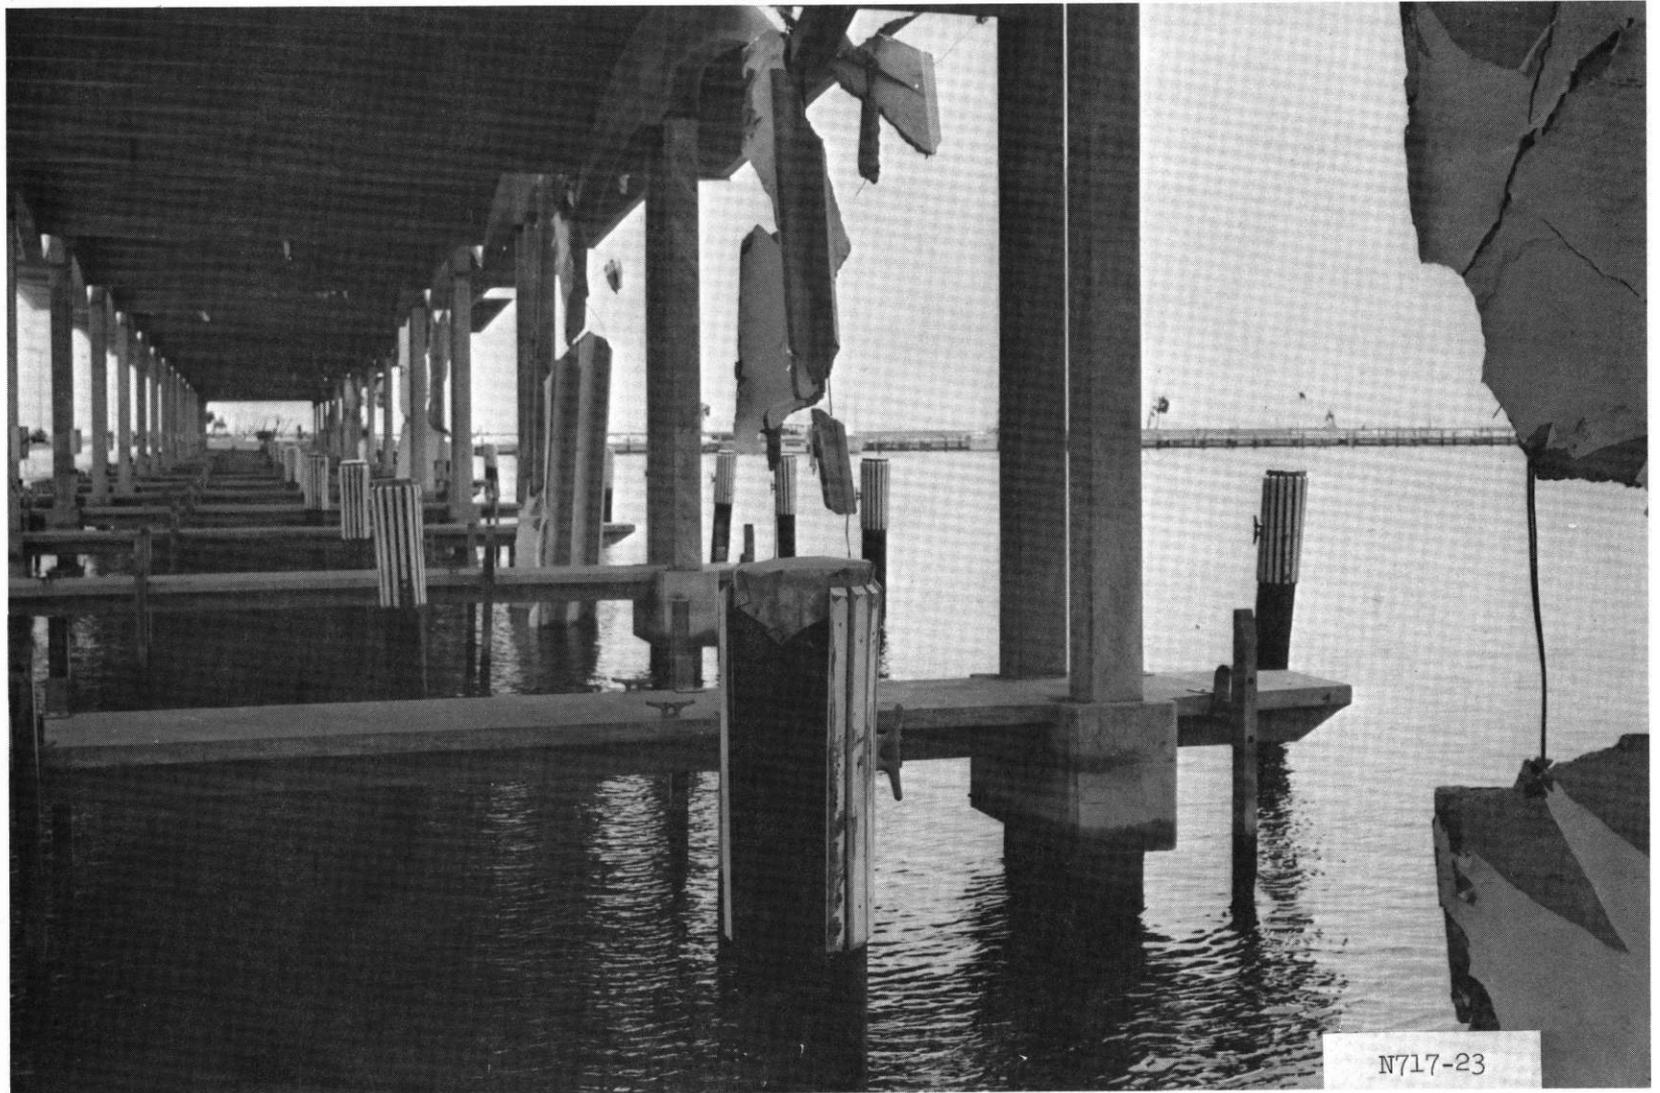
Figure 3.48 Broadwater Beach marina.

Some of the double T sections were damaged when the arches rocked back and forth (Figure 3.48) with differential motion occurring at the valley where two arches met.

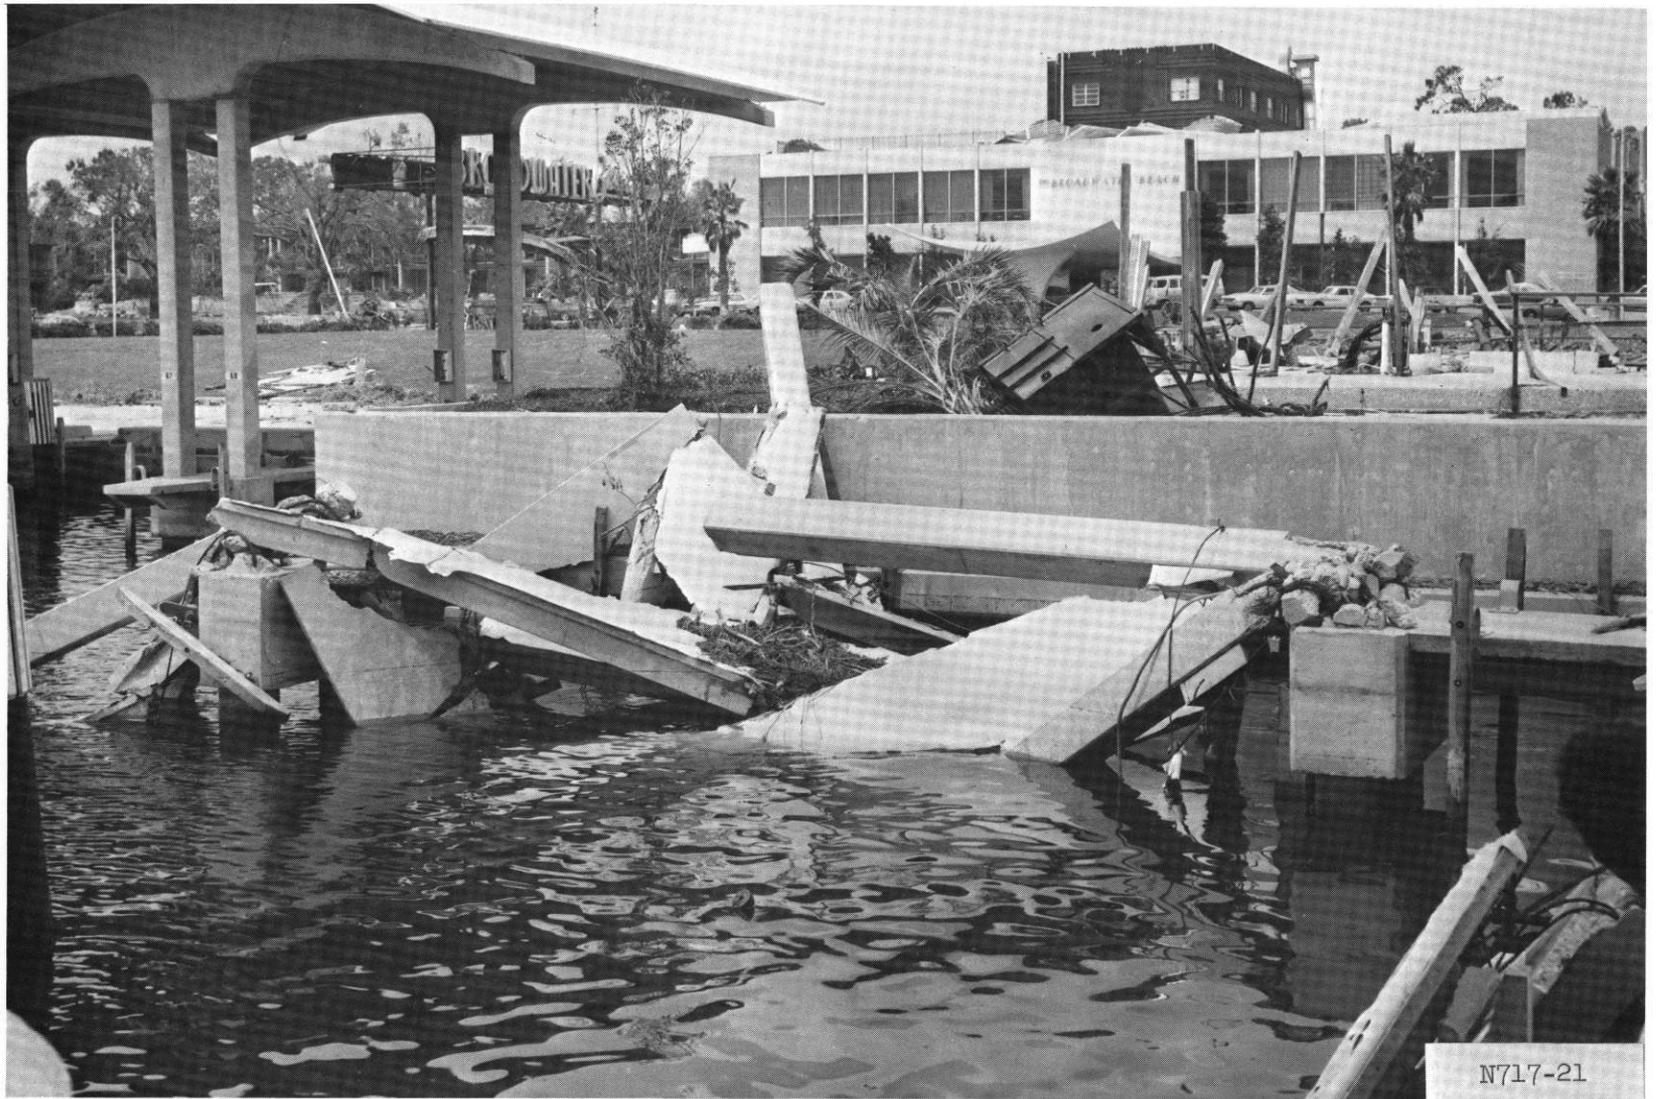
The two north corners of the marina were destroyed (Figures 3.49 and 3.50), very possibly by boats coming through these parts of the marina.

Figure 3.49 Northeast corner of Broadwater Beach marina, looking north.

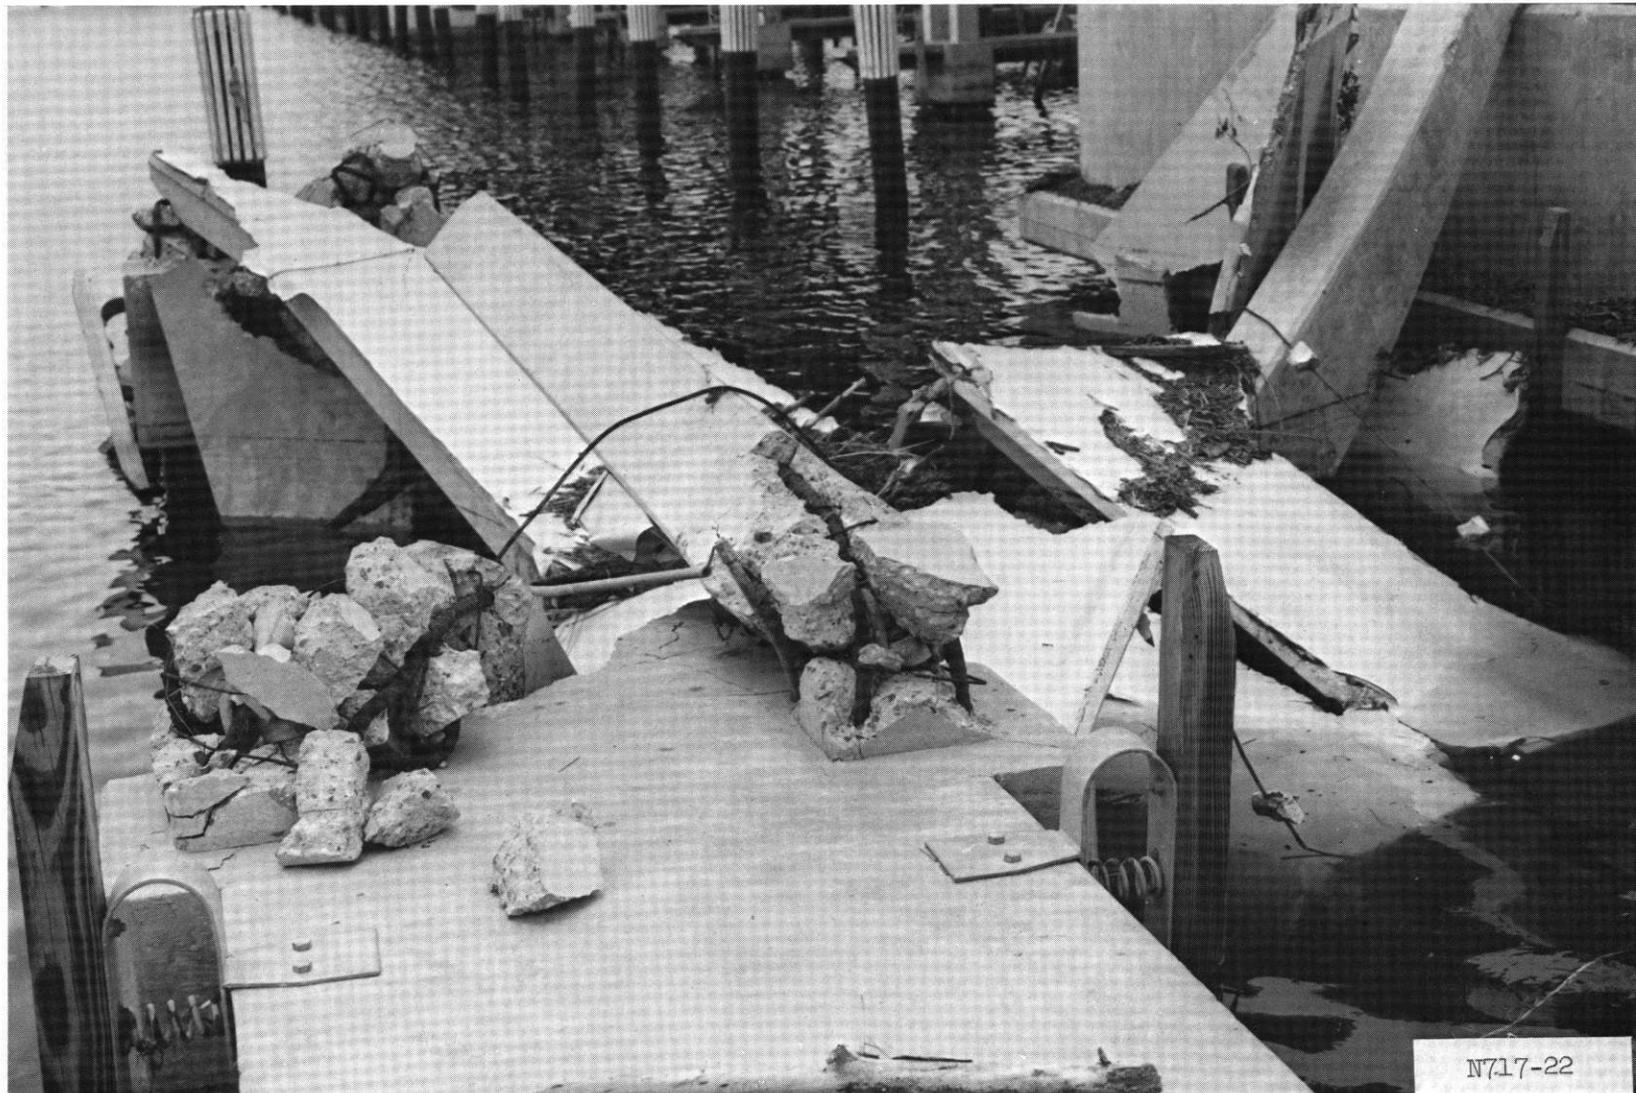
Figure 3.50 Northeast corner of Broadwater Beach marina, looking west.

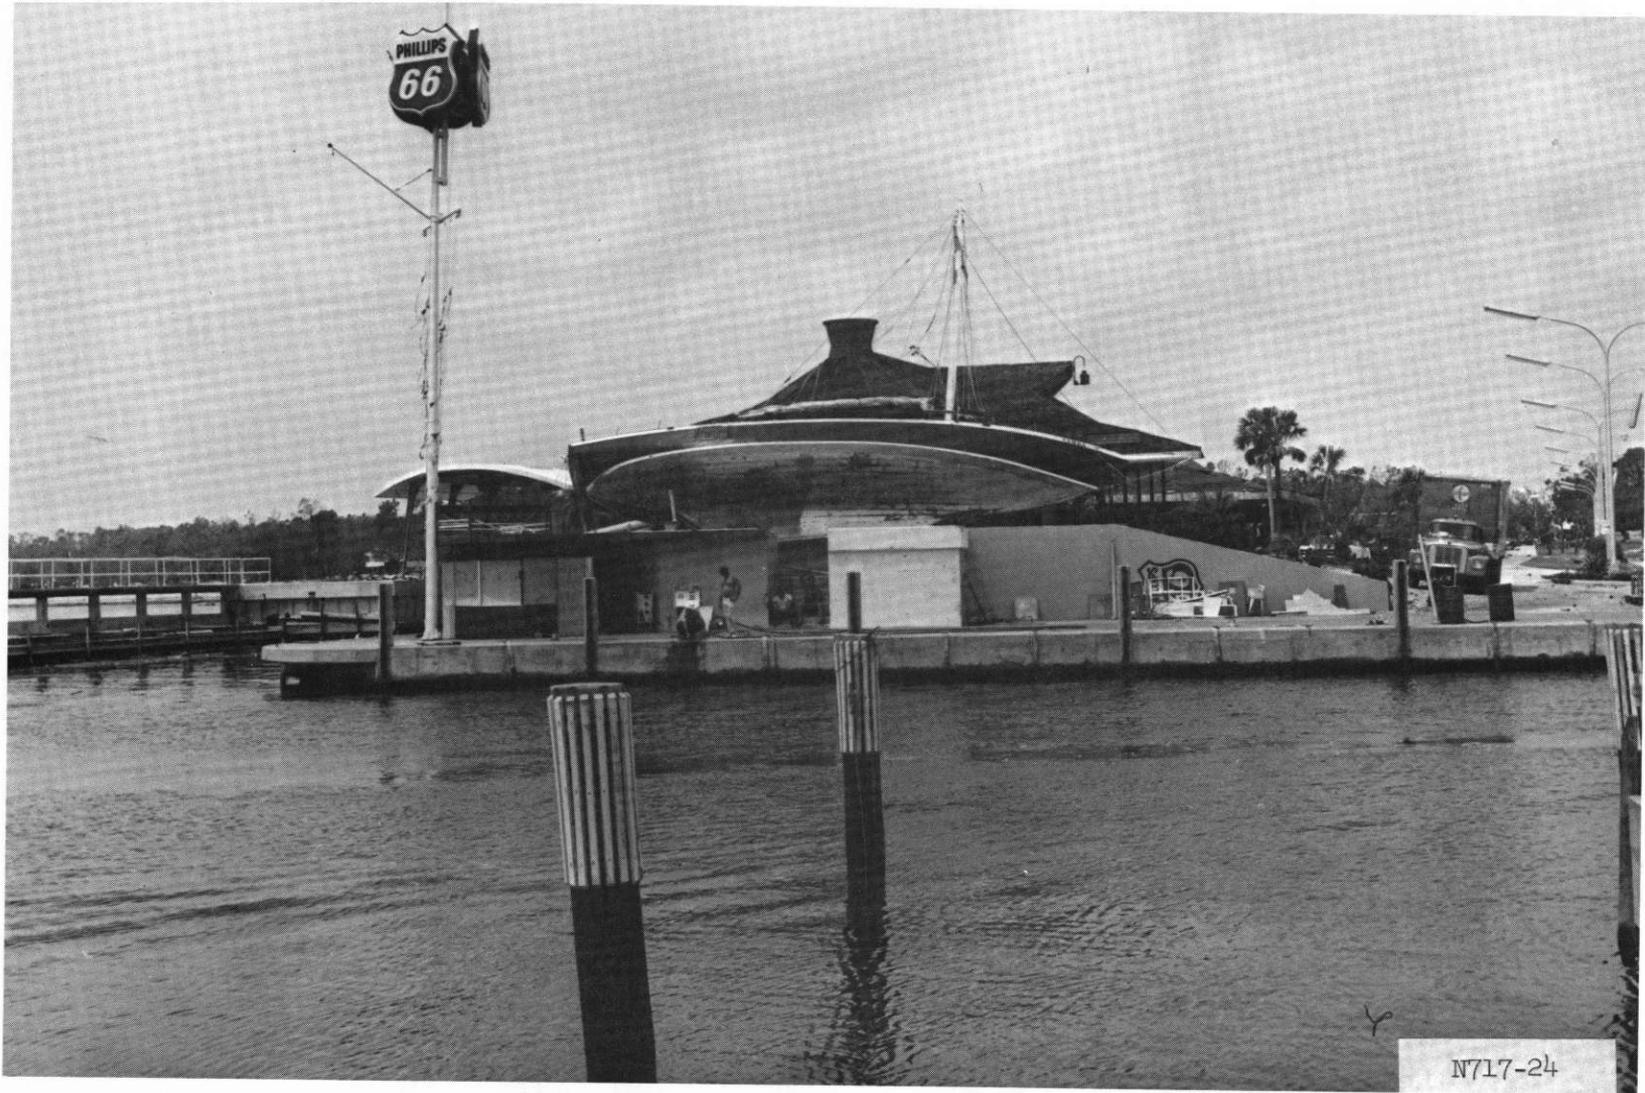
office area (Figure 3.51) indicates a lower bound on the water height in this area.

Figure 3.51 Sailboat on Edgewater Beach marina office area.

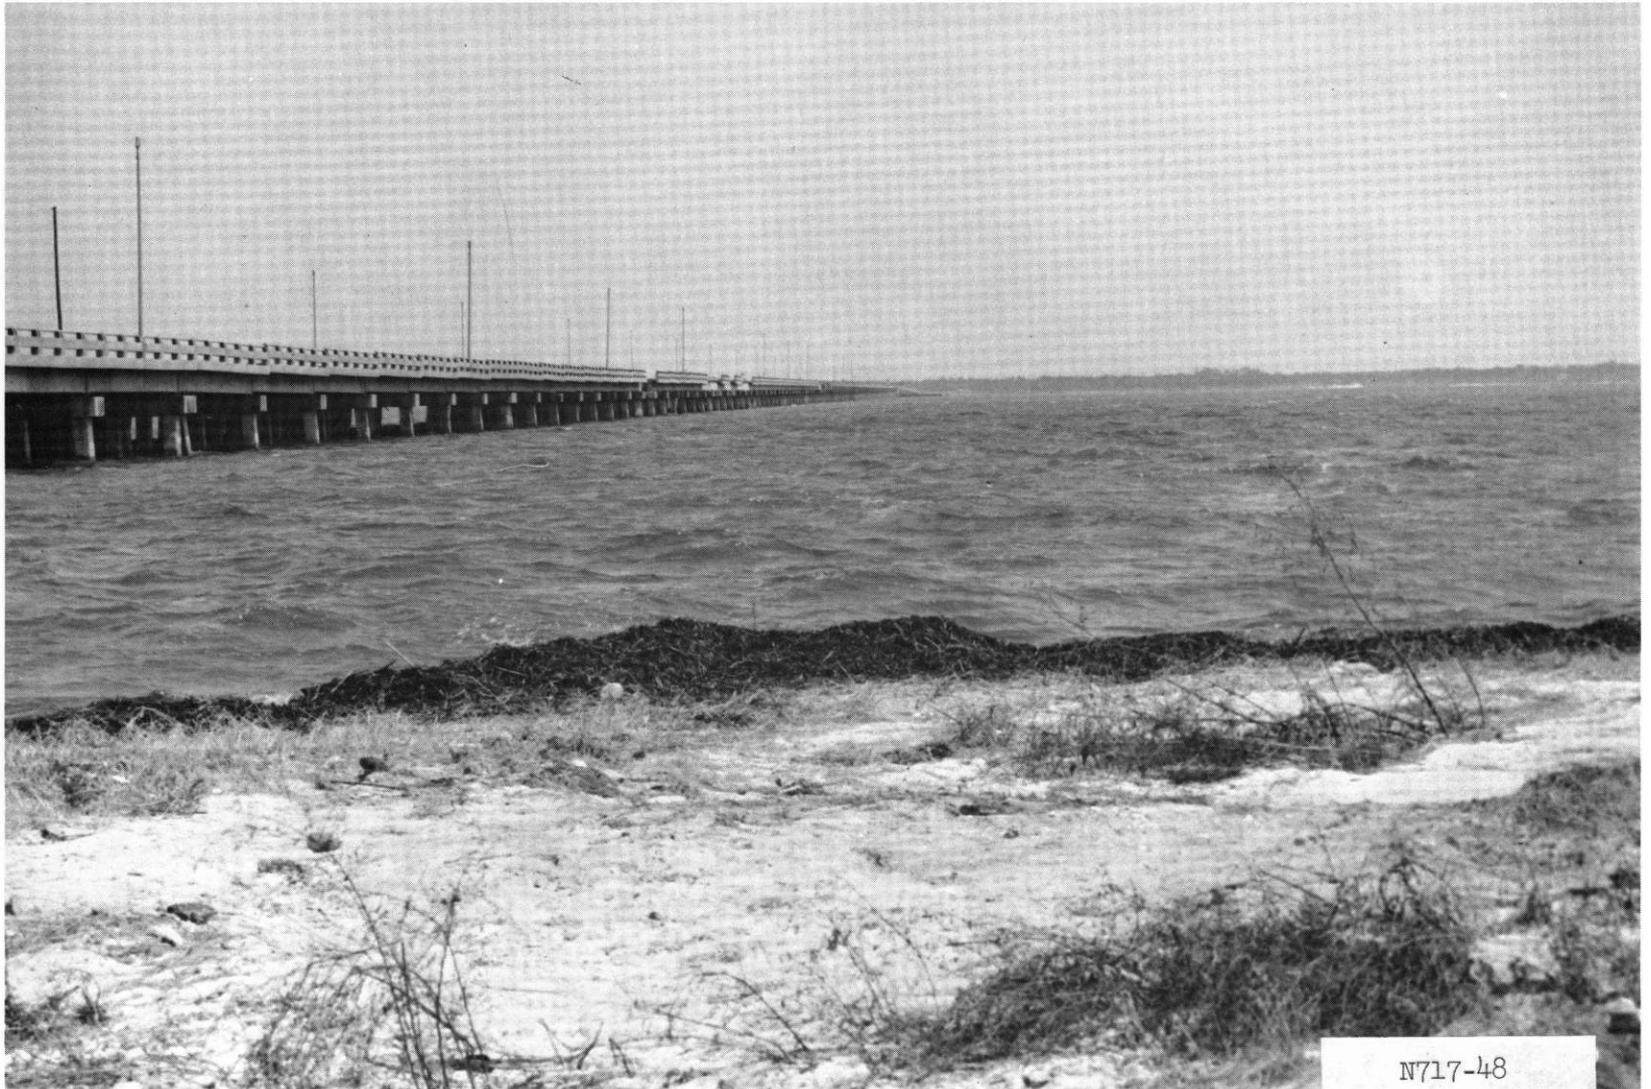
Figure 3.52 Bay Saint Louis Bridge, looking east.

The water appeared to have lifted the seaward deck slabs up enough for the rocker bearings on the east end of each span to fall out, resulting in a sawtooth appearance along the south side of the bridge (Figures 3.52 and 3.53). Some of the railing sections were tilted inland, and all but one lamp was torn from its pole. One span was moved about 4 feet laterally (Figure 3.54). Considerable concrete was spalled along the bridge centerline where the two deck slabs joined. The west abutment was heavily damaged by wave action (Figure 3.55).

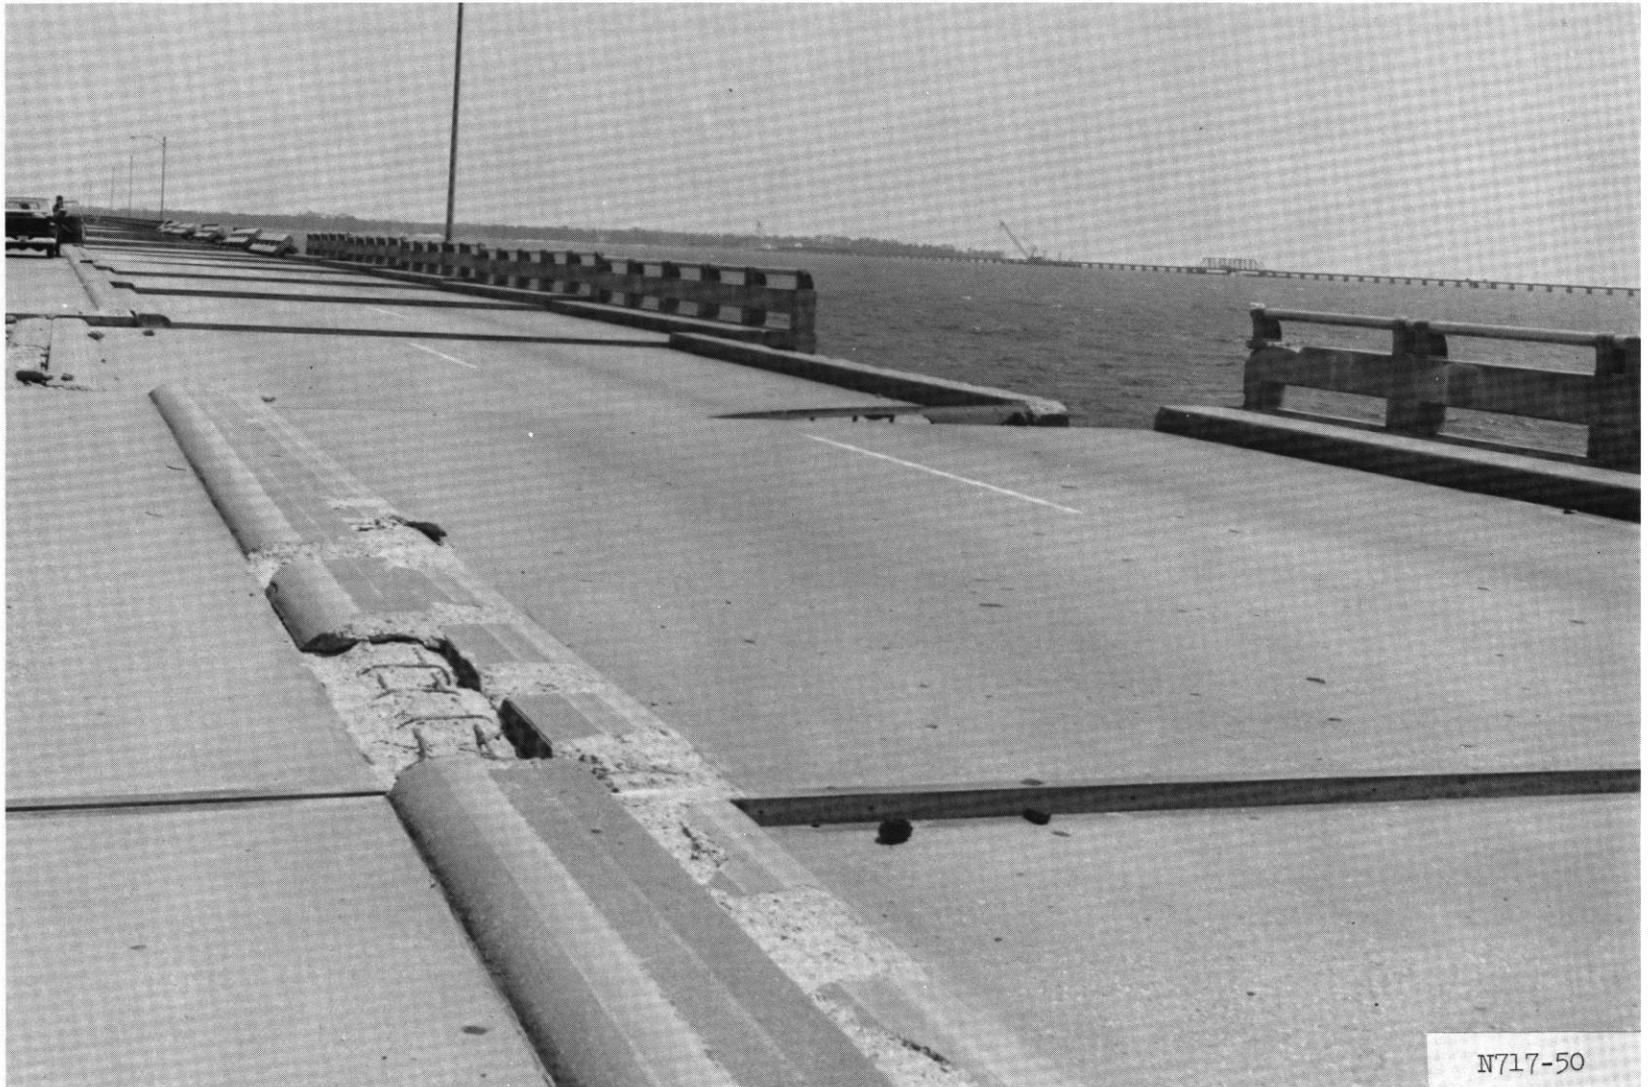
Figure 3.54 Displaced span of Bay Saint Louis Bridge.

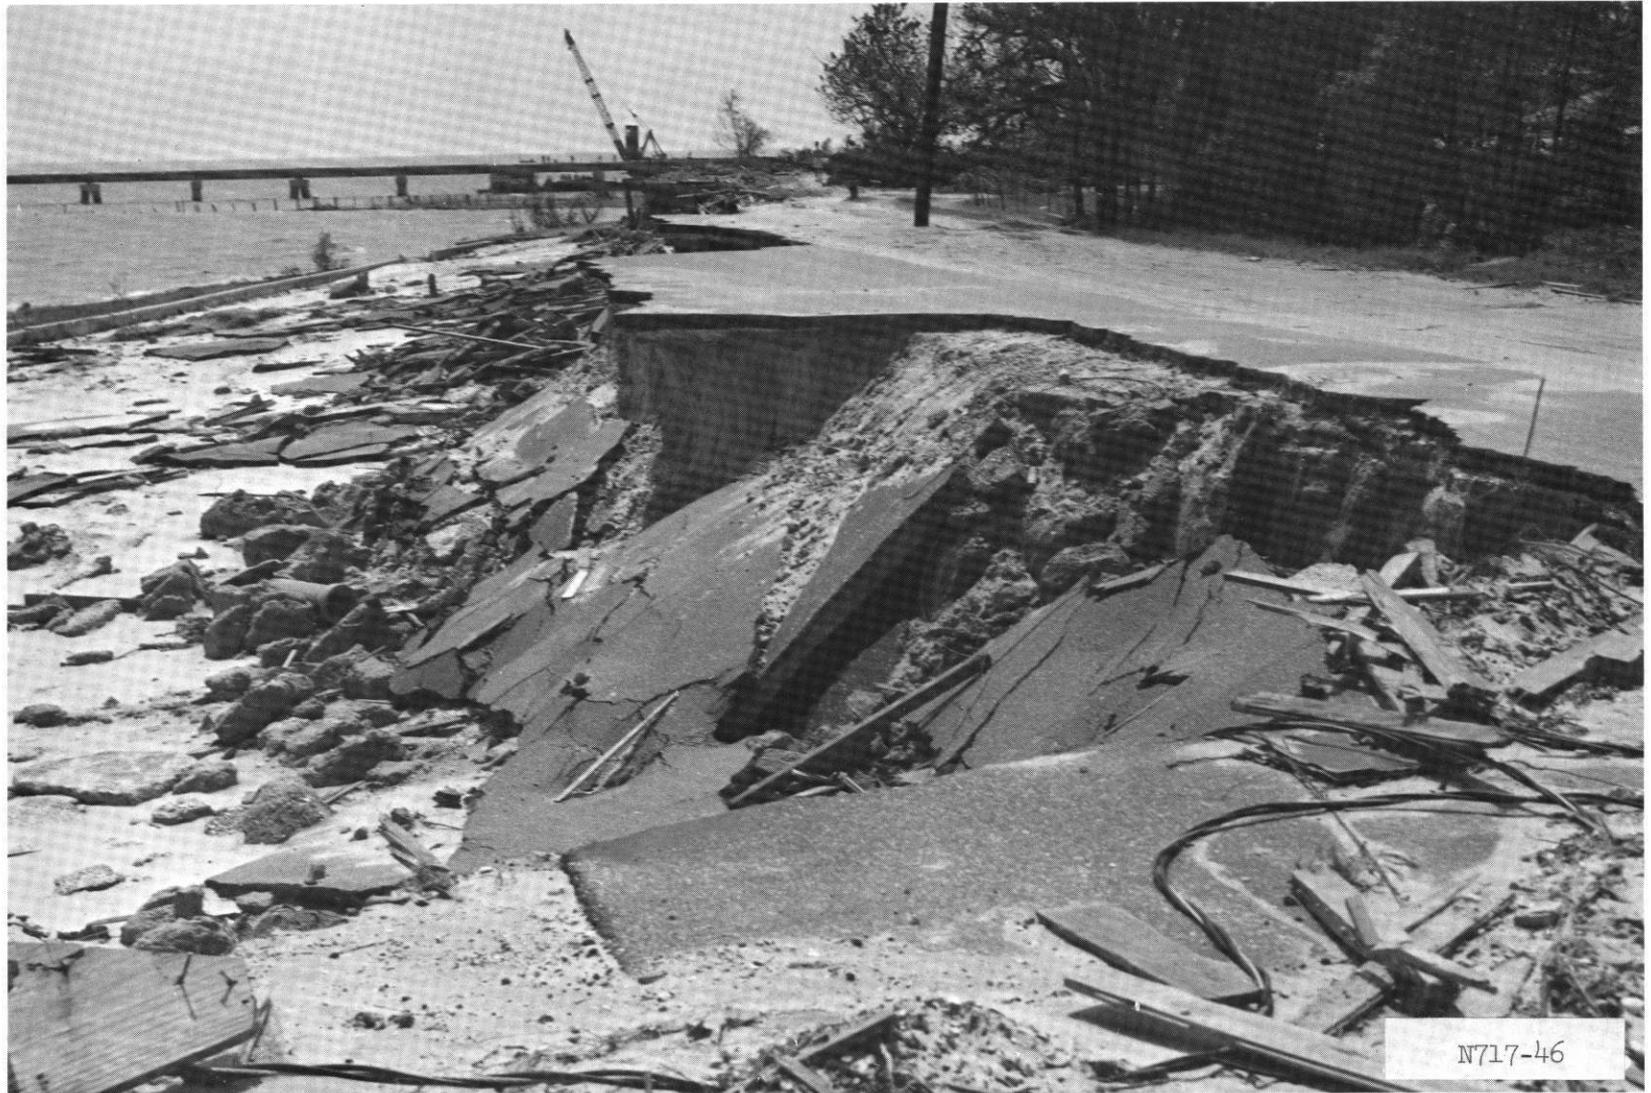
Figure 4.1 U. S. Highway 90 west of Bay Saint Louis.

Highway 90 along the west side of Bay Saint Louis was seriously undercut by wave erosion and washed away in places (Figure 4.1) even though the highway was at an estimated elevation of 20 feet.

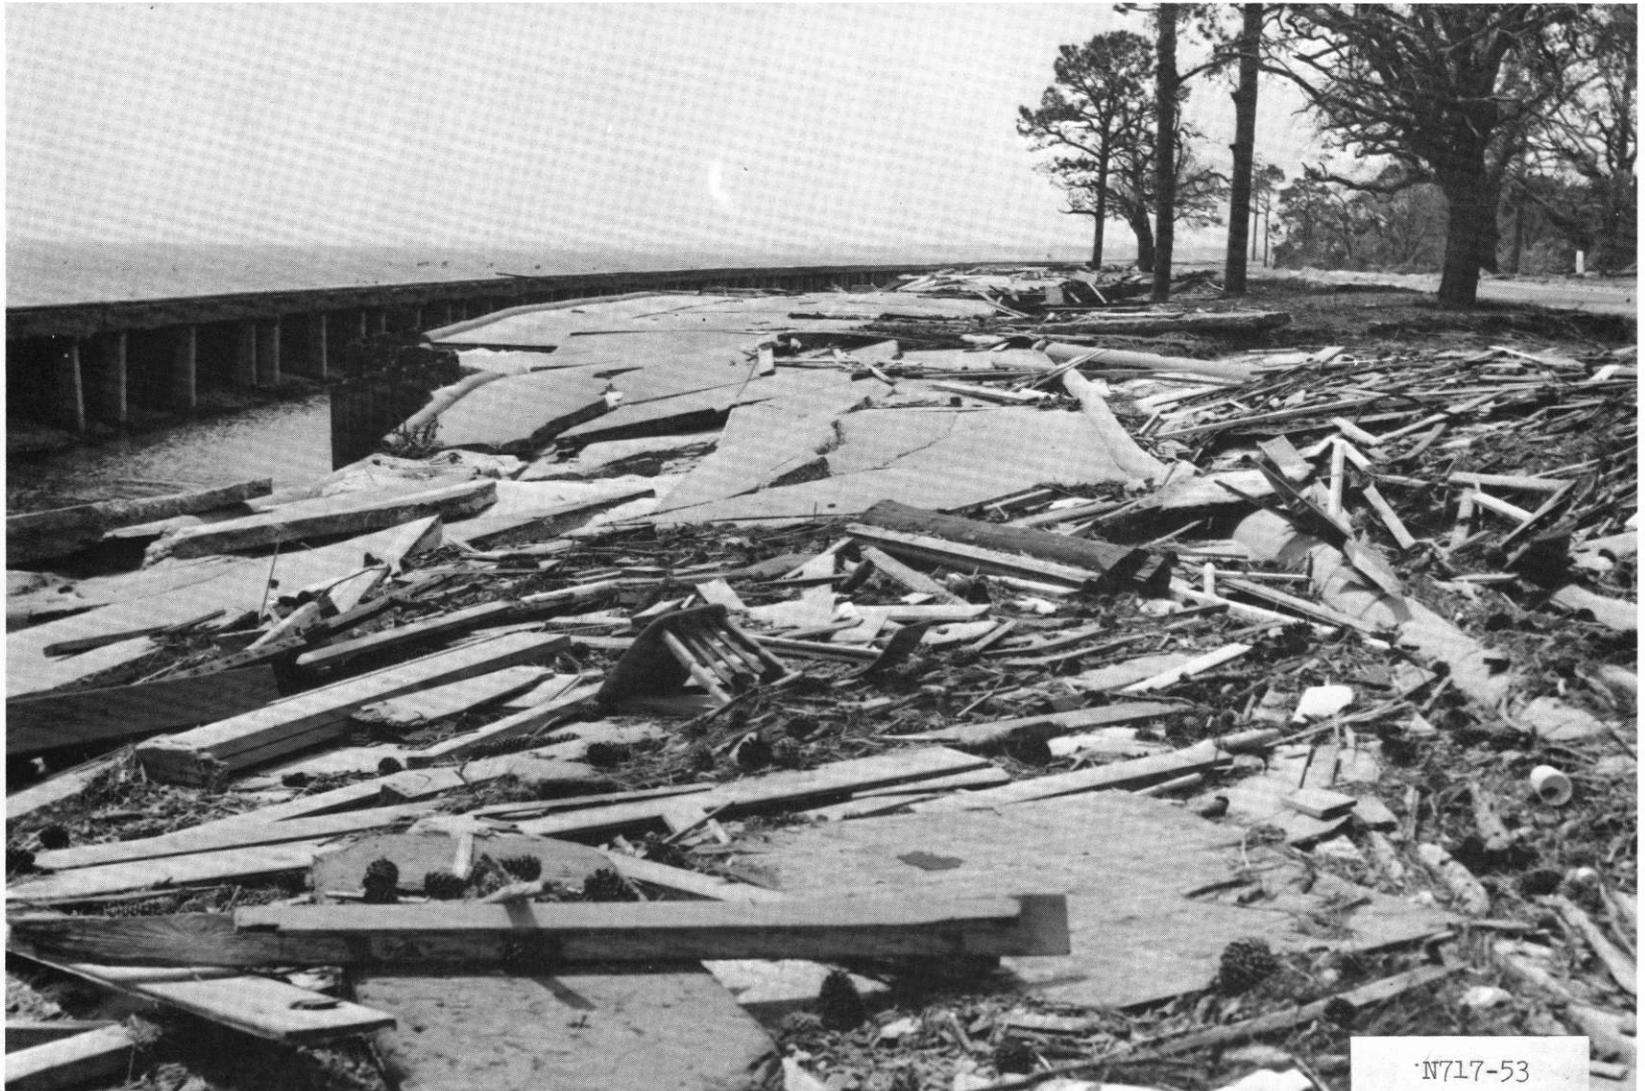
The seaward two lanes (east-bound lanes) of U. S. 90 along the coast were heavily damaged by water erosion, especially in the Pass Christian and Long Beach areas. Much of the soil between the seawall and the highway washed out, causing portions of the highway to collapse (Figures 4.2 and 4.3). The inland two lanes were passable at the time of this inspection trip.

Figure 4.2 U. S. 90 near west end of Pass Christian (east-bound lanes).
