OPERATION PLUMBBOB

Project 30.7

TEST OF GERMAN UNDERGROUND PERSONNEL SHELTERS

Ammann & Whitney New York, New York July 1960

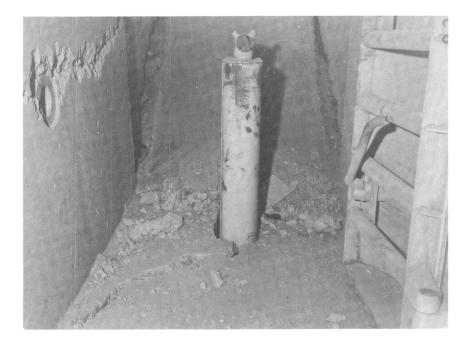
Fig. 3.7-Bottom of emergency-exit shaft (structure RAa). Note debris and sand bags in shaft.

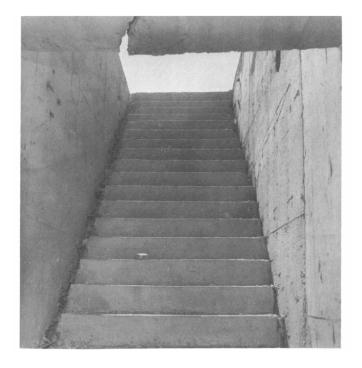
Fig. 3.9—Cracks along center of landing roof slab and at intersection with exterior wall (structure RAa).

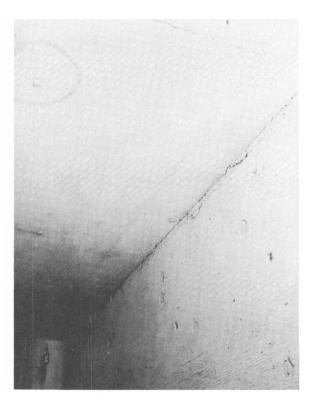
Fig. 3.45—Cracks in roof slab over landing, looking away from GZ (structure RAc).

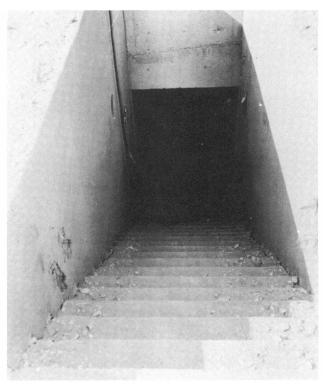
Fig. 3.47—Looking down entrance facing away from GZ, showing cracks between parapet wall and interior and exterior walls (structure RAc).

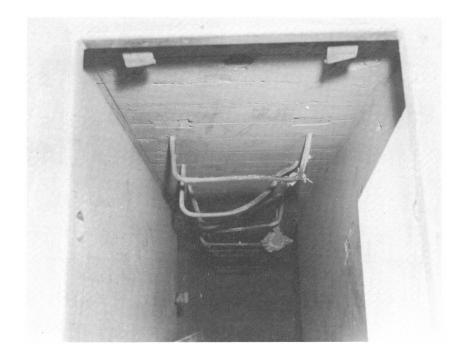
Fig. 3.79—Emergency-exit shaft (structure CAb). Note bent climbing rungs and straightened hinge straps.
