# **Final Report Summary of DM1200 Operation at VSL**

**VSL-06R6710-2, Rev. 0, 9/7/06**

K. S. Matlack  
Vitreous State Laboratory,  
The Catholic University of America

**Summary of DM1200 Operation at VSL**

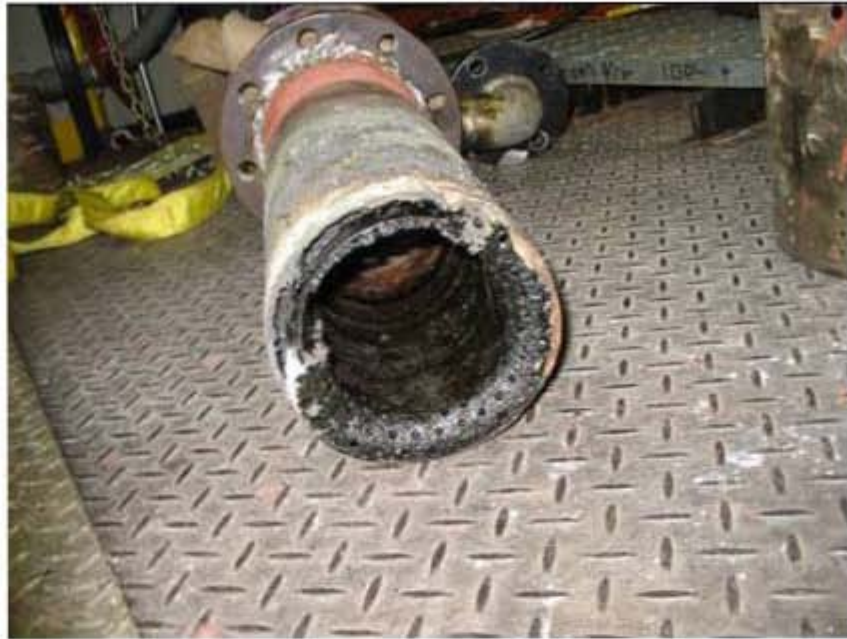
Film Cooler: At the end of the LAW Sub-Envelope A1 test series, the film cooler was removed and inspected in detail. Photographs of the solids deposits in various parts of the film cooler are provided in Figures 4.8 - 4.11. Although the mass of the deposits was not recorded, significant solids deposition can be observed in the photographs. In addition to the solids deposition, significant corrosion damage at the bottom of the film cooler was observed, as shown in Figures 4.12 - 4.19. DCP analysis of a sample of solids removed from the film cooler after washing indicated that the deposits consist mainly of sodium and silicon, with lesser amounts of aluminum, boron, chromium, iron, nickel, selenium, and zinc. Cleaning of the film cooler was only marginally successful, as shown in Figures 4.20 - 4.23.

**Figure 4.10.** View of bottom of the removed film cooler (pre-cleaning) after tests with LAW Sub-Envelope Al simulants [14].

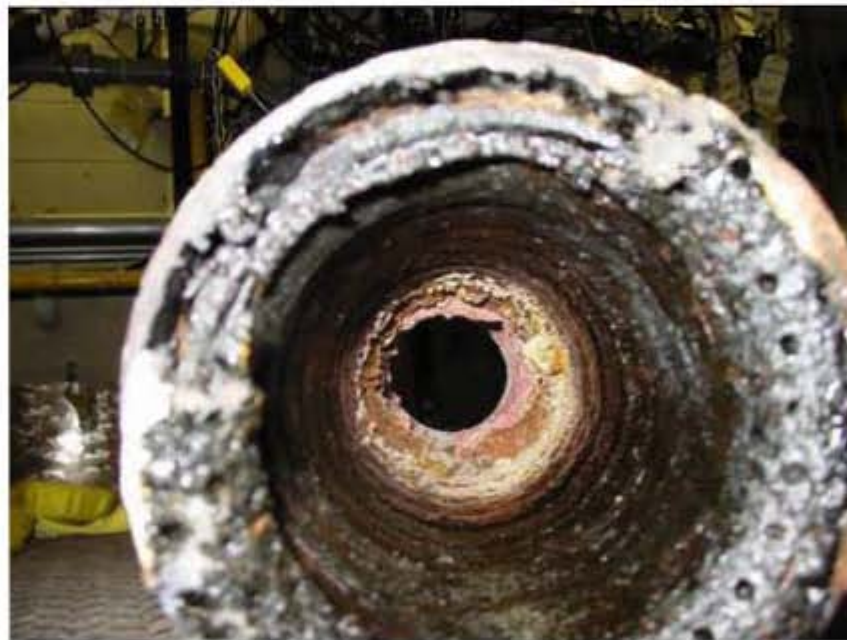
**Figure 4.11.** Close-up view of bottom of the removed film cooler (pre-cleaning) after tests with LAW Sub-Envelope Al simulants [14].

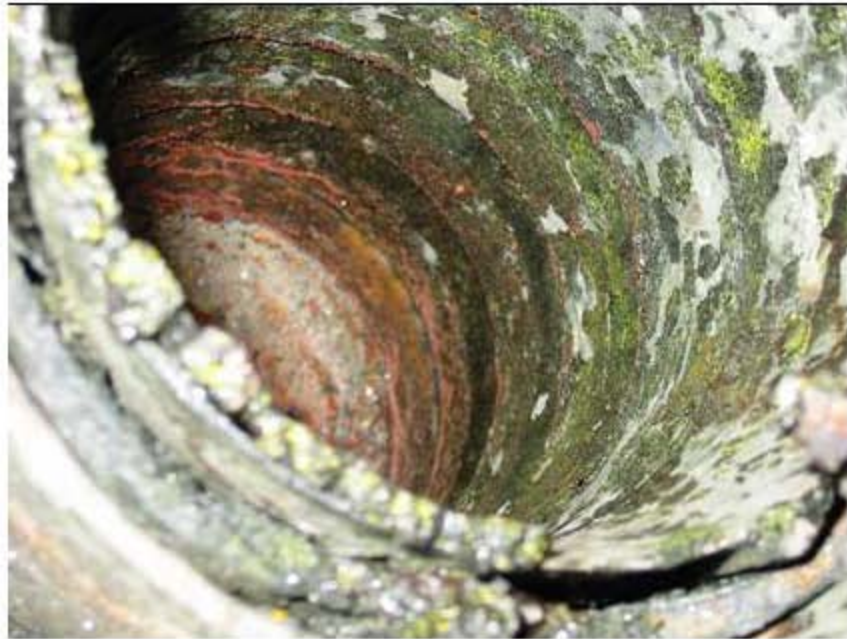
**Figure 4.18.** View of louvers of the film cooler (pre-cleaning) after tests with LAW Sub-Envelope A1 simulants [14].

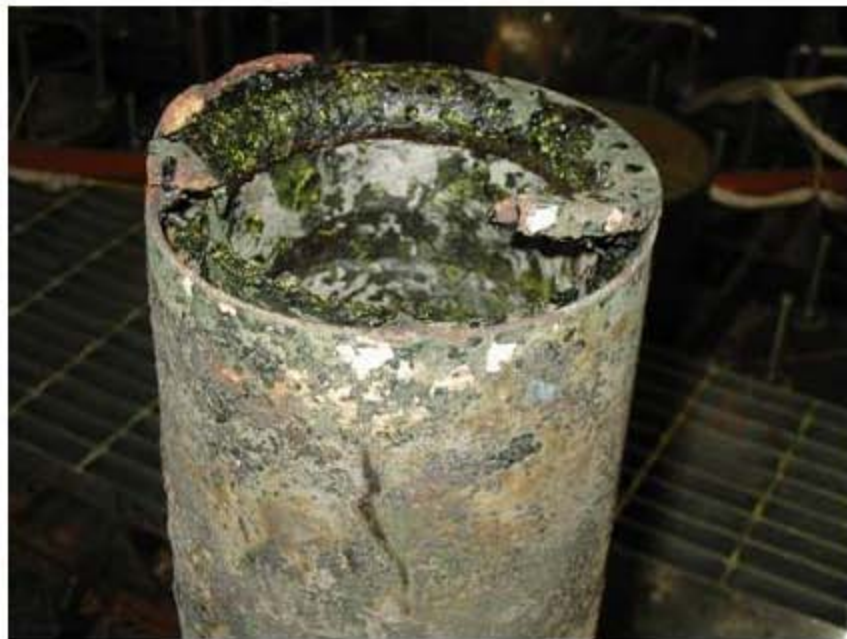
**Figure 4.19.** Side view of the film cooler (pre-cleaning) after tests with LAW Sub-Envelope A1 simulants [14].

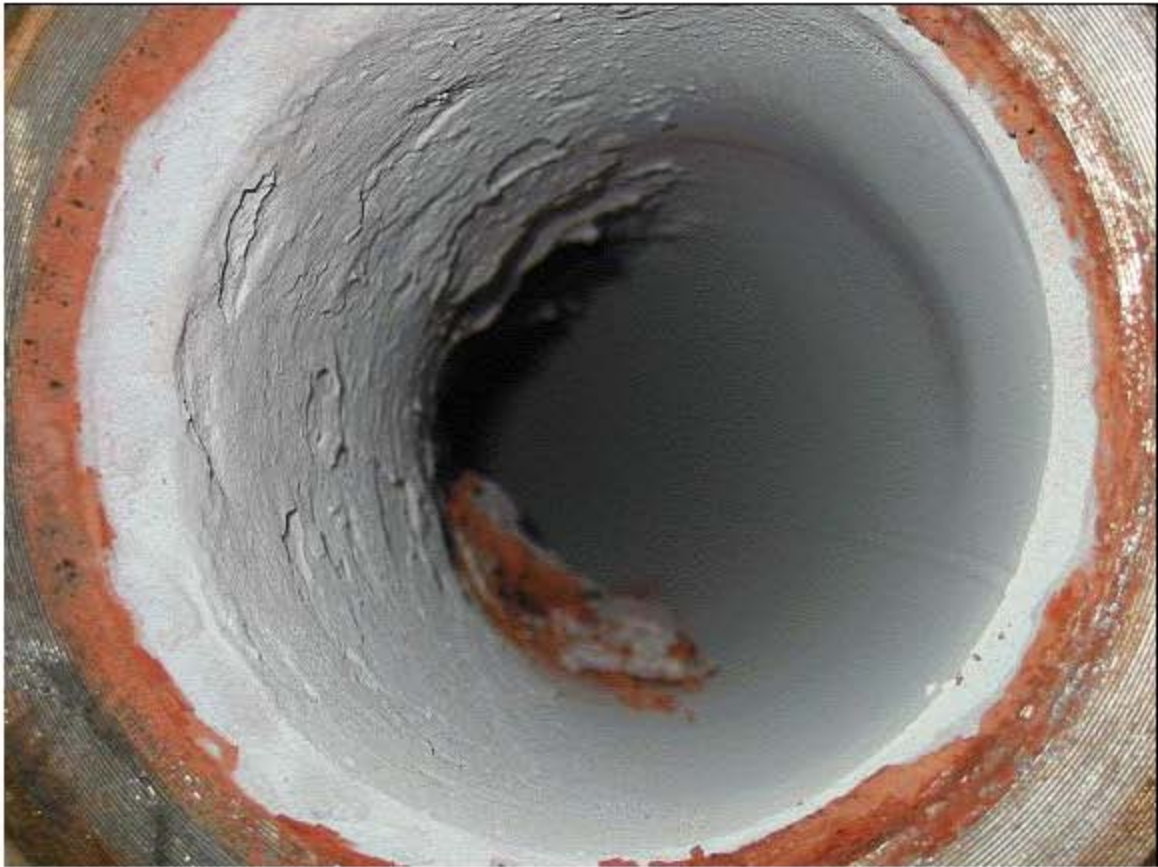
Photographs of the solids deposits in the film cooler after the HLW C-104/AY-101 test are shown in Figures 4.27 and 4.28. Photographs of the solids deposits in various sections of the transition line are provided in Figures 4.29 - 4.34. The largest mass of solids (3.11 kg) was collected from transition line section #2. DCP analysis of solids taken from this section shows major component composition similar to that of AZ-101, AZ-102, C-106/AY-102 and C-104/AY-101 melter feeds, indicating entrainment of feed components into the exhaust stream. However, the concentrations of volatile components such as selenium were higher than those in the feed, indicating volatilization from the glass surface or cold cap. Other notable elements were zinc, zirconium, lithium, and manganese, which are also present in all of the four HLW feeds. Sulfur is present in the sample and is present only in the AZ-101 and AZ-102 feeds.

**Figure 4.29. Transition line section #2 inlet after tests with HLW C-104/AY-101 simulants [28].**

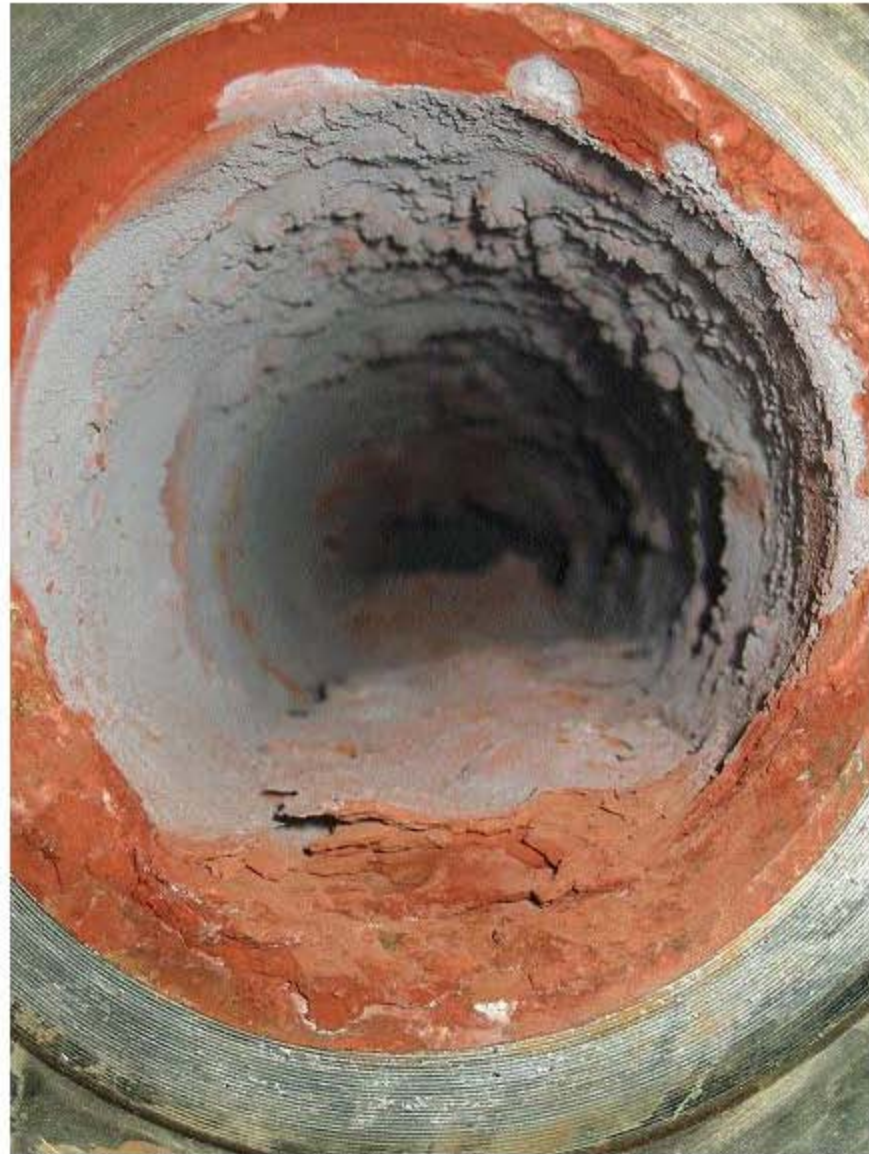
**Figure 4.30. Transition line section #2 outlet after tests with HLW C-104/AY-101 simulants [28].**

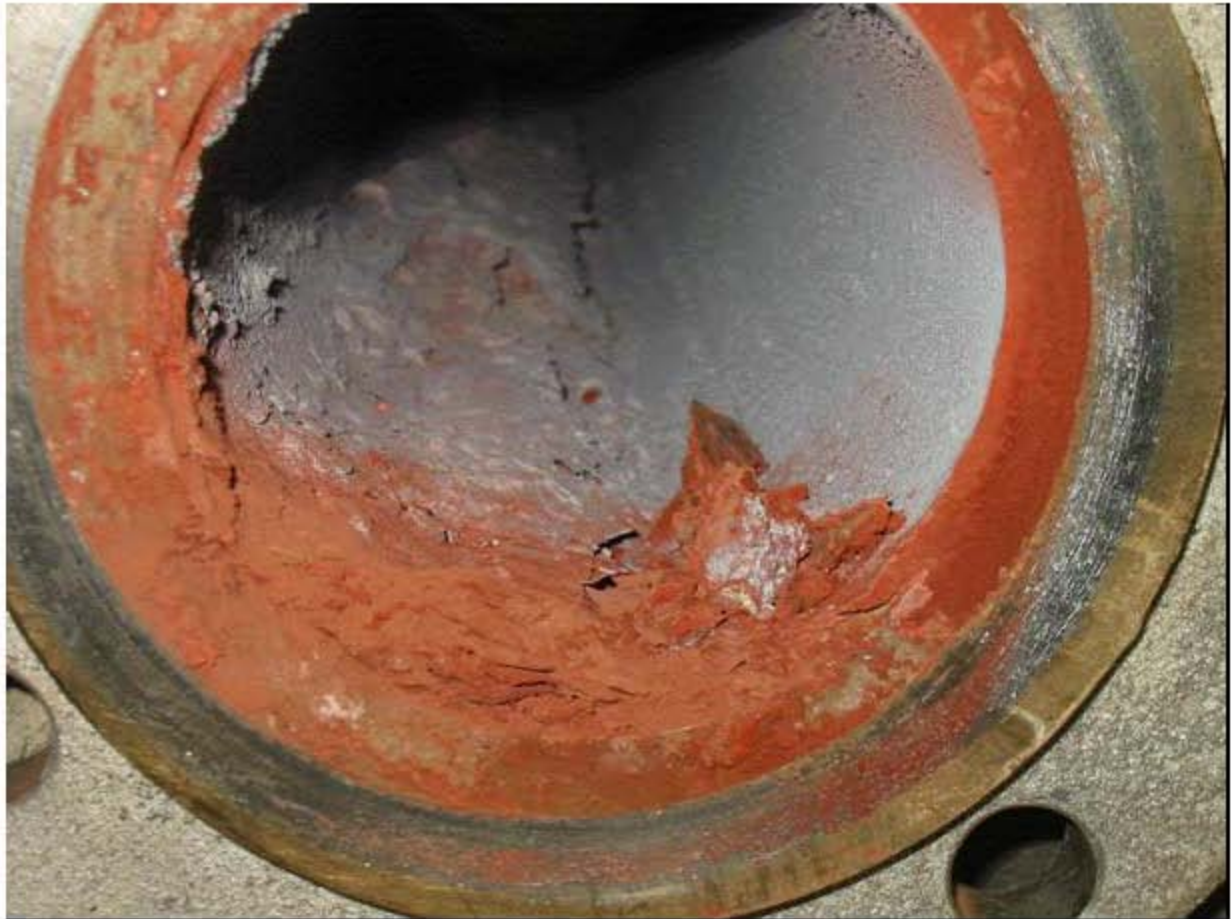
Figure 4.31. Transition line section #3 inlet after tests with HLW C-104/AY-101 simulants [28].

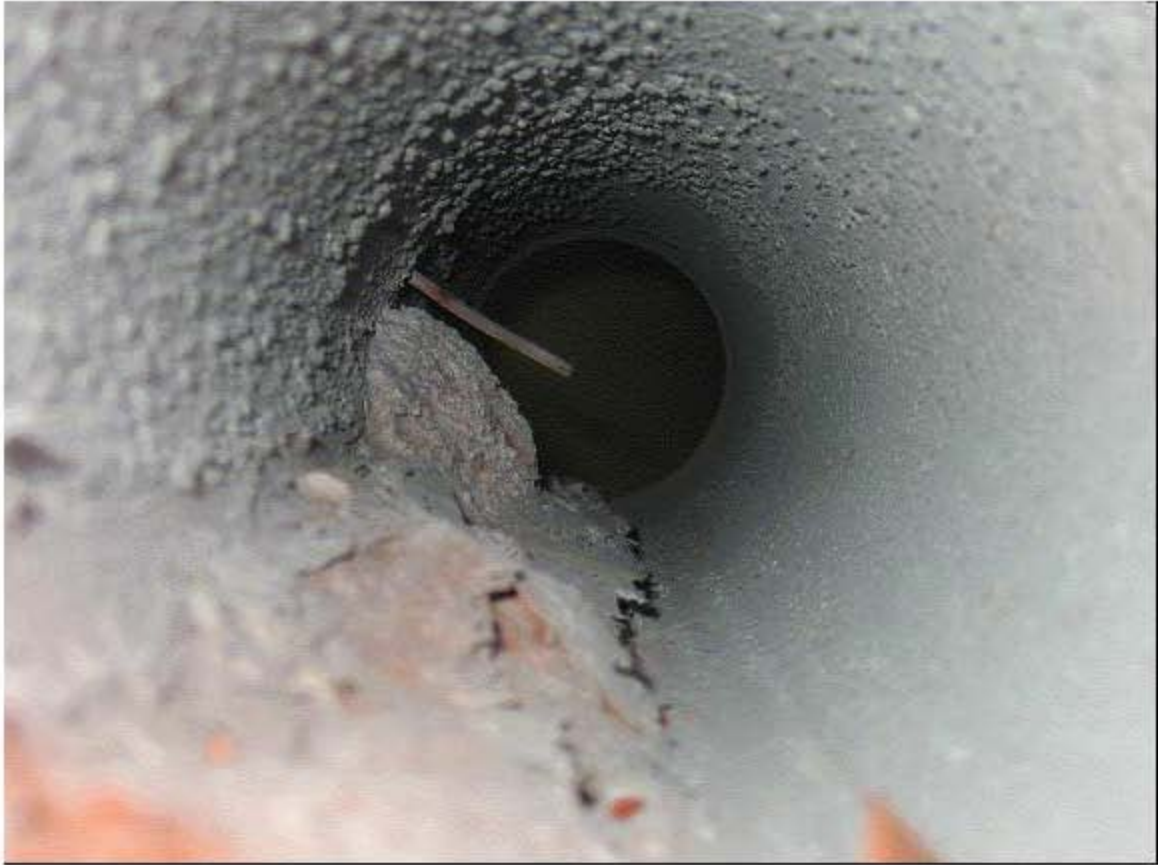
**Figure 4.32. View of transition line section #3 inlet after tests with HLW C-104/AY-101 simulants [28].**

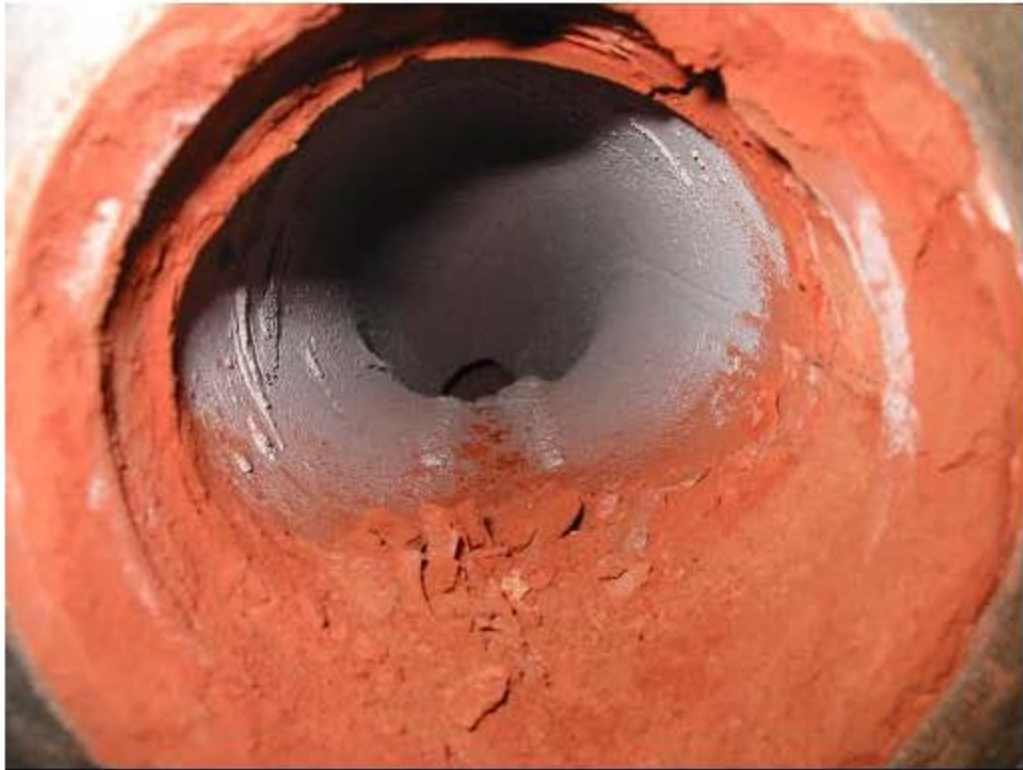
**Figure 4.34. SBS transition line inlet after tests with HLW C-104/AY-101 simulants [28].**

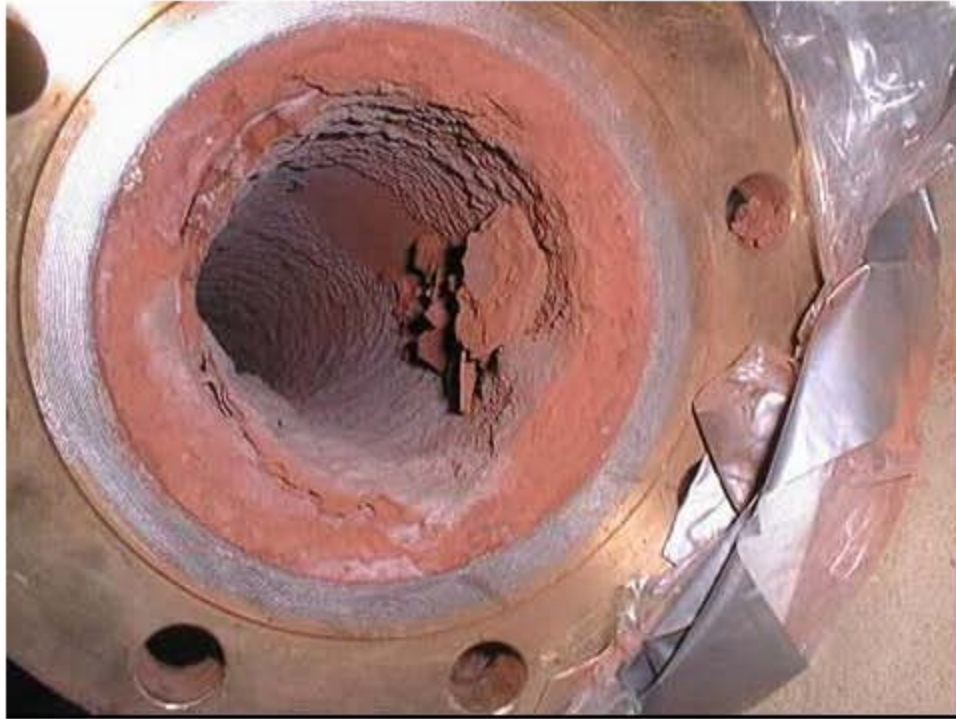
Solids deposits at the inlet of the film cooler are shown in Figure 4.35. Photographs of the solids deposits throughout the transition line are given in Figures 4.36 - 4.41. The film cooler and

**Figure 4.37. Transition line section #2 inlet after Configuration Test 2 [30].**

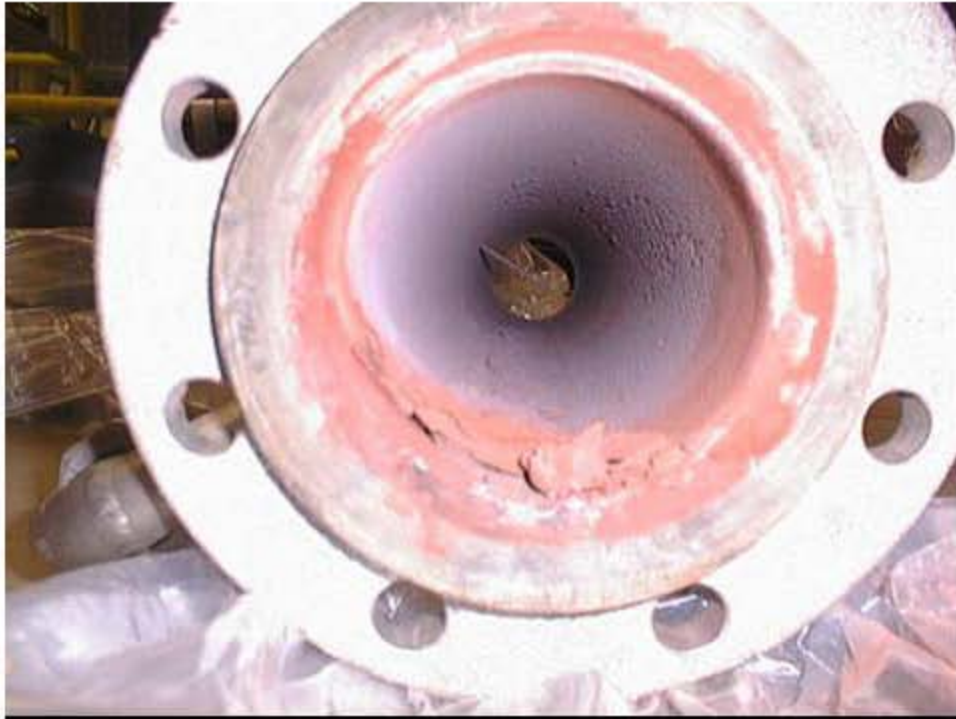
**Figure 4.38. Transition line section #3 inlet after Configuration Test 2 [30].**

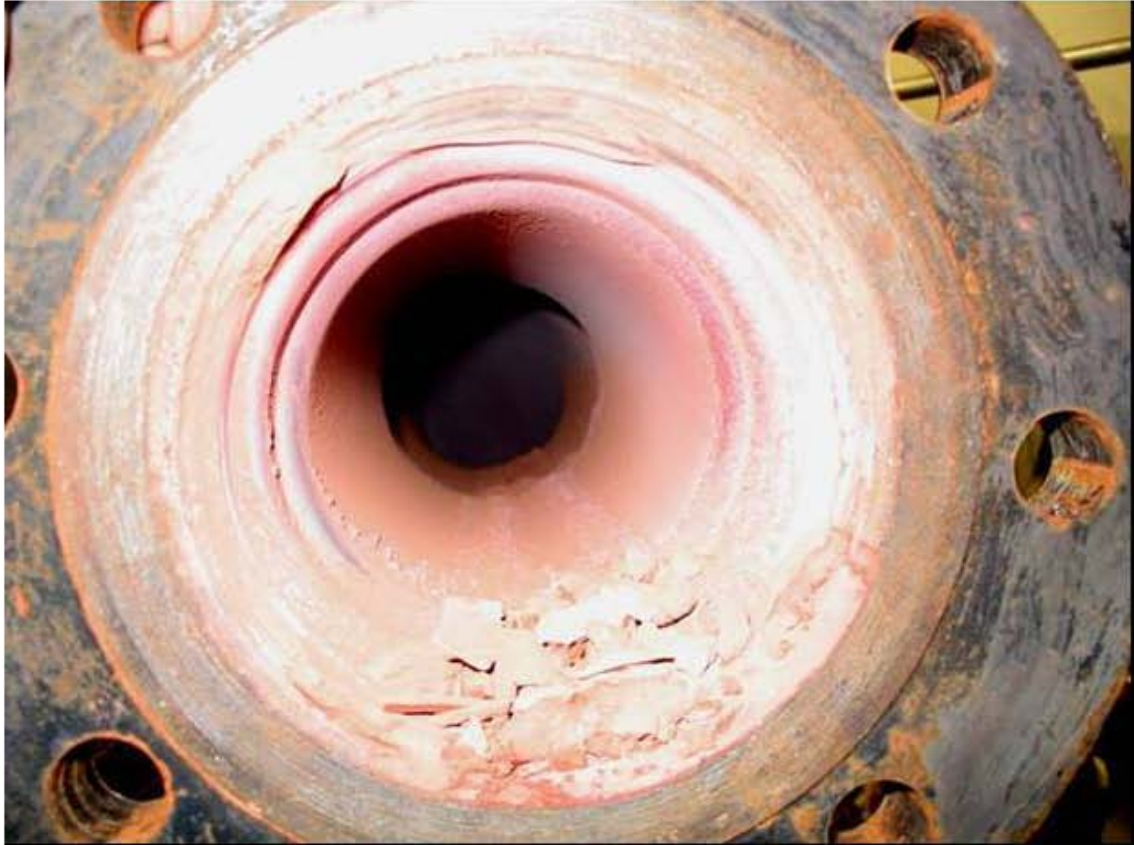
After the test, the film cooler, transition line sections #2, #3, and transition line bellows were inspected. Very little particulate was observed in the film cooler or transition line sections #2 and #3. A photograph of the solids deposits at the transition line bellows inlet is provided in Figure 4.42. About 10 grams of solids deposits was removed from the transition bellows. The film cooler and the above mentioned sections of the transition line were cleaned before reassembly.

**Figure 4.42. Transition line bellows inlet after Configuration Test 1 [30].**

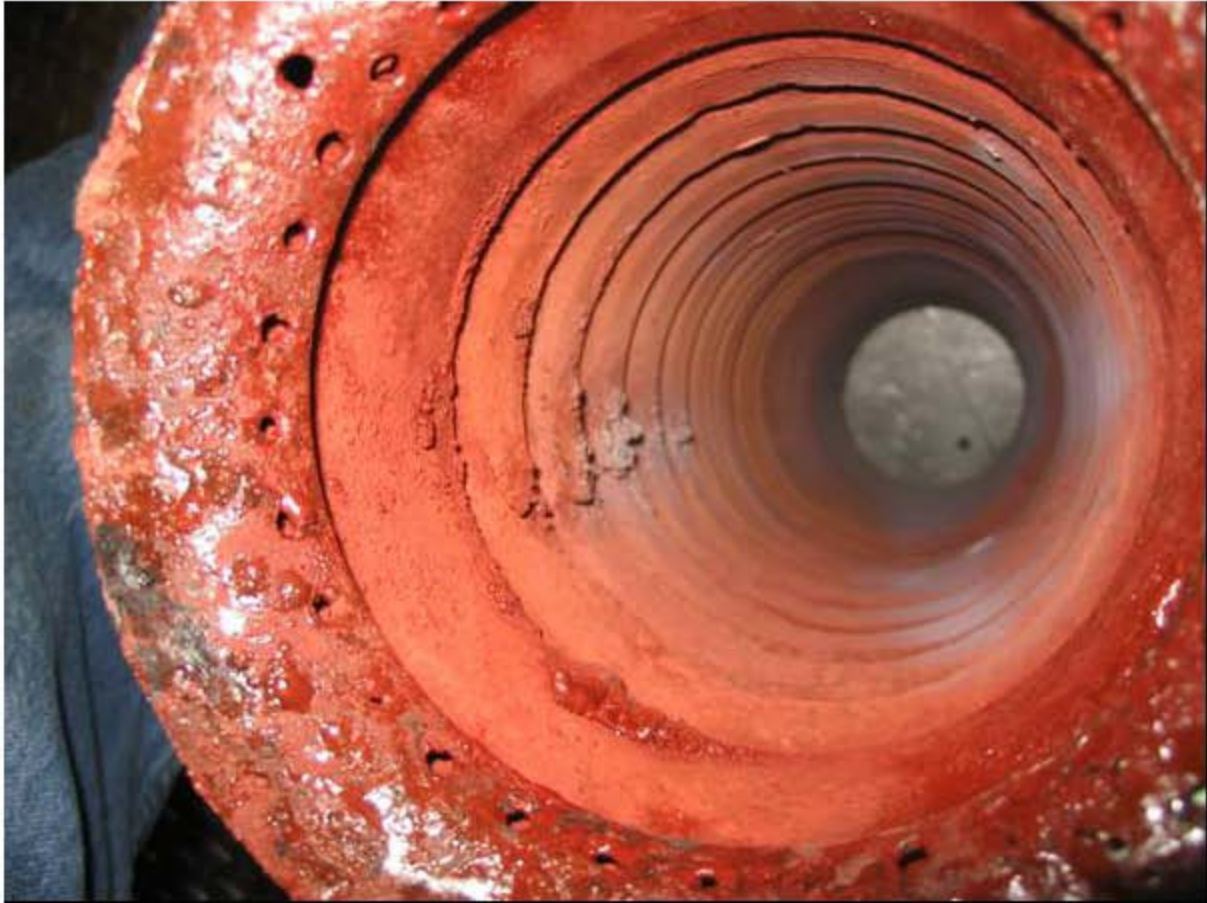
At the end of the test, the film cooler was removed and inspected. Figure 4.44 shows some glazed build up of solids on air vent holes at the very bottom of the film cooler. There was also moderate particulate buildup on its louvers. The film cooler (2<sup>nd</sup> installed on the DM1200) was replaced on 7/23/03, before Test 8. The transition line segments were not inspected after the test.

Figure 4.44. Close-up of clogged perforation of film cooler inlet after Configuration Test 3 [30].

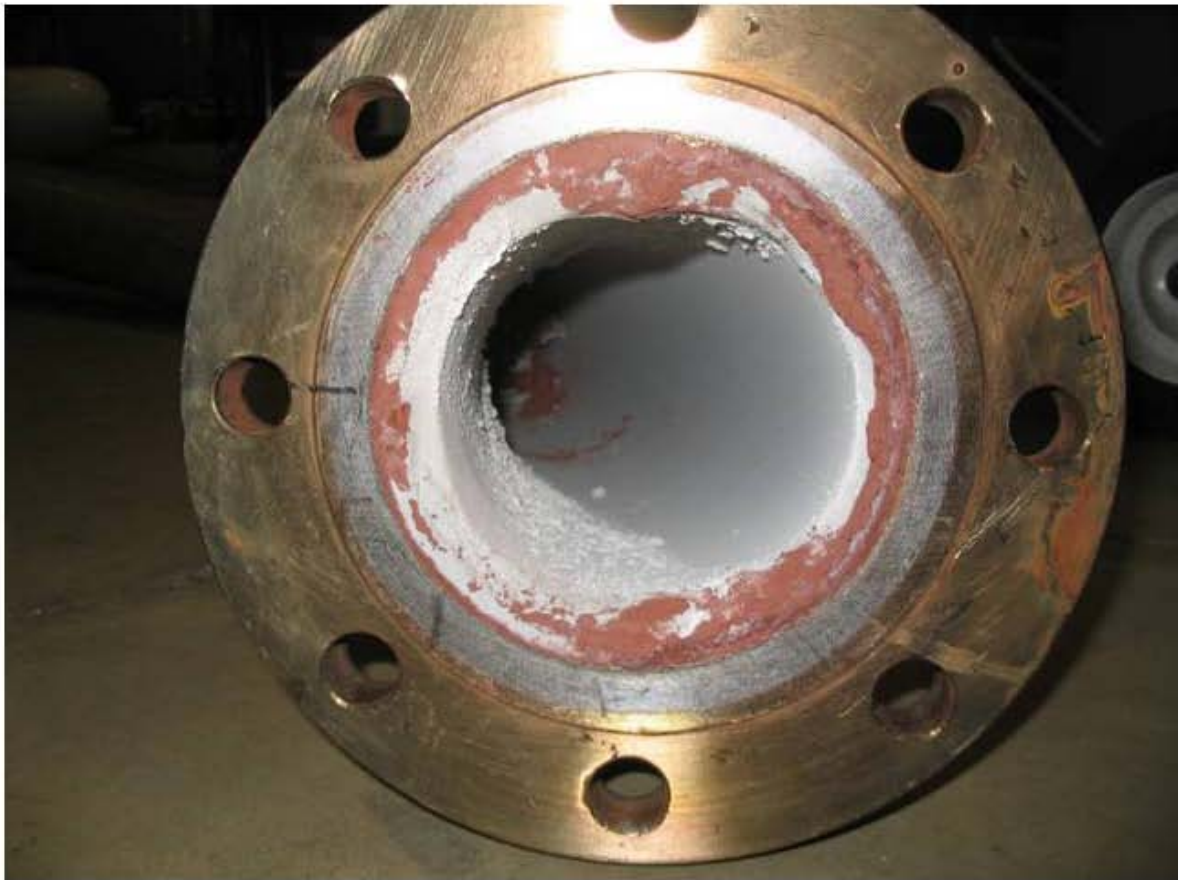
The mass of solids removed from the film cooler and transition line segments was 0.57 kg and 1.5 kg, respectively. Photographs of the film cooler inlet are shown in Figures 4.45 and 4.46. Photographs of the solids deposits throughout the transition line are given in Figures 4.47 - 4.53. The white deposits seen in the figures are presumed to be alkali halides (sodium chloride was spiked into the feed during Test 10). The film cooler and all sections of the transition line were cleaned before reassembly. The cleaned film cooler inlet is shown in Figure 4.54.

**Figure 4.48. Transition line section #2 inlet after Configuration Test 10 [30].**

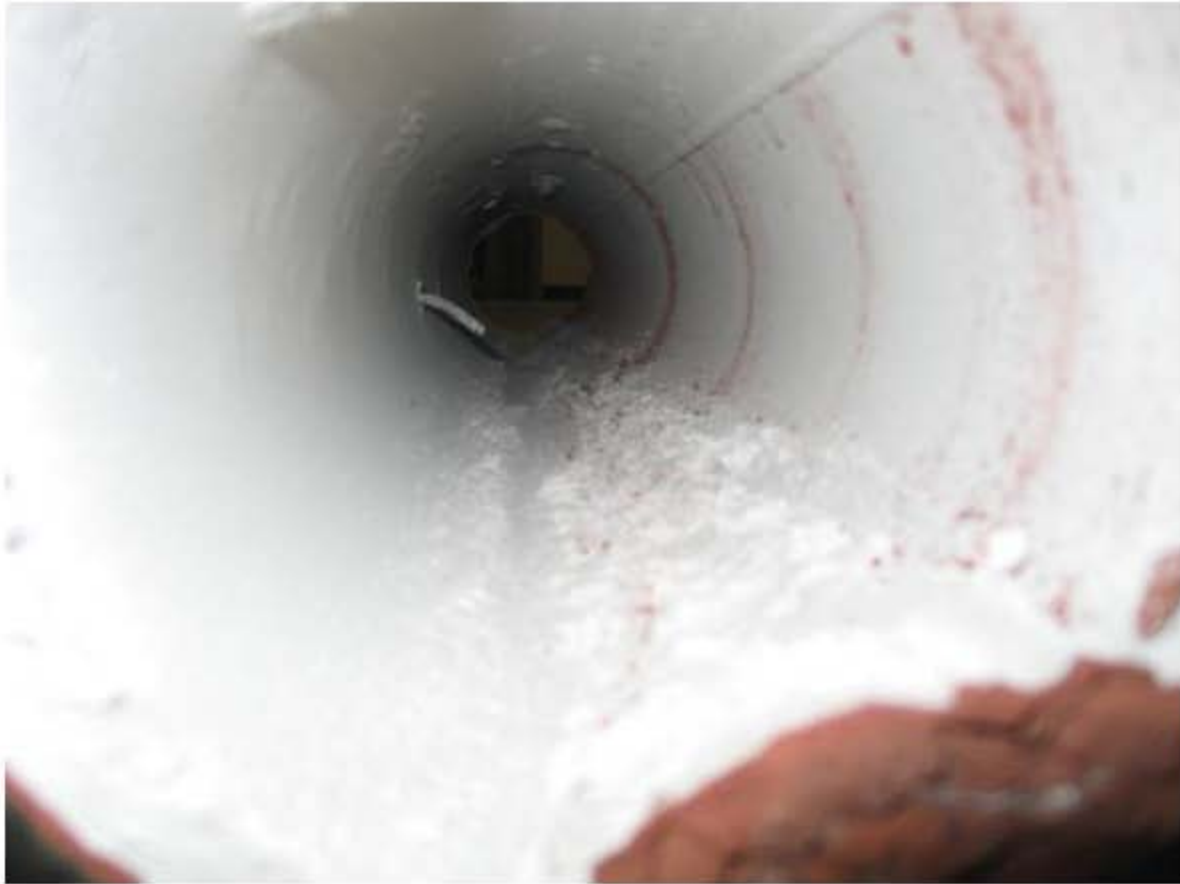
**Figure 4.49. Transition line section #3 inlet after Configuration Test 10 [30].**

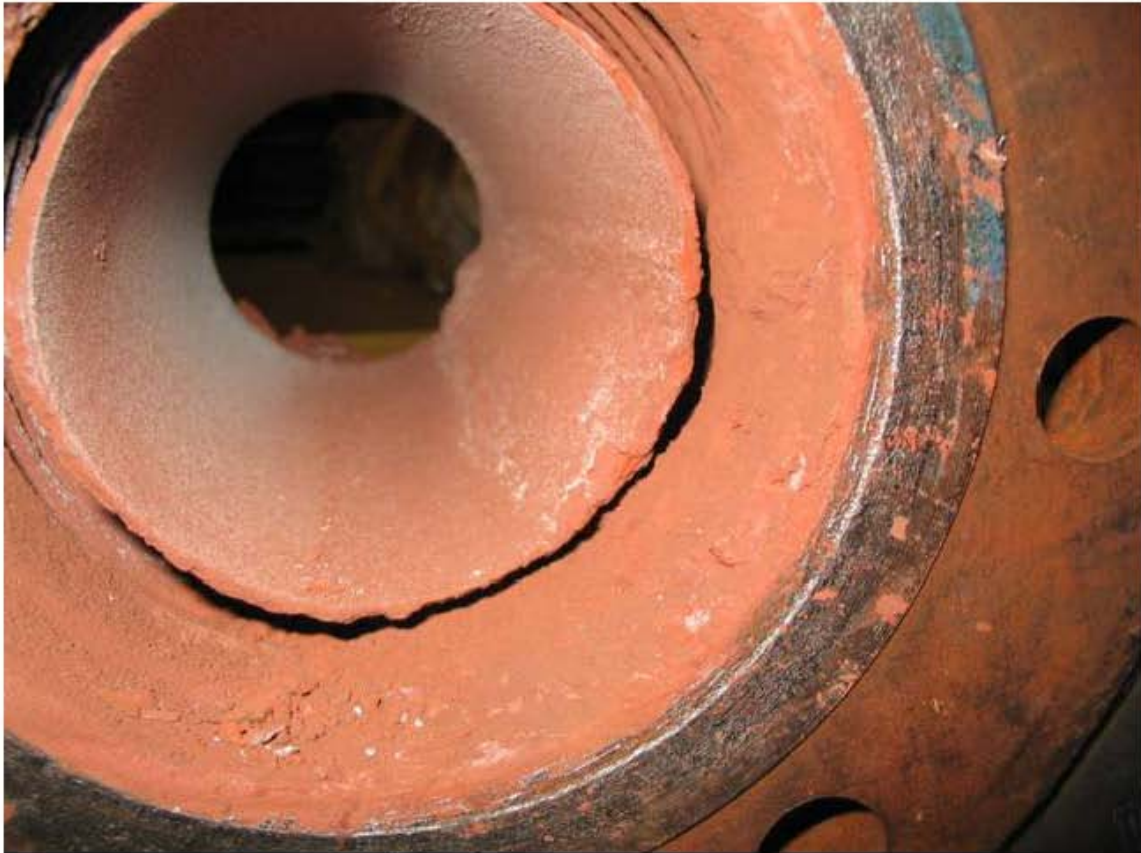
**Figure 4.52. Transition line bellows outlet after Configuration Test 10 [30].**

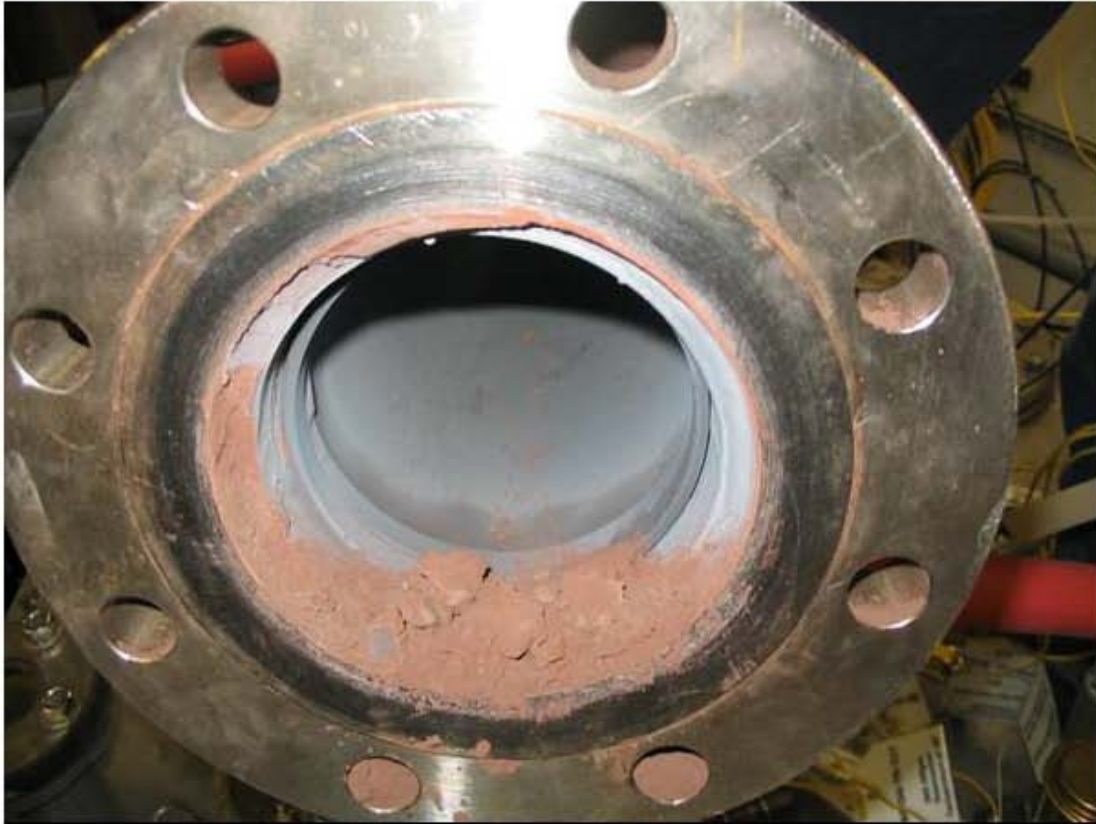
Figure 4.55 shows some glazed buildup of solids on air vent holes at the very bottom of the film cooler. Only slight solids deposits were observed throughout the transition line except in the transition line section in between the bellows and the SBS inlet, as shown in Figure 4.56. The film cooler was partially cleaned, as shown in Figure 4.57, before the next test. The transition line sections were deliberately not cleaned before reassembly; however, some solids in the transition line section connected to the SBS inlet fell out.

**Figure 4.56. Inlet of transition line section in between bellows and SBS inlet (on bellows side) after Configuration Test 9 [30].**

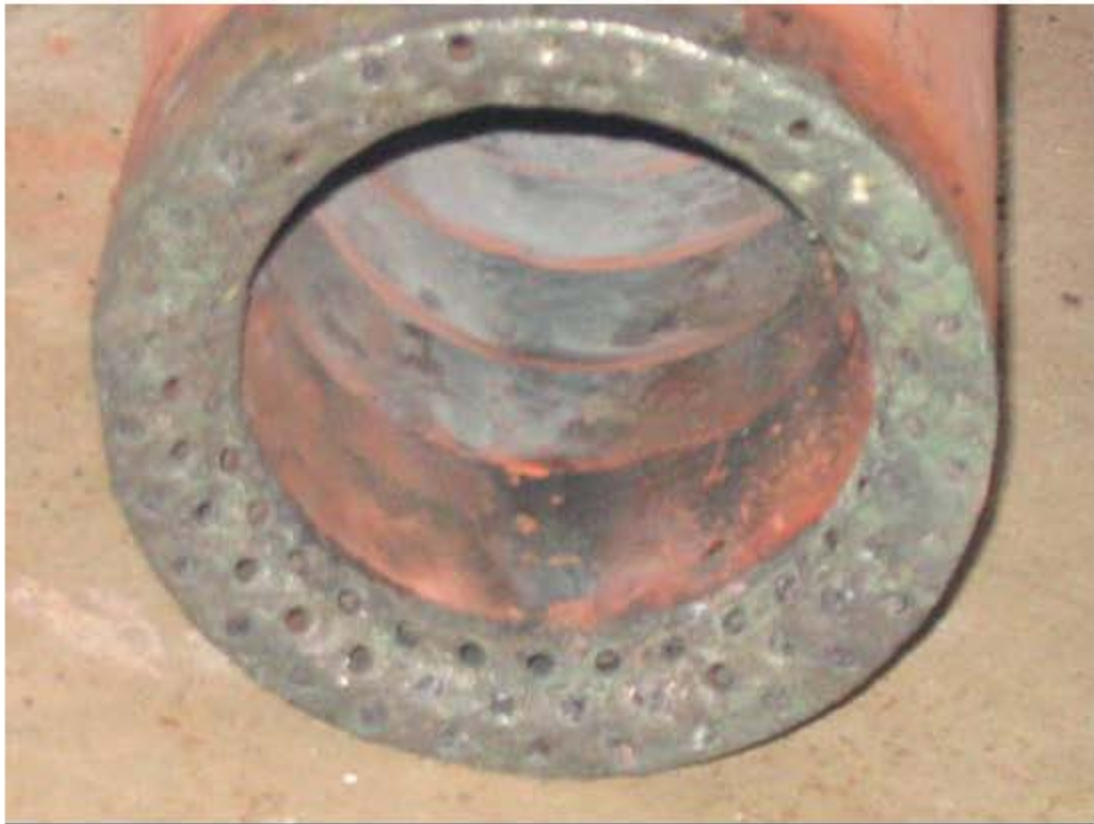
**Figure 4.57. View of film cooler inlet and internals (partial post-cleaning) after Configuration Test 9 [30].**

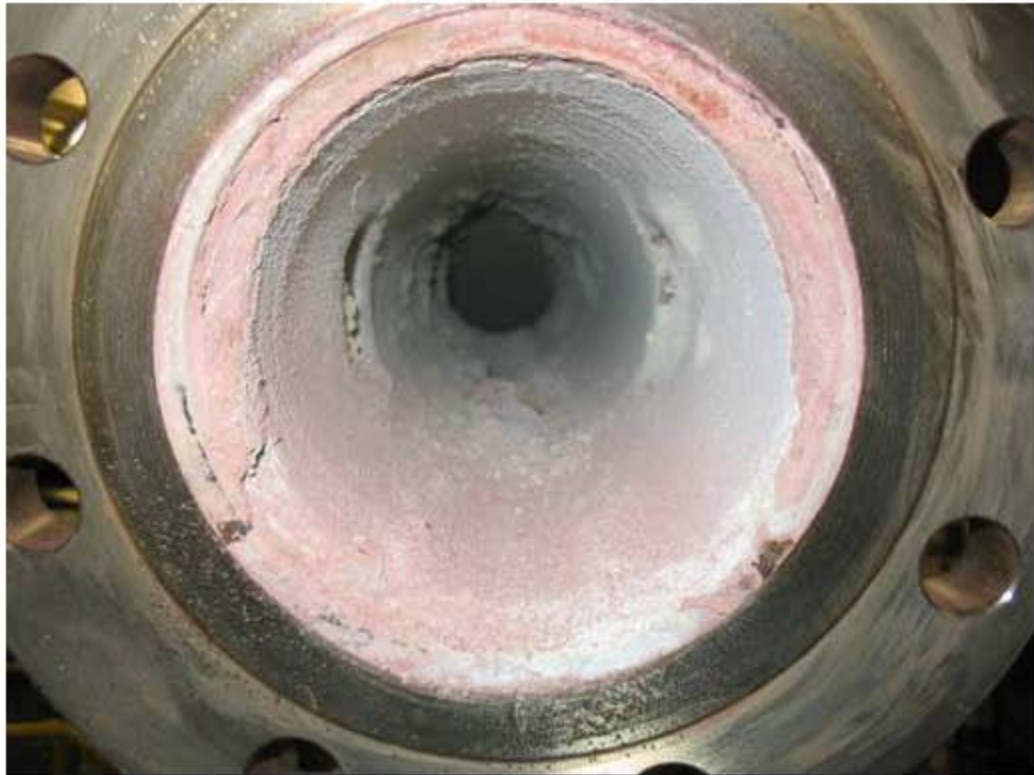
After both the Production Rate and Foaming Tests, the transition line bellows were removed. About 60 grams of small chunks and very fine white solids were removed from the transition line bellows. The results from this test were similar to the previous LAW Sub-Envelope C1 test [10] in that no blockages of the transition line occurred and only a small amount of material was deposited in the transition line bellows. Photographs of deposits observed in the transition line after the Foaming Tests are given in Figures 4.58 - 4.60. Sixteen grams of solids was removed from transition line section #3 and fourteen grams was removed from transition line section #2.

**Figure 4.58. Transition line section #2 outlet after Foaming Test [31].**

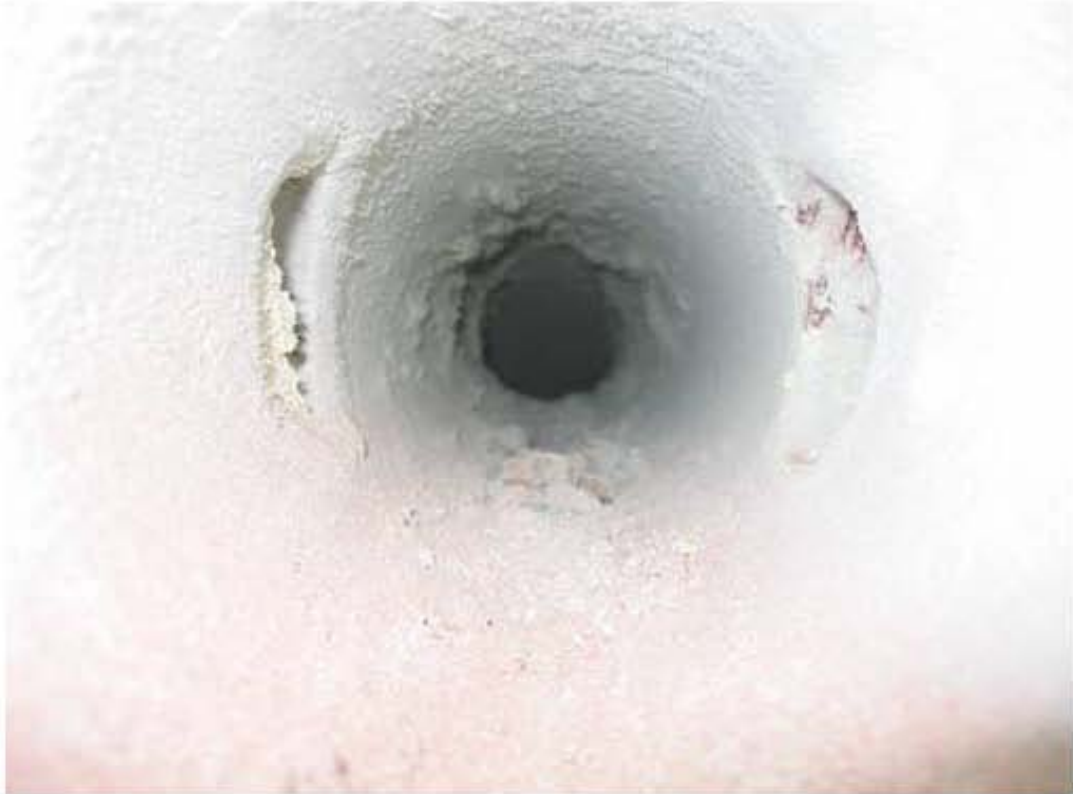
**Figure 4.59. Close-up of transition line section #2 outlet after Foaming Test [31].**

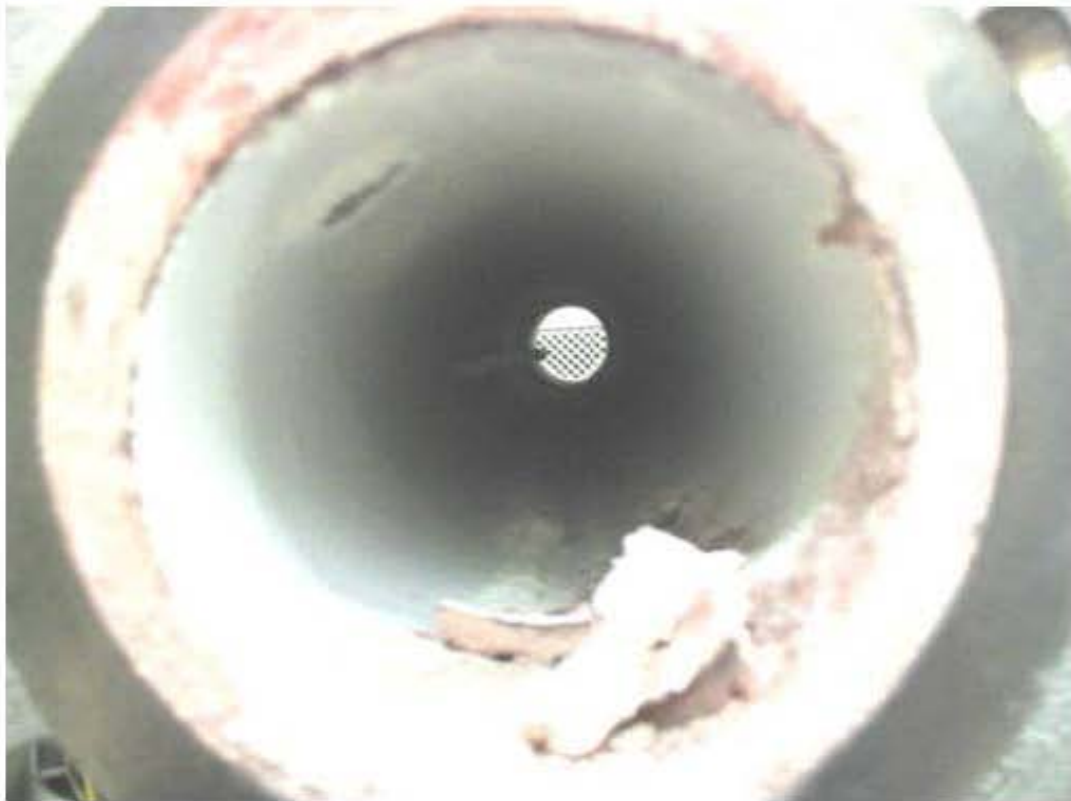
**Figure 4.60. Transition line section #3 inlet after Foaming Test [31].**

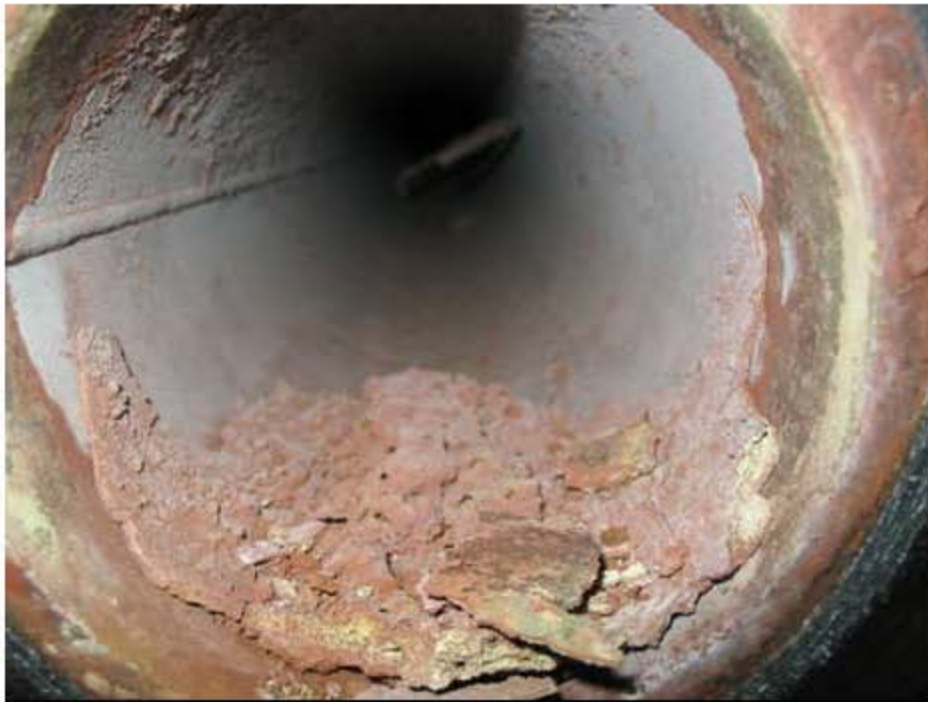
**Figure 4.62. Inlet of transition line section in between bellows and SBS inlet at 26.9 hours of HLW Turnover Test following the MACT tests [41].**
