Hooper Bay Housing Analysis and Energy Feasibility Report

Prepared for:
Sea Lion Corporation
Main Airport Road
Hooper Bay, AK
99604

December 30th, 2012

Prepared by:
Cold Climate Housing Research
Center
1000 Fairbanks, AK 99708
907.457.3454
www.cchrc.org

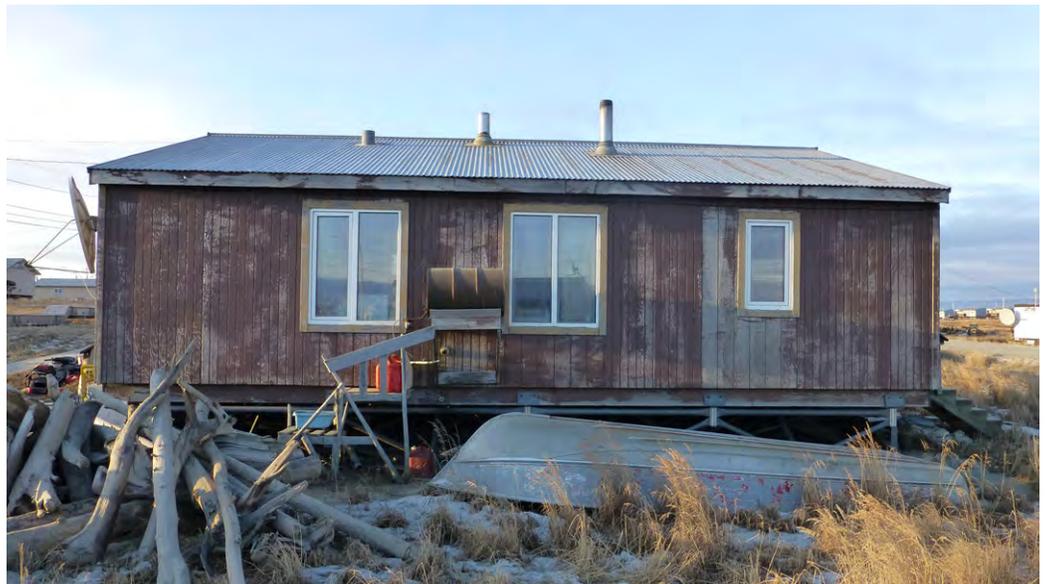
Bosco Olson House. The building has an interior arctic entry for cold storage. It is oriented so that no windows are on the south side to take advantage of solar gain.

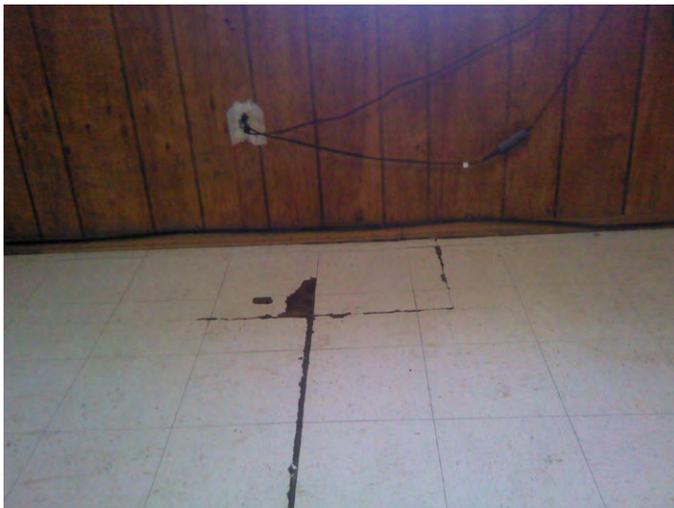
Leonard Bell House. View of floor where it meets an exterior wall

Thermal imaging reveals poor sealing or a cold spot where the wall meets the floor, possibly at the rim joist.

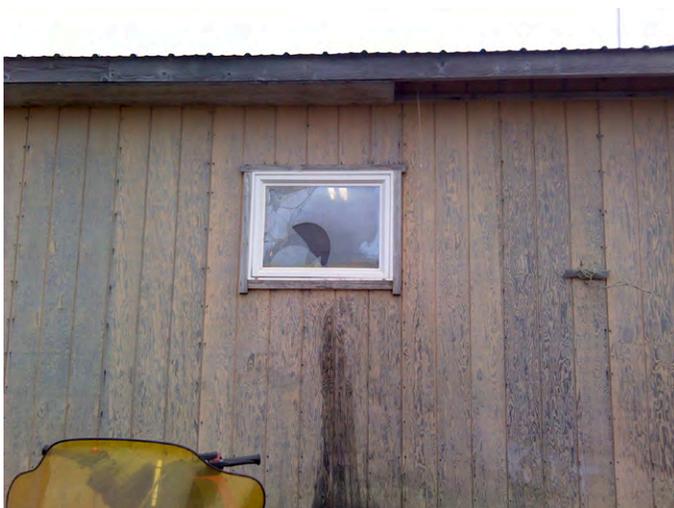
Leonard Bell House. View of window

- Leonard turns the living room fan off when it's windy but leaves the bathroom fan on always
- 6 drums of fuel for winter (330 gallons)
- He sealed the attic entrance
- There's one fresh 80 but it's closed
- Mold sample taken #28006781
- Wife has asthma
- During weatherization they blew in 12" of cellulose on top of the existing fiberglass
- The weatherization seems to be effective and he uses the ventilation system.
- Windows are a remaining concern. They are poorly sealed

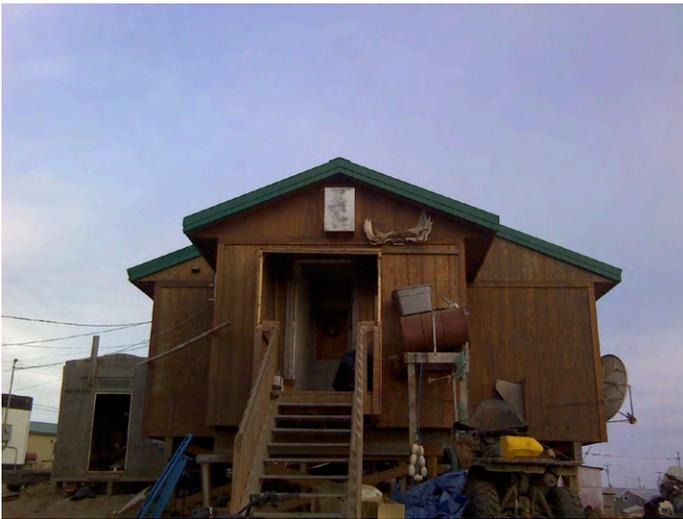
Large arctic entry

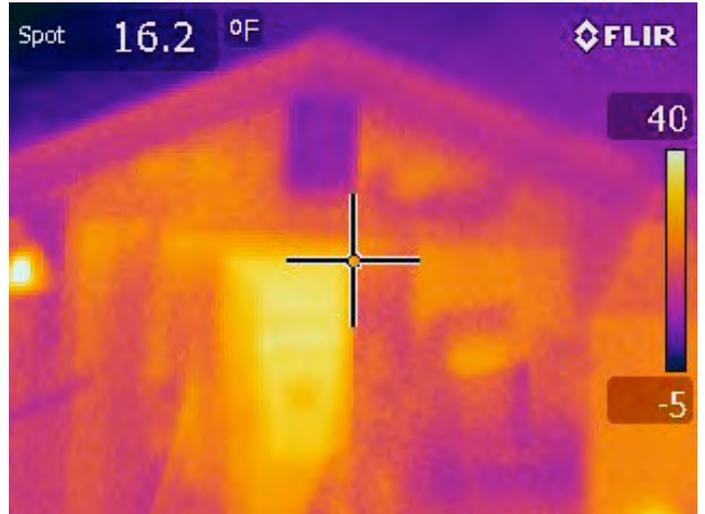
Thermal imaging of the home.

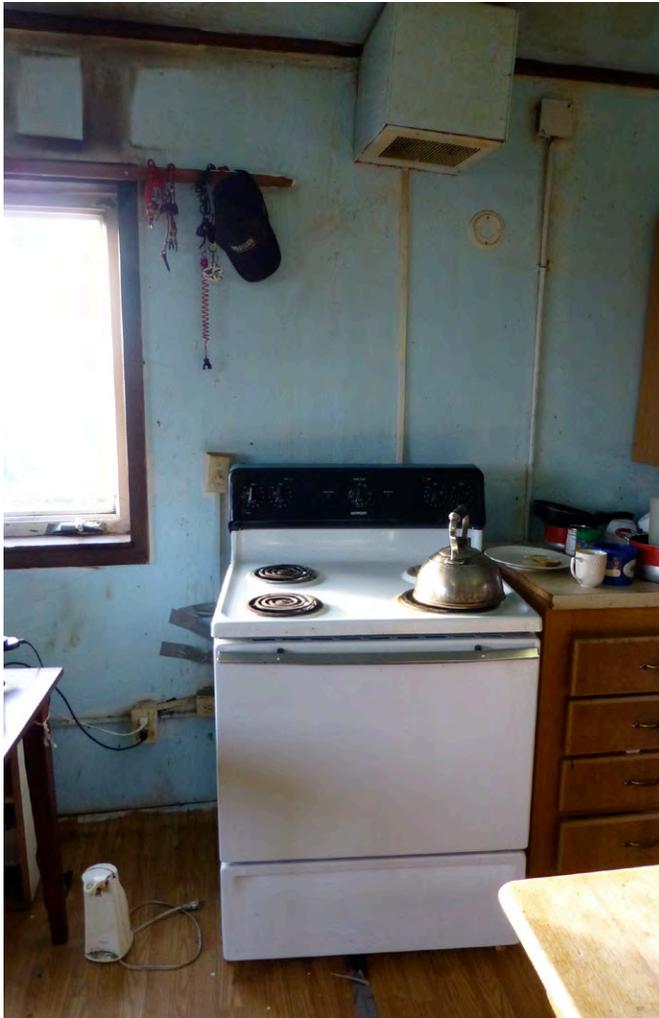
Ventilation fan installed above stove.

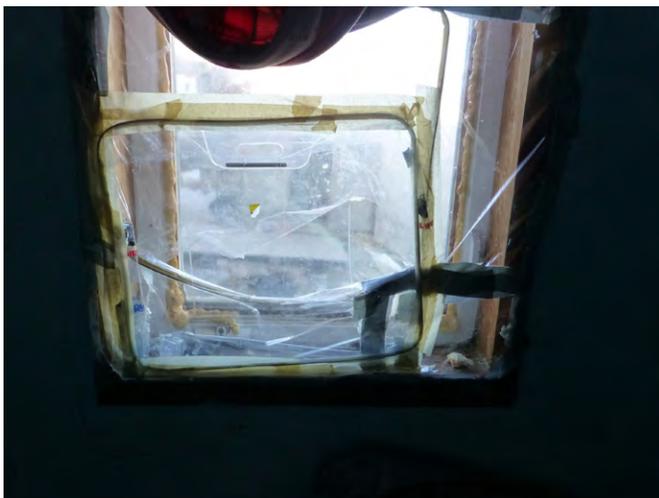
The windows are poorly caulked and drafty. The occupant covers them with plastic in the winters.

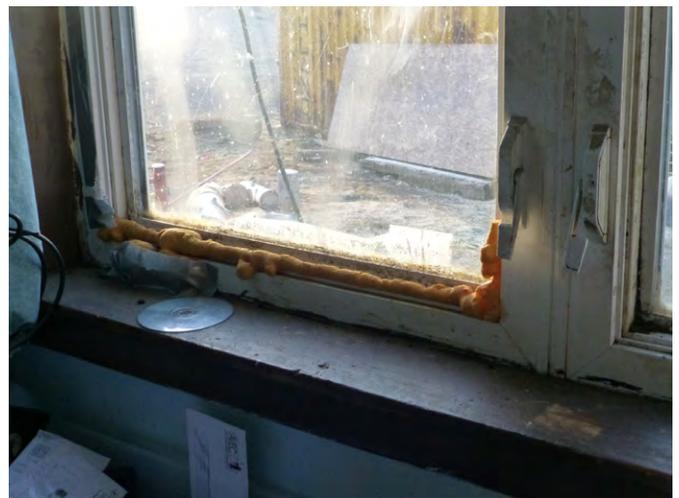
The windows are poorly caulked and drafty. The occupant covers them with plastic in the winters.

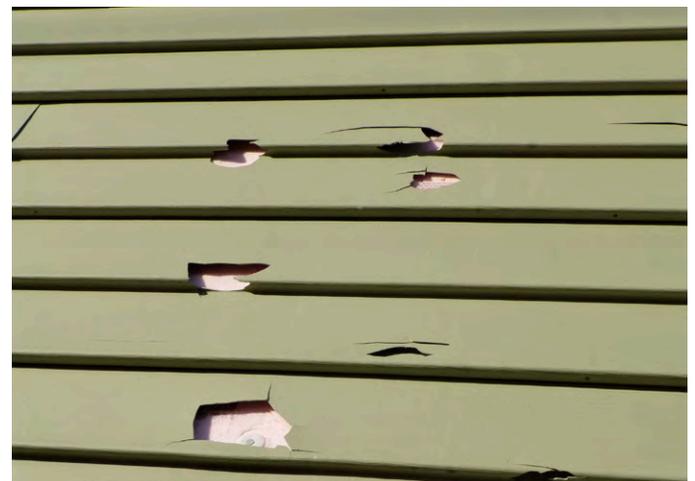
Moses Night House. Exterior rigid insulation was applied during a prior retrofit.

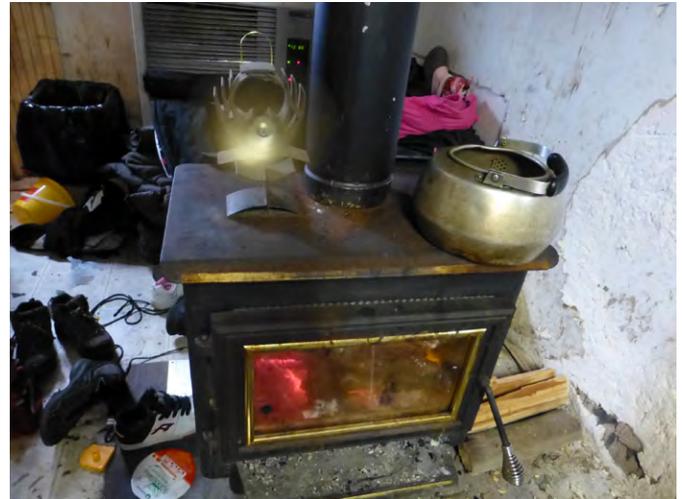
A passive fan atop the woodstove moves heat laterally into the living area.

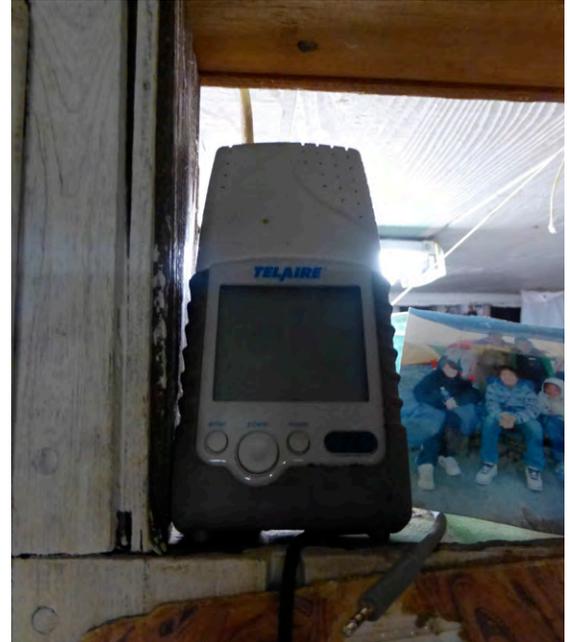
Glen Joe Sr. House. In a prior weatherization application the family was provided with a humidity monitor that beeps at them when humidity is high, and they turn the fan on to create air exchanges.

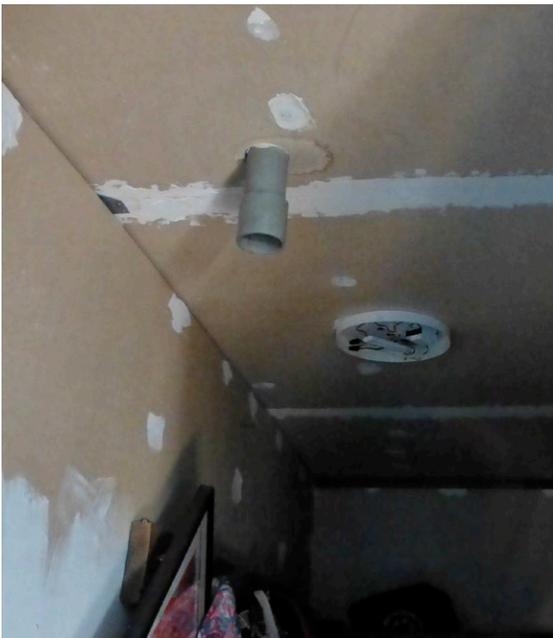
Henrietta Naneng House. A traditional passive vent has been installed in the closet for moist stale air to exit. The building depends on make-up air from the inherent lack of airtightness in the home.

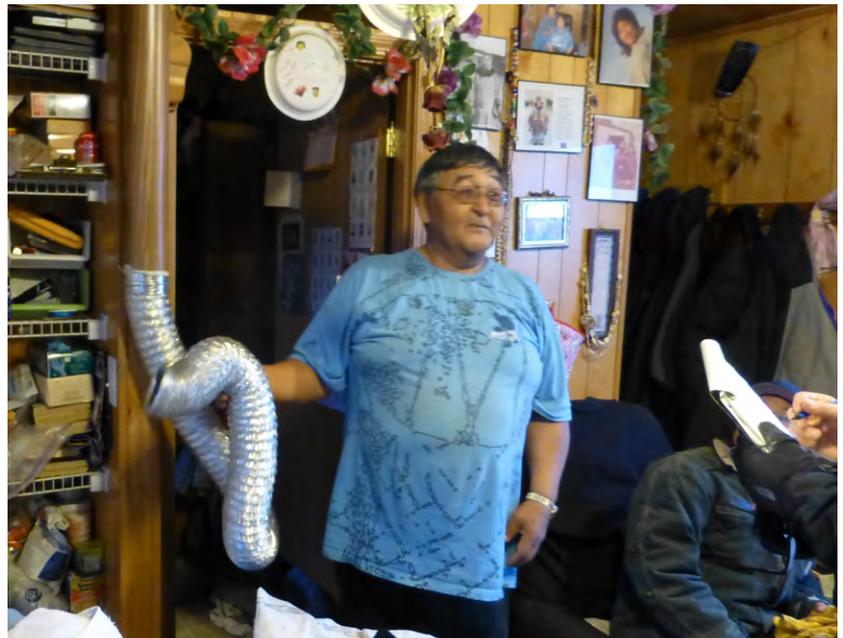
Harvey and Mary Tinker House. The resident has constructed a passive air exit vent that can be moved to the floor or higher in the home during the winter and summer, respectively. The intake air is through a Fresh 80 vent.
